A Database of Damaging Earthquakes of Moment Magnitude from 4.0 to 5.5 (Part 2)

**Cecilia I Nievas, Michail Ntinalexis, Danai Kazantzidou-Firtinidou,
Jovana Borozan, Marialuigia Sangirardi, Helen Crowley & Julian J
Bommer**

Datum March 2019

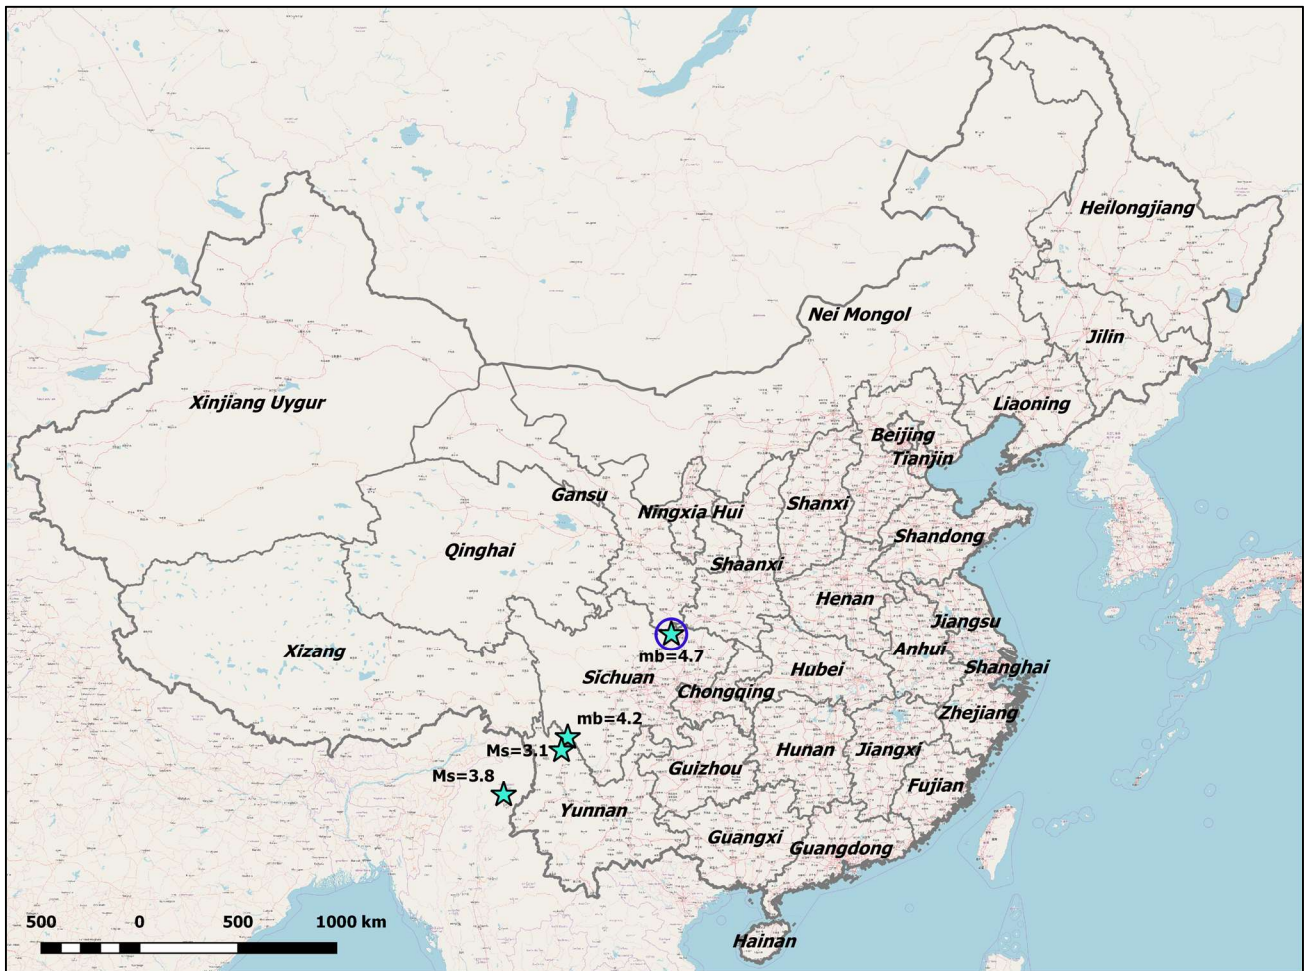
Figure 2.2. Potential earthquakes identified by the computer code as the possible Sichuan earthquake of 22nd September 2015. Selected event marked with a circle.

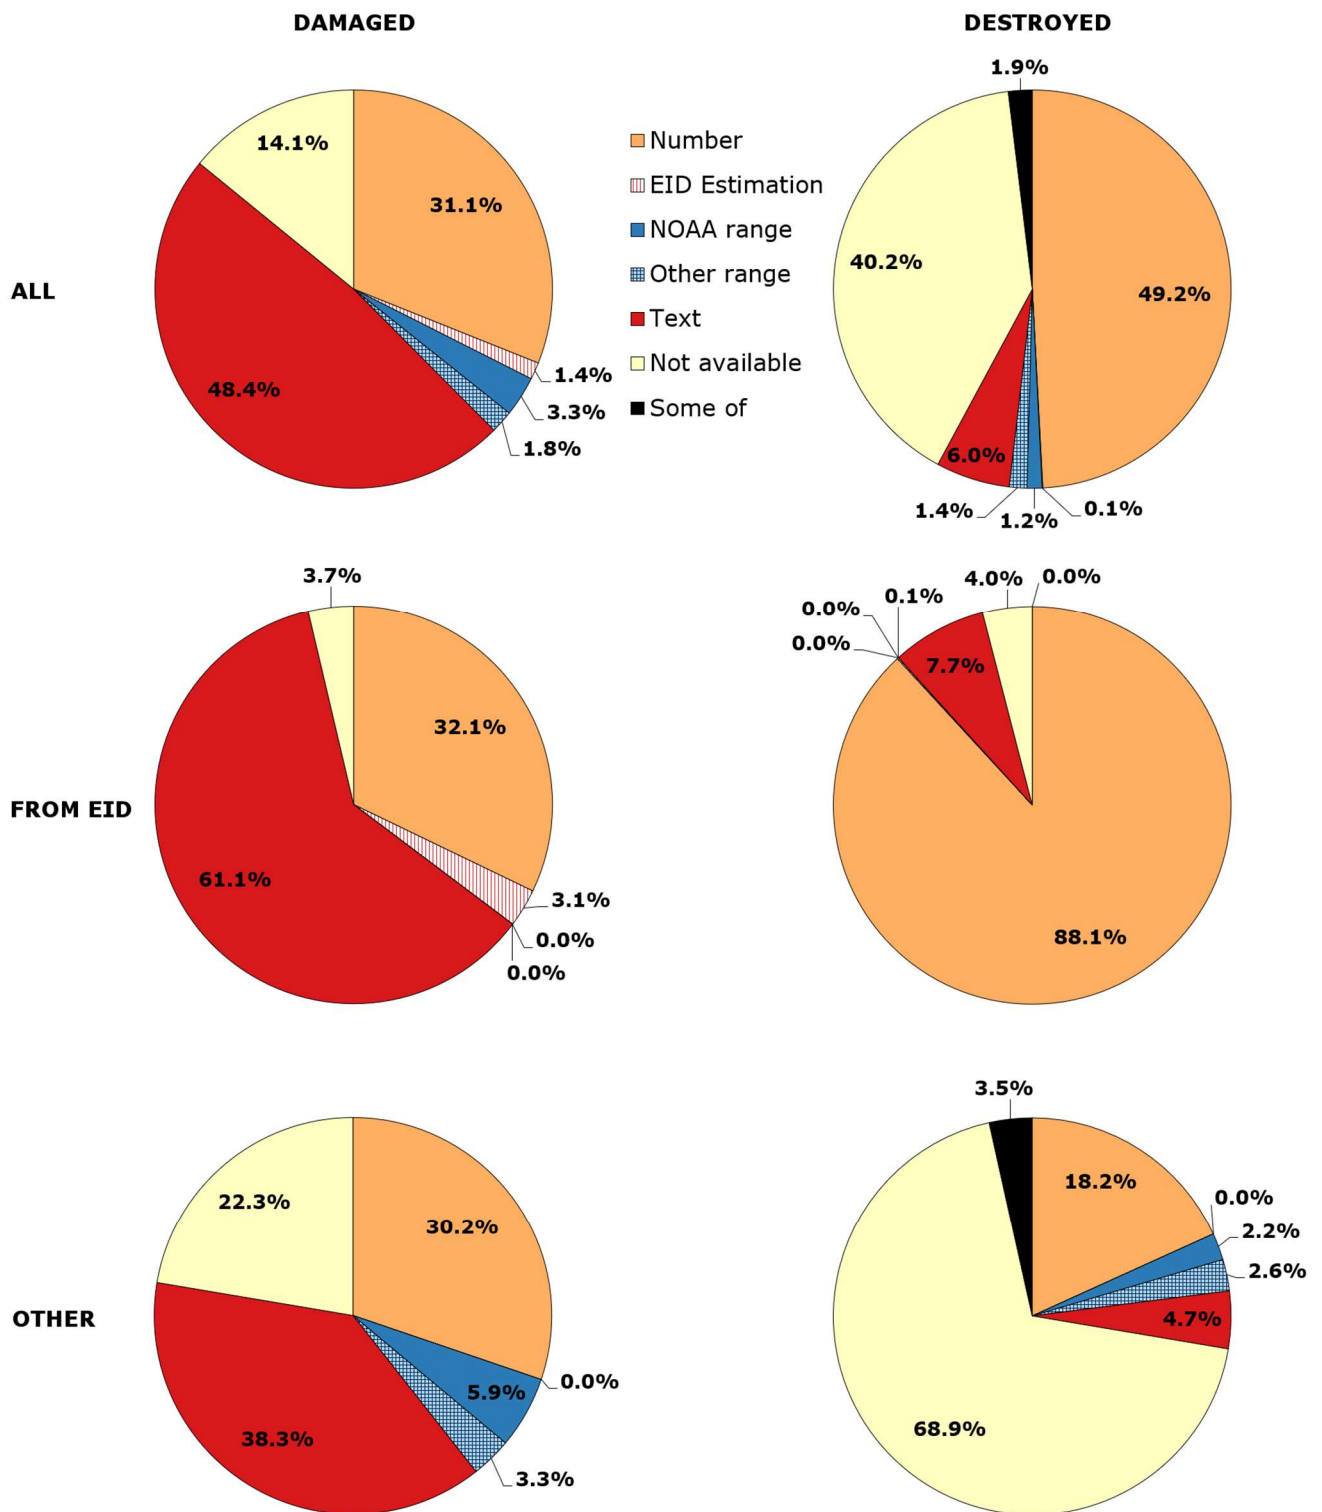
Figure 2.11. Kind of information available regarding damaged (left) and destroyed (right) buildings for the whole of the Database of Damaging Small-to-Medium Magnitude Earthquakes (top) and for earthquakes retrieved from the EID (centre) and all other sources (bottom).

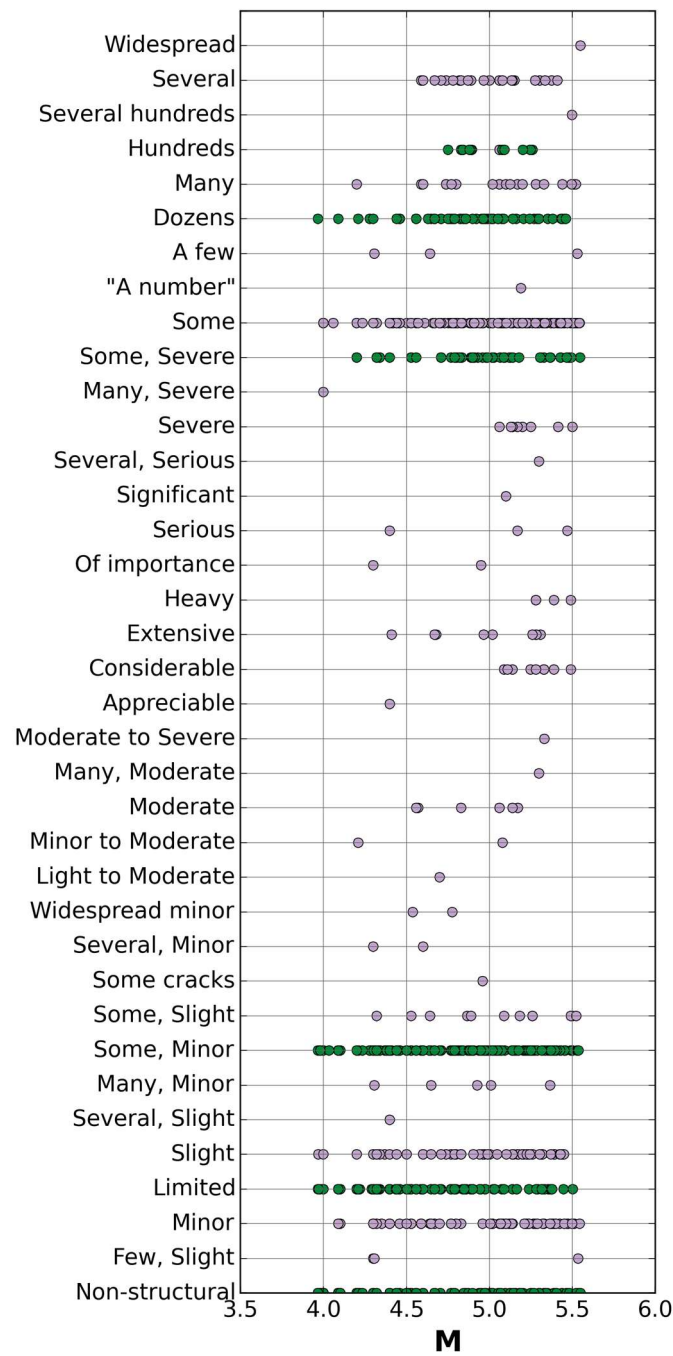
Figure 2.15. Descriptions of damage of damaged buildings as a function of moment magnitude for the whole of the Database of Damaging Small-to-Medium Magnitude Earthquakes for which only verbal descriptions were found (948 earthquakes). Green and lilac indicate events retrieved from the EID and all other sources, respectively.

As mentioned earlier, Figures 2.15 and 2.16 gather information on the cases for which only verbal descriptions were available: 948 earthquakes in the case of damaged buildings and 118 earthquakes in the case of destroyed buildings. There are five and one earthquakes with verbal descriptions of damaged and destroyed buildings, respectively, that are not depicted in Figures 2.15 and 2.16 due to their descriptions being too specific. These are four cases in which a percentage of damaged buildings is given and two cases in which the name of a village considered to have suffered damage/destruction to 100% of its buildings is provided.

In Figure 2.15, the topmost nine descriptions (from “Widespread” until “Some”, inclusive) refer only to quantities of buildings, while the rest make reference as well to the kind of damage. It is clearly difficult to draw sound conclusions from verbal descriptions. However, it is noted that, in general terms, the most negative wording (e.g., severe, serious, significant, heavy, extensive, considerable, etc.) appears to be more commonly associated with larger magnitudes than lower magnitudes, as would be expected. Of the 410 earthquakes for which the description regarding damaged buildings is either “Non-structural”, “Limited” or “Some, Minor” (which represent 43% of the total cases depicted in Figure 2.15), 97% correspond to cases retrieved directly from the EID. It is interesting to note that, in general, these three expressions—which correspond to translations from damage levels 1, 1-2 and 2 as per Table 2.4—are associated with the complete range of magnitudes, while “some, severe” and “dozens”—damage levels 2-3 and 3—appear to cover the whole range as well but become more dense for $M>4.5$, and there are only a few instances of “hundreds”—damage levels 3-4 and 4—all with $M>4.7$.

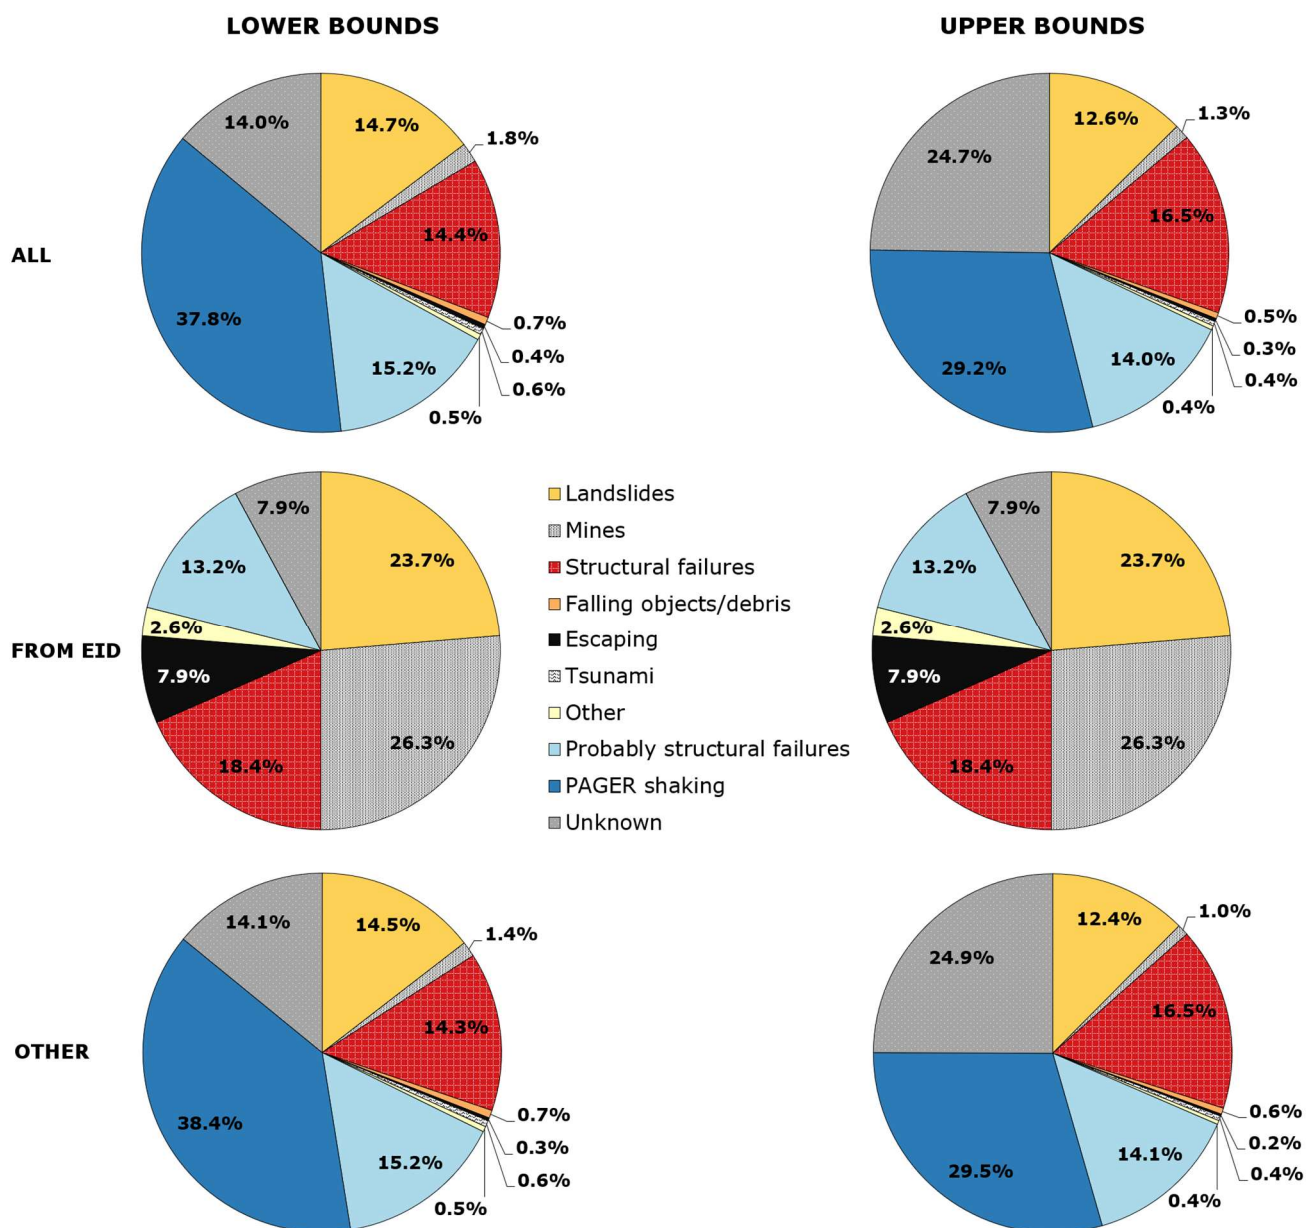
Figure 2.26 Causes of death for all total deaths excluding deaths attributed to heart attacks reported in the Database of Damaging Small-to-Medium Magnitude Earthquakes (top) and for earthquakes retrieved from the EID (centre) and all other sources (bottom), in terms of proportions of the number of deaths. Lower- and upper-bound values shown on the left and right, respectively. Total number of deaths (for the whole database): 2,307, lower bounds; 3,125, upper bounds.

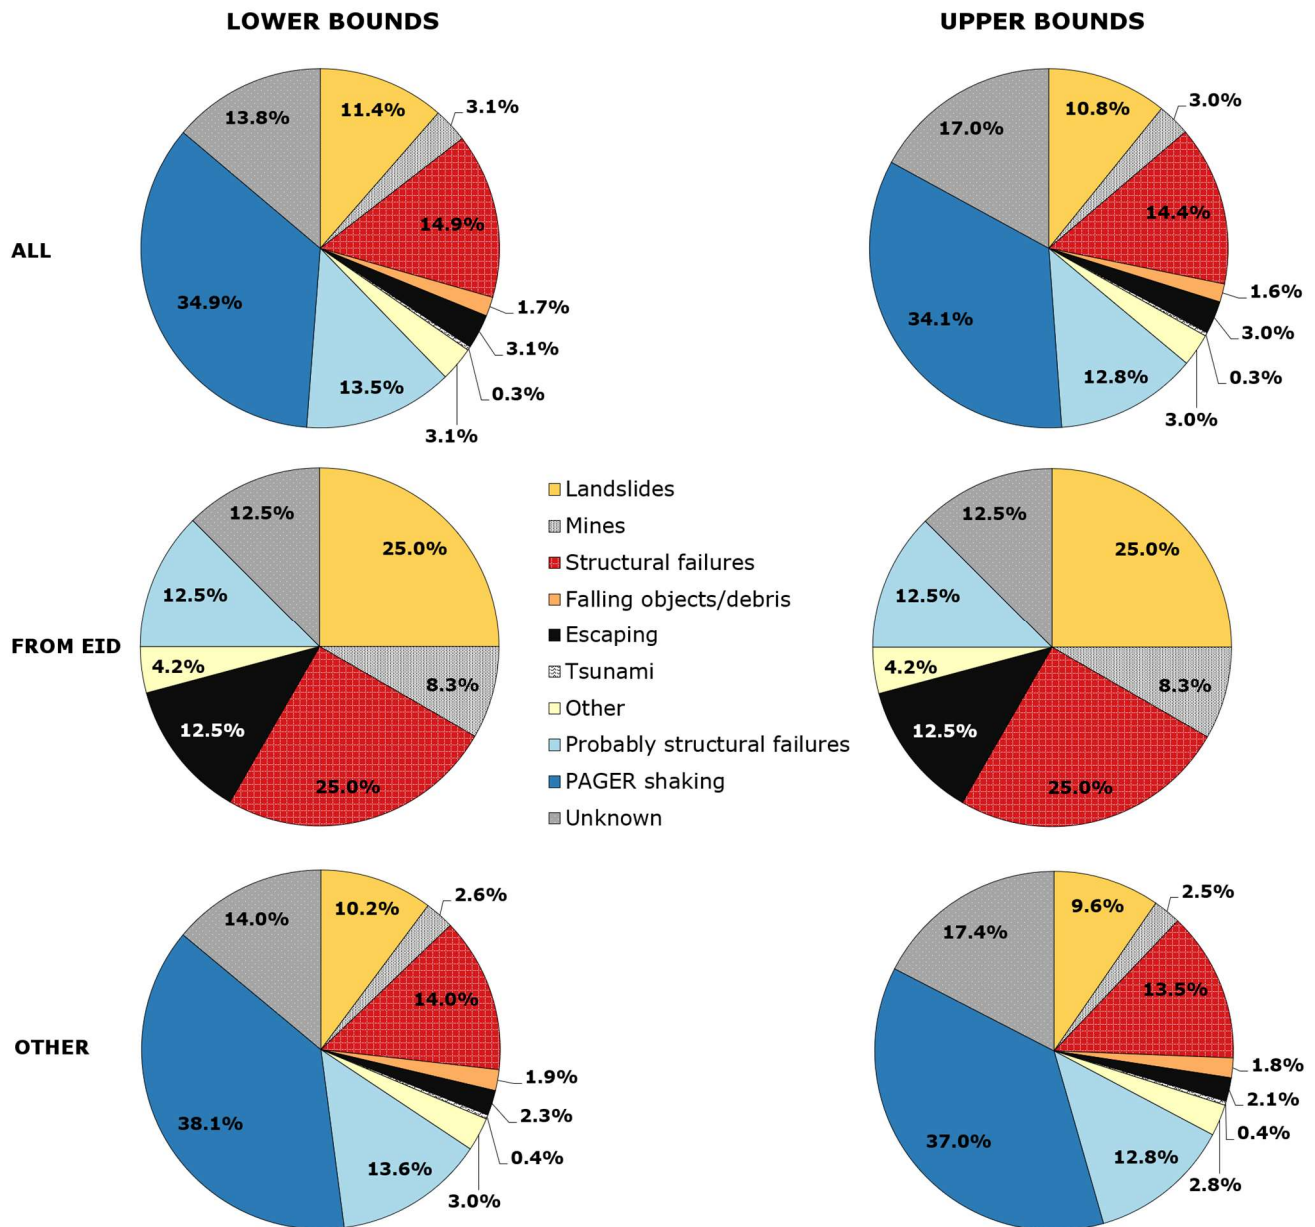
Figure 2.27 Causes of death for all total deaths excluding deaths attributed to heart attacks reported in the Database of Damaging Small-to-Medium Magnitude Earthquakes (top) and for earthquakes retrieved from the EID (centre) and all other sources (bottom), in terms of proportions of the number of instances. Lower- and upper-bound values shown on the left and right, respectively. Total number of instances (for the whole database): 289, lower bounds; 305, upper bounds.

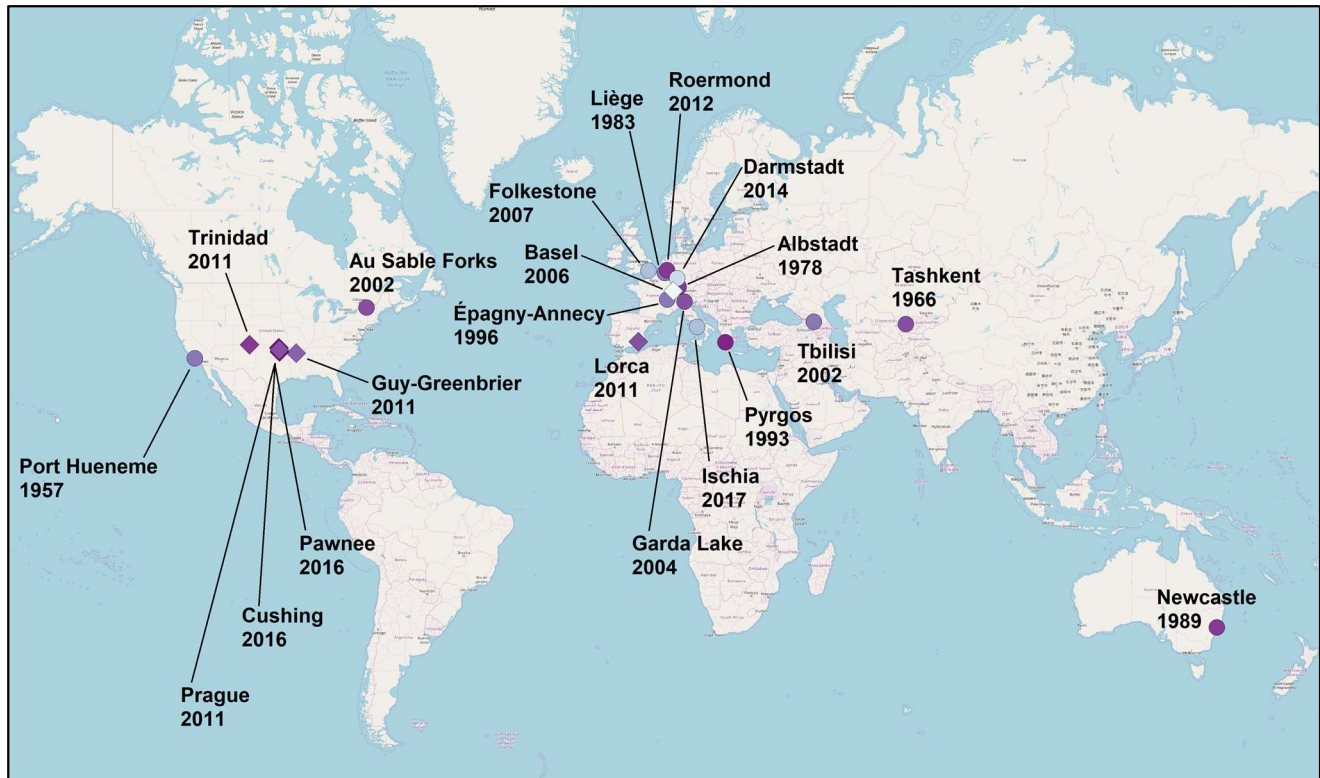
Figure 4.1. Epicentral locations of the earthquakes studied in detail as case histories. Rhombuses and circles indicate induced/triggered and tectonic origins, respectively. Colour scale indicates moment magnitude, from **M**3.4 (light purple) through **M**5.8 (dark purple).

Twenty-one earthquakes have been studied in detail in the present report, including eight believed to be of induced origin. Their locations and magnitudes are depicted in Figure 4.1 and Tables 4.1 and 4.2. This is too small a sample to allow any general conclusions to be drawn that would be applicable to the potential effects of moderate-magnitude seismicity, but nonetheless several significant observations can be made regarding the nature and impact of these earthquakes. The detailed case histories are contained in Appendices III and IV.

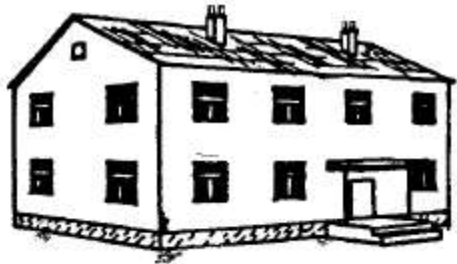
<p>Grade 1: Negligible to slight damage (no structural damage, slight non-structural damage) Hair-line cracks in very few walls. Fall of small pieces of plaster only. Fall of loose stones from upper parts of buildings in very few cases.</p>

Damage is classified into five grades, defined separately for masonry and reinforced concrete buildings. Figures A2.1.2 and A2.1.3, extracted from Grünthal (1998), define said damage grades.

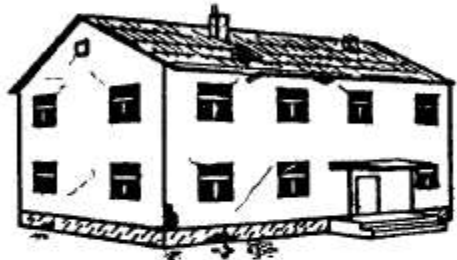
<p>Grade 2: Moderate damage (slight structural damage, moderate non-structural damage) Cracks in many walls. Fall of fairly large pieces of plaster. Partial collapse of chimneys.</p>

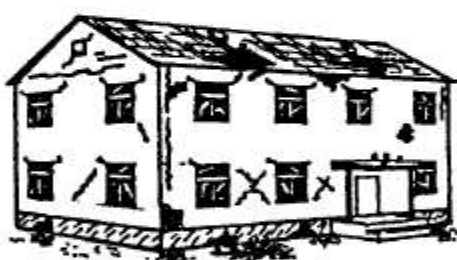
<p>Grade 3: Substantial to heavy damage (moderate structural damage, heavy non-structural damage) Large and extensive cracks in most walls. Roof tiles detach. Chimneys fracture at the roof line; failure of individual non-structural elements (partitions, gable walls).</p>

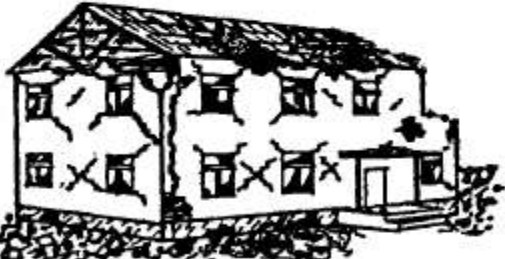
<p>Grade 4: Very heavy damage (heavy structural damage, very heavy non-structural damage) Serious failure of walls; partial structural failure of roofs and floors.</p>

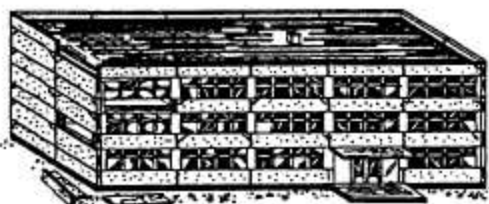
<p>Grade 3: Substantial to heavy damage (moderate structural damage, heavy non-structural damage) Cracks in columns and beam column joints of frames at the base and at joints of coupled walls. Spalling of concrete cover, buckling of reinforced rods. Large cracks in partition and infill walls, failure of individual infill panels.</p>

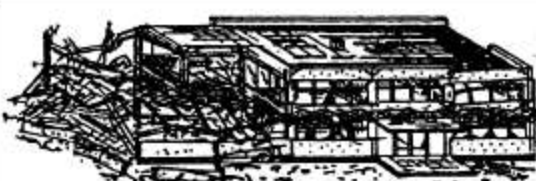
<p>Grade 5: Destruction (very heavy structural damage) Collapse of ground floor or parts (e. g. wings) of buildings.</p>

Figure A2.1.3. Definition of EMS-98 damage grades for reinforced concrete (RC) buildings.
From Grünthal (1998).

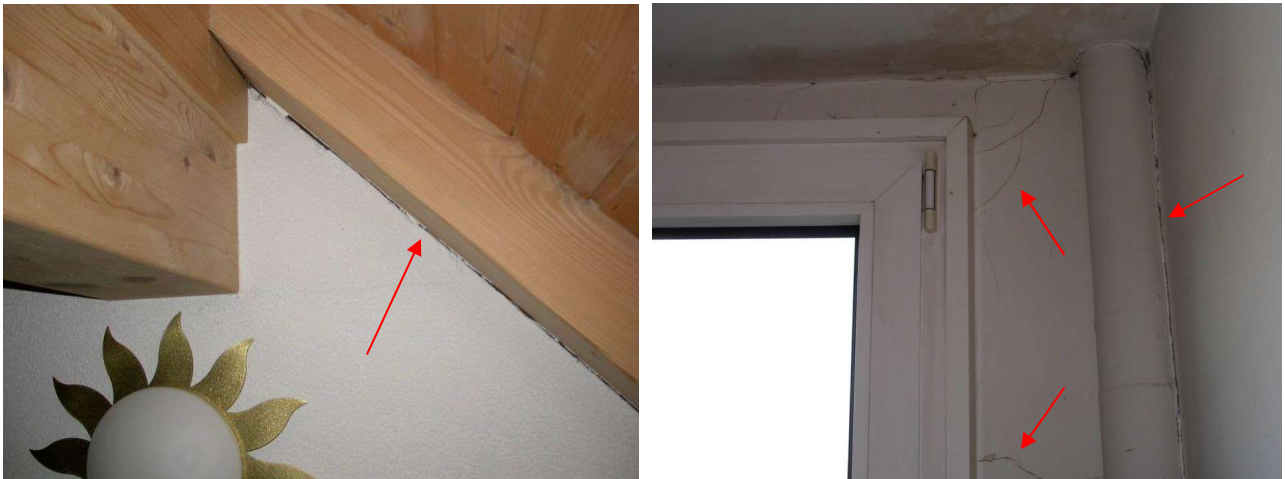
Figure A3.1.32. Crack in connection between wall and timber roof (left). Cracks in corner of a window (right).

Figures A3.1.32 through A3.1.34 show examples of the kind of damage observed.

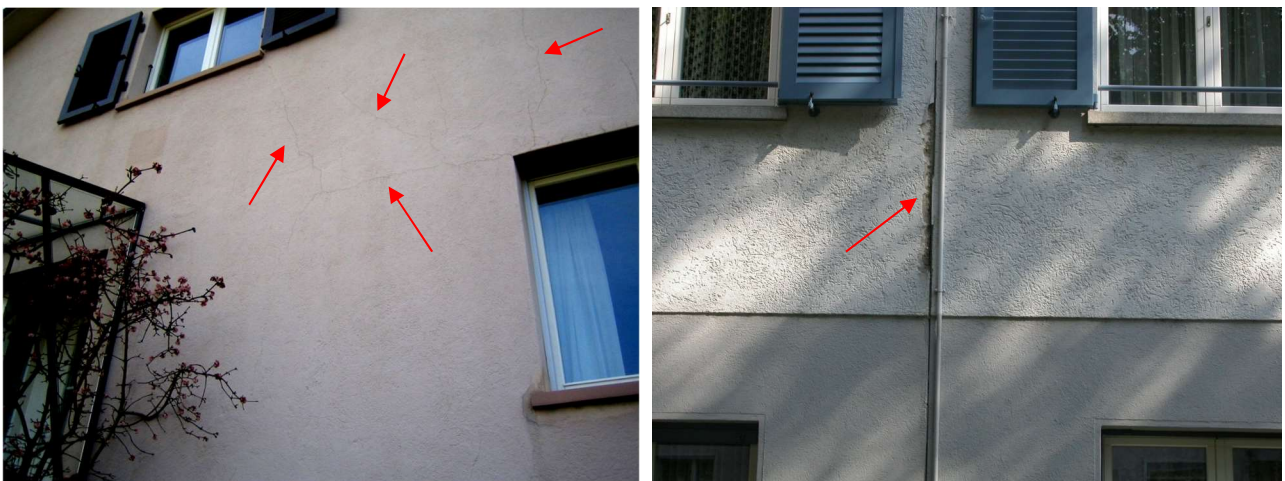
Figure A3.1.33. Hairline cracks in plaster (left). Minor plaster spalling (right).

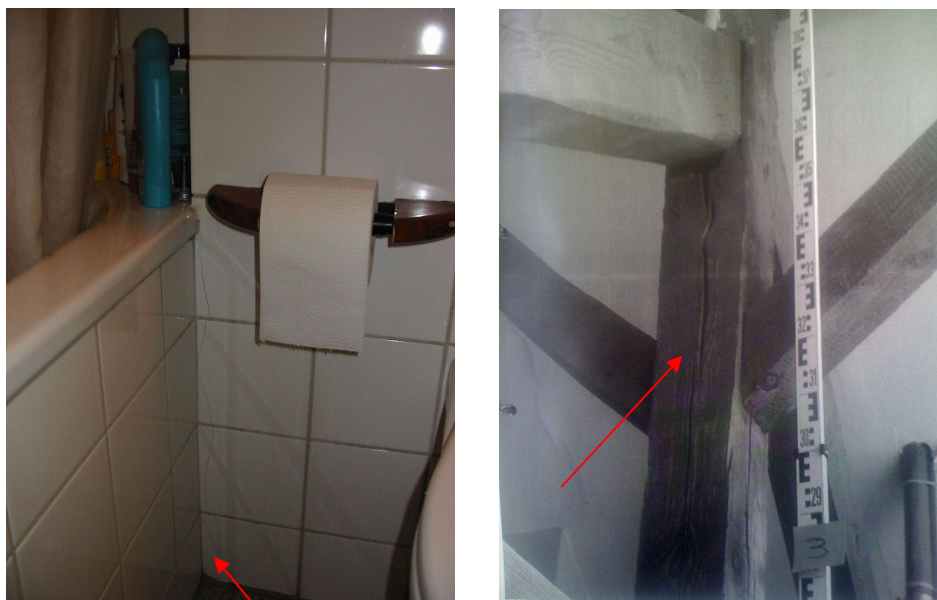
Figure A3.1.34. Crack in intersection of two perpendicular masonry elements (left). Crack parallel to the orientation of fibres in a timber element (right).

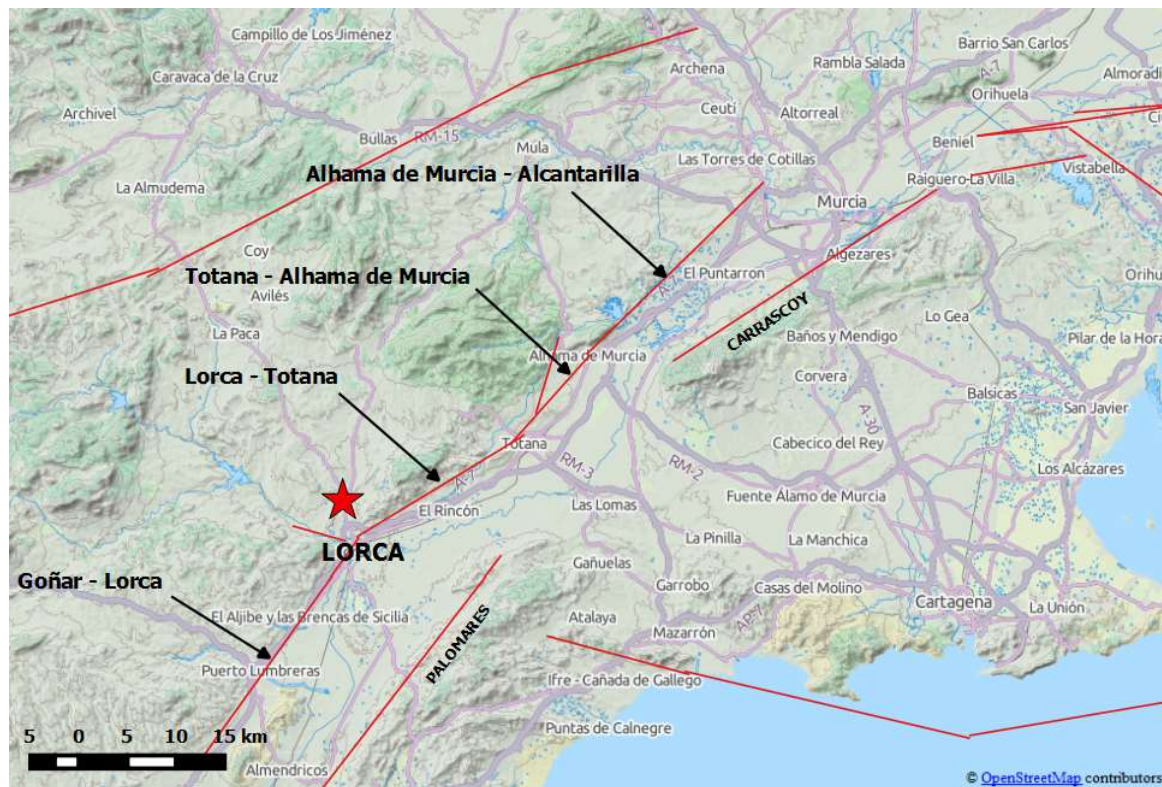
Figure A3.3.2. Segments that make up the Alhama de Murcia fault. The red star shows the location of the epicentre of the 11th May 2011 main shock, as reported by the Spanish National Geographic Institute (Instituto Geográfico Nacional, IGN). Location and dimension of faults in digital format obtained from García-Mayordomo *et al.* (2012)

It should be noted that other researchers (e.g., Pro *et al.*, 2014), indicate that the 2011 Lorca earthquake was not originated within the Alhama de Murcia fault itself, but along a secondary fault parallel to the latter, located to the north of the city of Lorca, called the Cejo de los Enamorados fault. Its location is not reported in the Quaternary Active Faults Database of Iberia (QAFI, García-Mayordomo *et al.*, 2012) and it is therefore not shown in Figure A3.3.2, but it approximately coincides with the epicentre reported by the Spanish National Geographic Institute (Instituto Geográfico Nacional, IGN) shown in the figure.

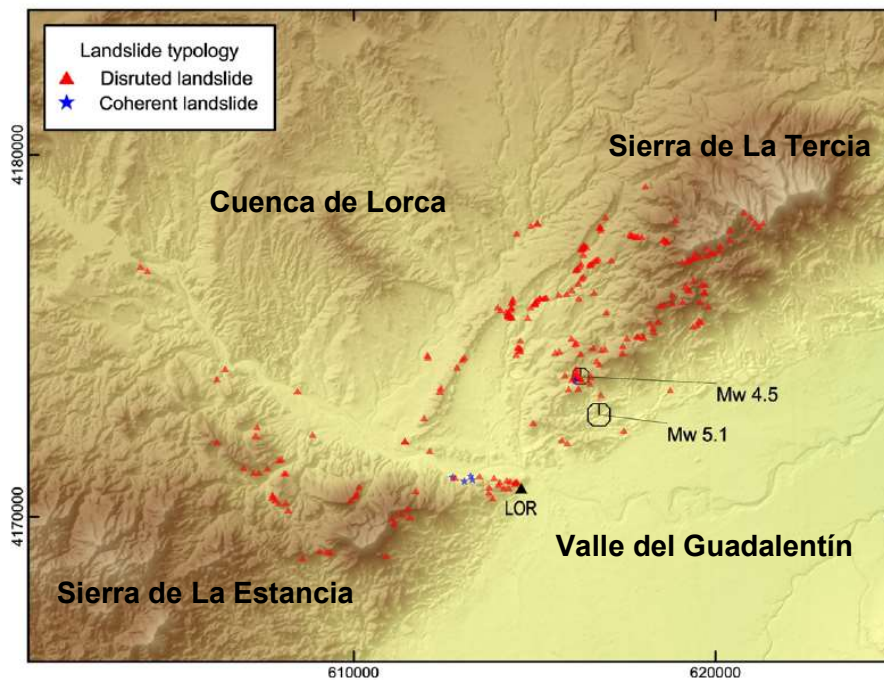
Figure A3.3.30. Landslides identified by Alfaro *et al.* (2012). "LOR" makes reference to Lorca station. From Alfaro *et al.* (2012).

highly-fragmented rocks and soil) over coherent (*i.e.*, unfragmented) ones, as defined by Keefer (1984), and highlight the fact that neither of them can be attributed to a singular event within the seismic sequence. Further, they also observed some instabilities along the Guadalentín river, which crosses the city. Those observed upstream were clearly earthquake-induced, while those downstream seemed to be the consequence of previous heavy rains, as explained by local land-owners. The maximum observed distances from the epicentre of the main shock to the landslides was 13.3 km for disrupted landslides and 4.4 km for coherent ones. Figure A3.3.30 shows the landslides they identified.

Alfaro *et al.* (2012) and Rodríguez-Peces *et al.* (2014) coincide in saying that landslides were more common in Miocene materials such as calcareous sandstones, conglomerates and marls, followed by argillites, gypsums, fine-grained soil, phyllite/slate, and coarse-grained soil.

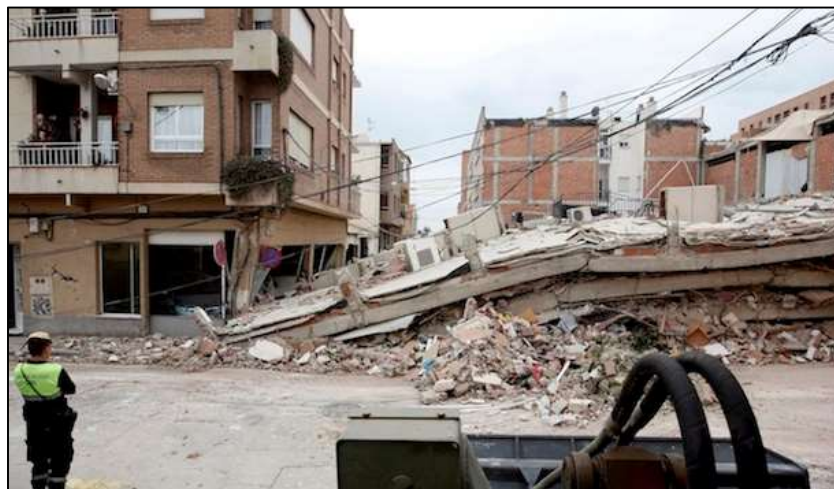
The RC building that collapsed during the main shock was located in La Viña neighbourhood, an area that was particularly damaged, as reported in the Damage Distribution section. This building was a 10-year old, 3-storey residential structure, with a partially subterranean parking lot constructed on a slope. The collapse was due to the short column effect of the parking level columns, as it became clear from a neighbouring building with similar characteristics whose columns exhibited damage associated to this phenomenon (Cabañas Rodríguez *et al.*, 2011). While collapsing, the building across the street was hit and damaged. Figure A3.3.36 shows the collapsed building.

Figure A3.3.36. Building located in La Viña neighbourhood which collapsed during the main shock (Meteoweb, 2016). A street runs in between the two buildings shown.

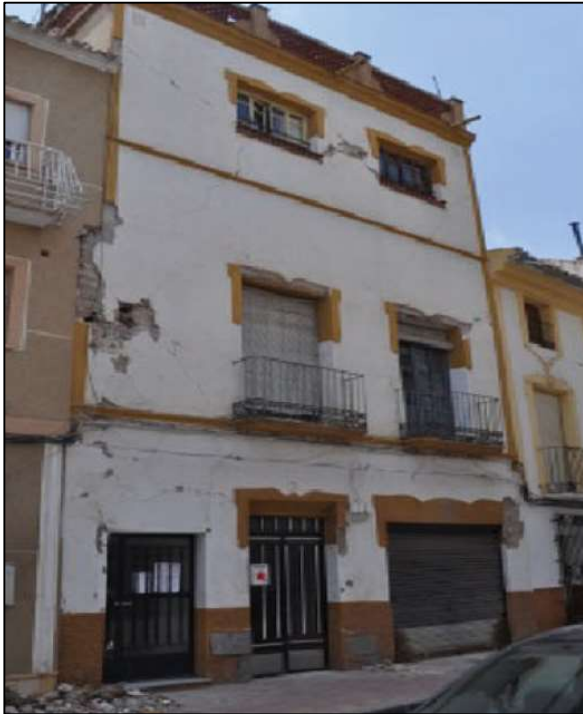
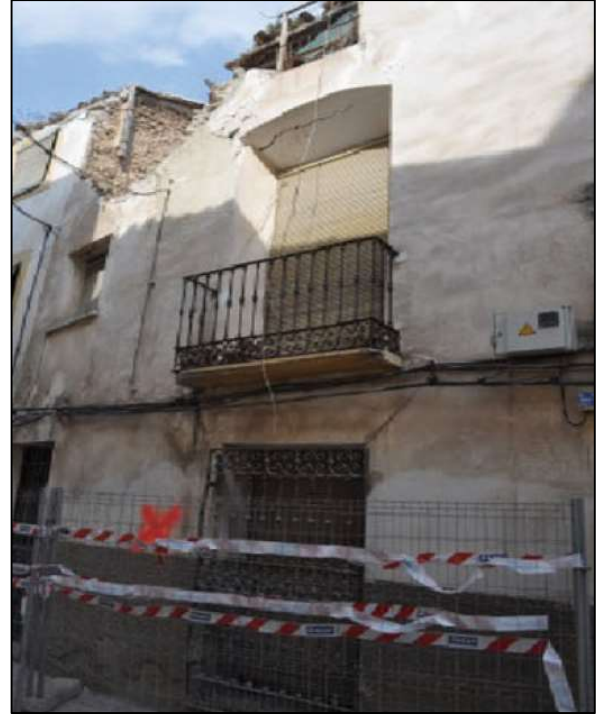
Figure A3.3.39. Examples of masonry buildings that suffered EMS-98 damage grade 3 (left) and 4 (right). From Basset-Salom & Guardiola-Víllora (2014).

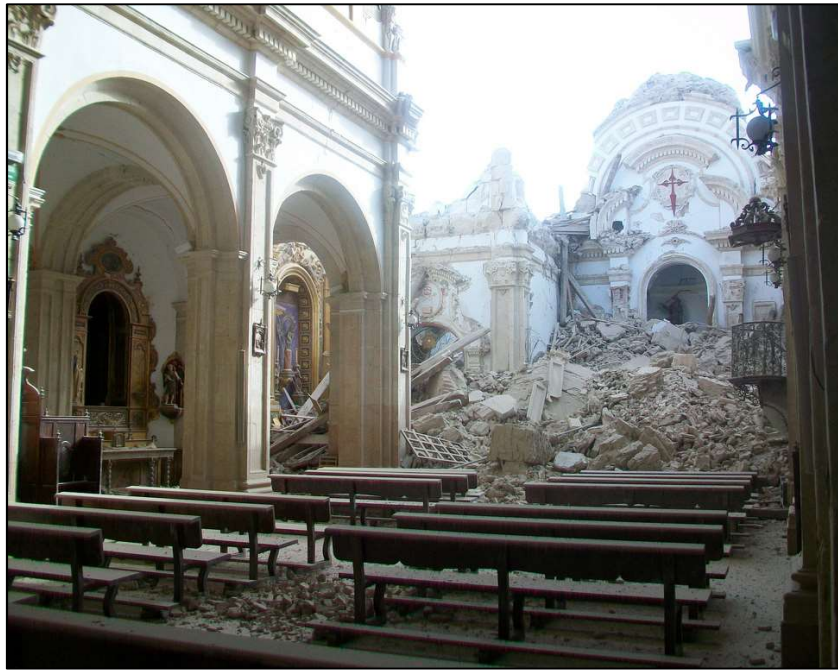
The possible examples of damages in churches are several, but that of the Church of Santiago is of particular interest not only due to its severity but also to the fact that said building had been retrofitted in the 1960s. At that time, the dome and transept area were strengthened using reinforced concrete with the aim of providing some kind of diaphragm action (Romão *et al.*, 2013; Feriche *et al.*, 2012). During the main shock, the dome, roof and vaults collapsed, as shown in Figure A3.3.40.

Figure A3.3.40. Collapse of the transept area of the Church of Santiago (Wikipedia).

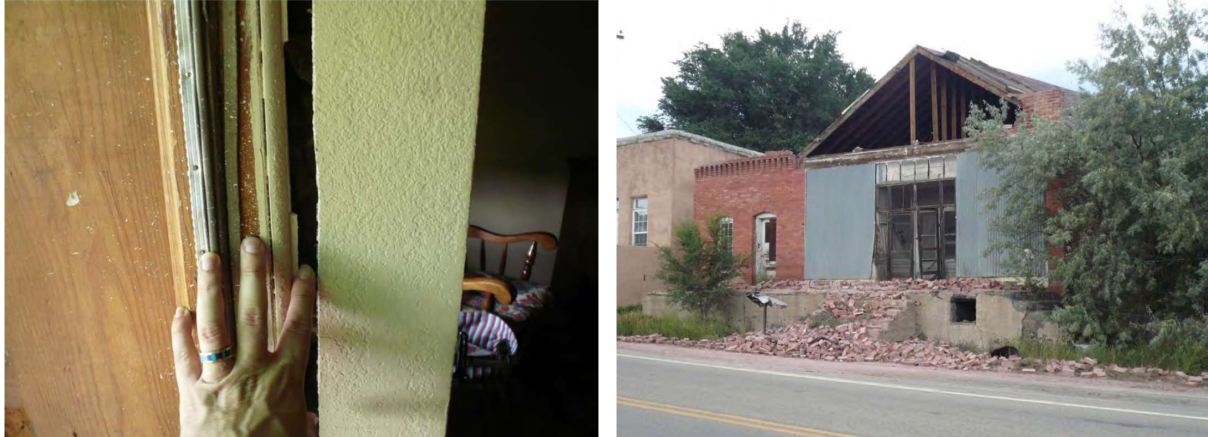
Figure A3.4.19. Damage observed at Segundo: on the left, the exterior wall pulled away approximately 2.5 cm from the interior wall; on the right, the front of this brick building collapsed (Morgan & Morgan, 2011).

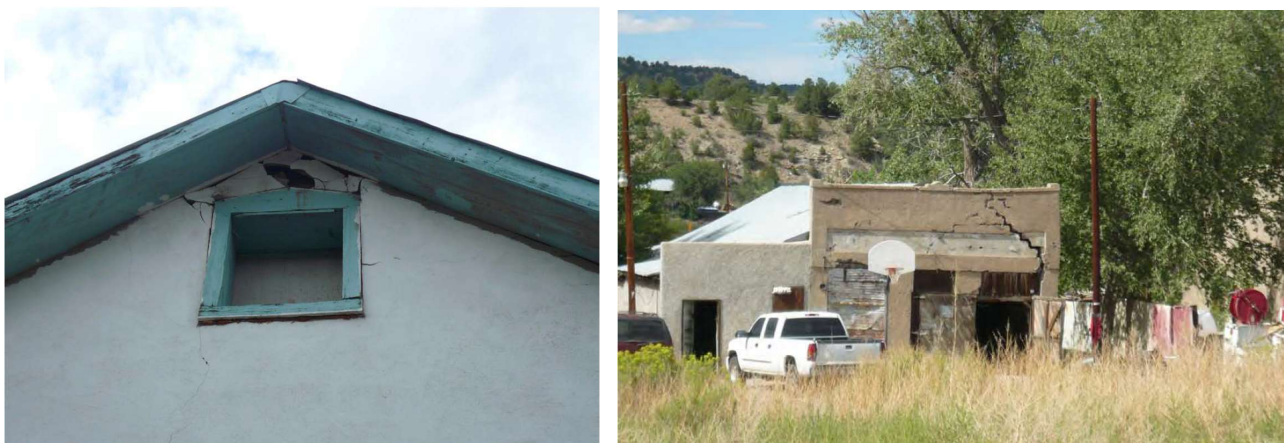
Figure A3.4.20. Major brick damage to a home in Segundo (left) and to a garage in Valdez (right) (Morgan & Morgan, 2011).

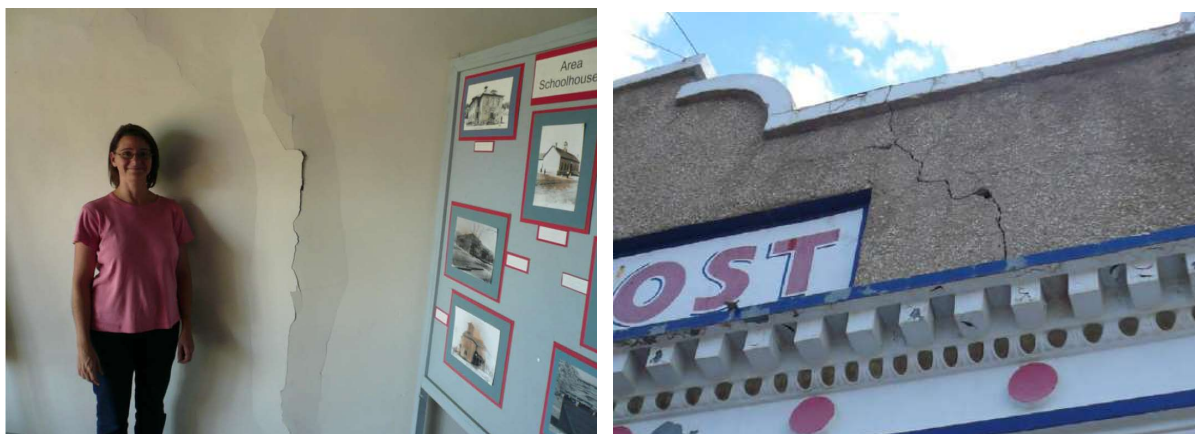
Figure A3.4.21. A 3 metres long vertical crack in the building of the Cokedale post office/city hall (left); cracked plaster on a façade in Segundo (Morgan & Morgan, 2011).

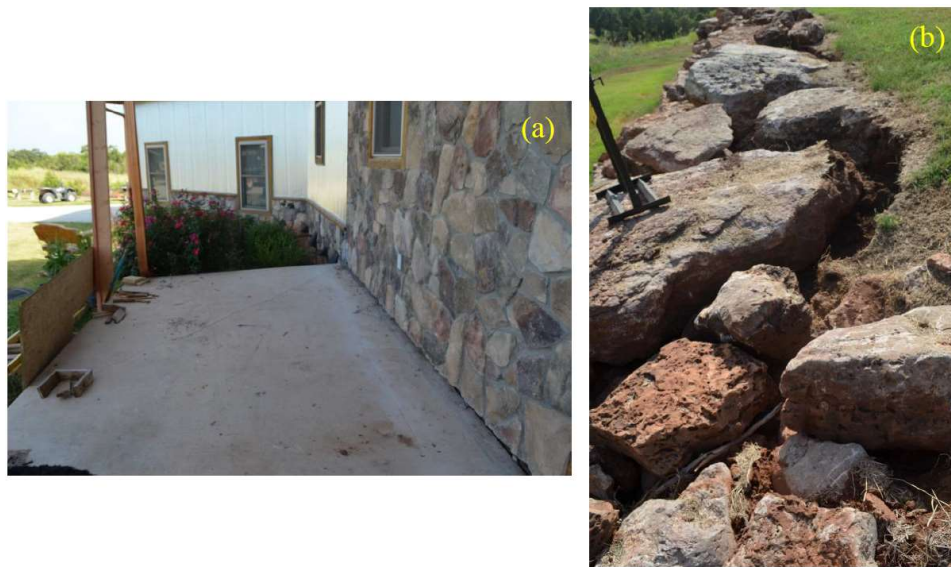
For the case of the 2016 **M5.8** Pawnee earthquake, Clayton *et al.* (GEER report, 2016) describe a small slump failure that caused a 4-cm settlement of a private house (marked as “Porche settlement” in Figure A3.5.40). The property owner expressed that the site had been experiencing ground displacements before the earthquake, but that the shaking had played a role in aggravating the situation. Figure A3.5.39 shows photos of the settlement (left) and the slope failure (right).

Figure A3.5.39. Porch settlement (left) and slump failure causing it (right) due to the 2016 **M5.8** Pawnee earthquake. From GEER report (Clayton *et al.*, 2016).

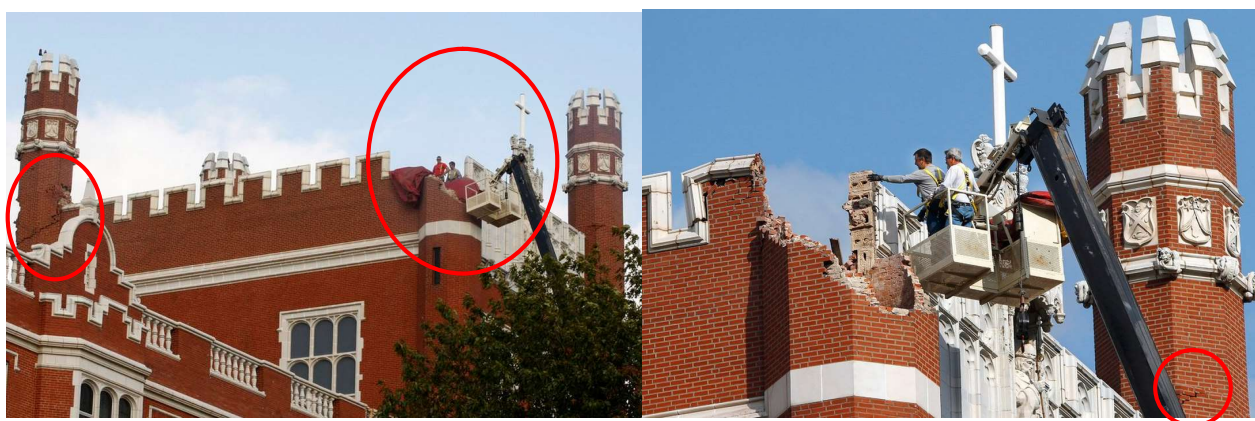
Figure A3.5.46 shows the damage to Benedictine Hall, a five-storey administrative building at St. Gregory's University, in Shawnee, built in 1915, one of whose 7-8 metre four towers collapsed (Reuters, 2011). According to Brad Collins, spokesman for the University, and as can be observed in Figure A3.5.46, the other three towers also sustained damage (Fox News, 2011).

Figure A3.5.46. Damage to one of the towers of Benedictine Hall at St. Gregory's University in Shawnee after the **M5.7** 2011 Prague main shock. Photos by Jim Beckel, from News OK (2011).

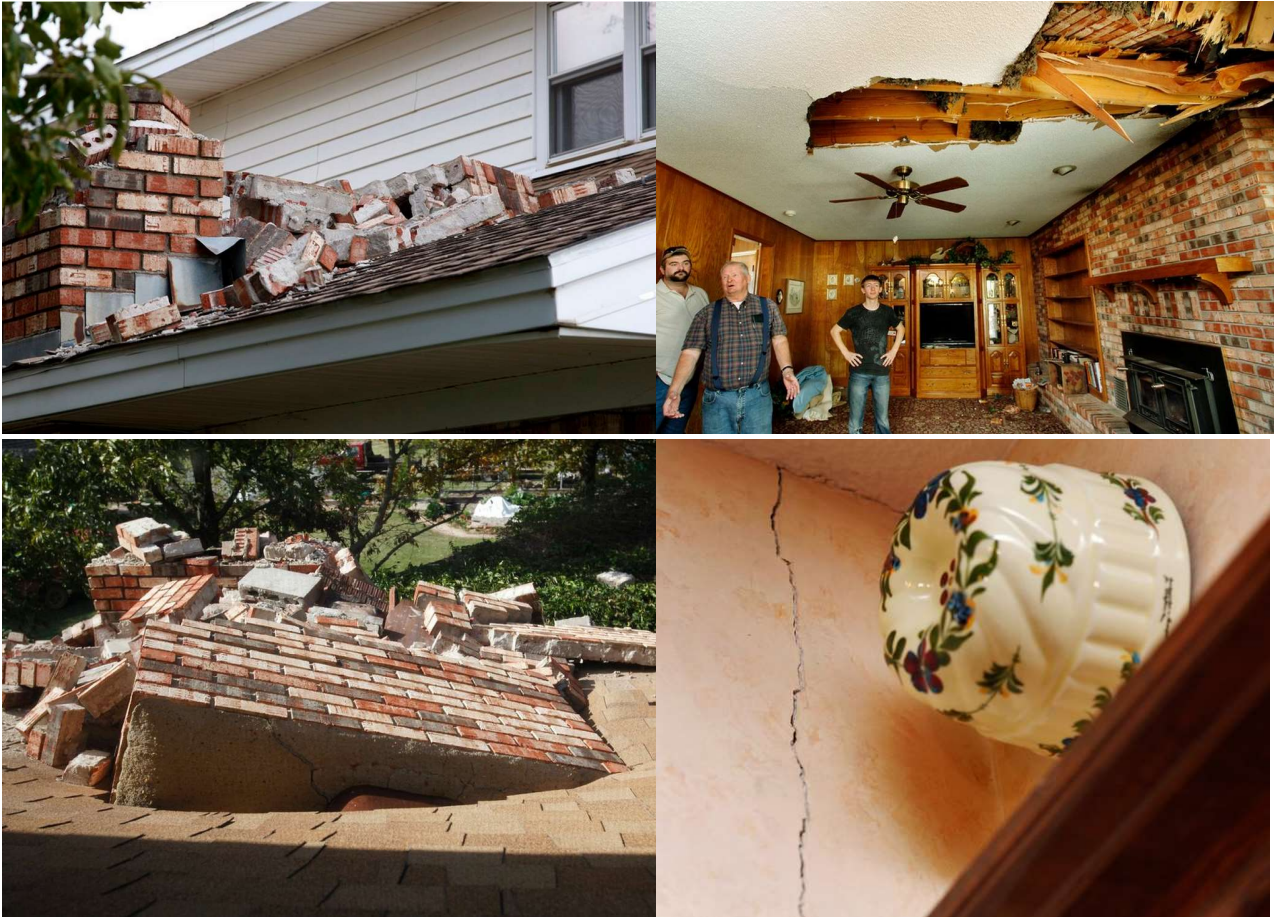
Figure A3.5.47. Damage to a house in Sparks. The chimney toppled over the roof. Photos by Sue Ogrocki (News OK, 2011).

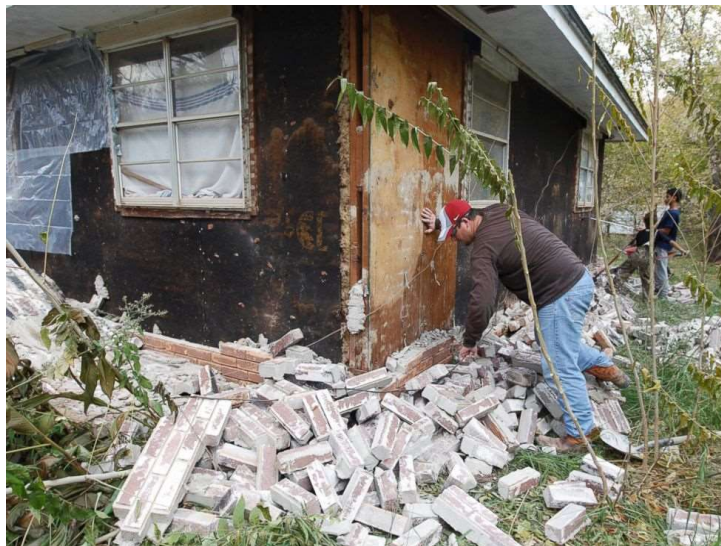
As shown in Figure A3.5.48, the façade bricks of a house in Sparks almost completely detached from its wood-frame structure. News 9 (2011) reports quite extensively on this case, but does not mention any structural damage to the house.

Figure A3.5.48. Façade bricks detached from the wood-frame structure of a house in Sparks. Photo by AP PHoto as in ABC News (2015).

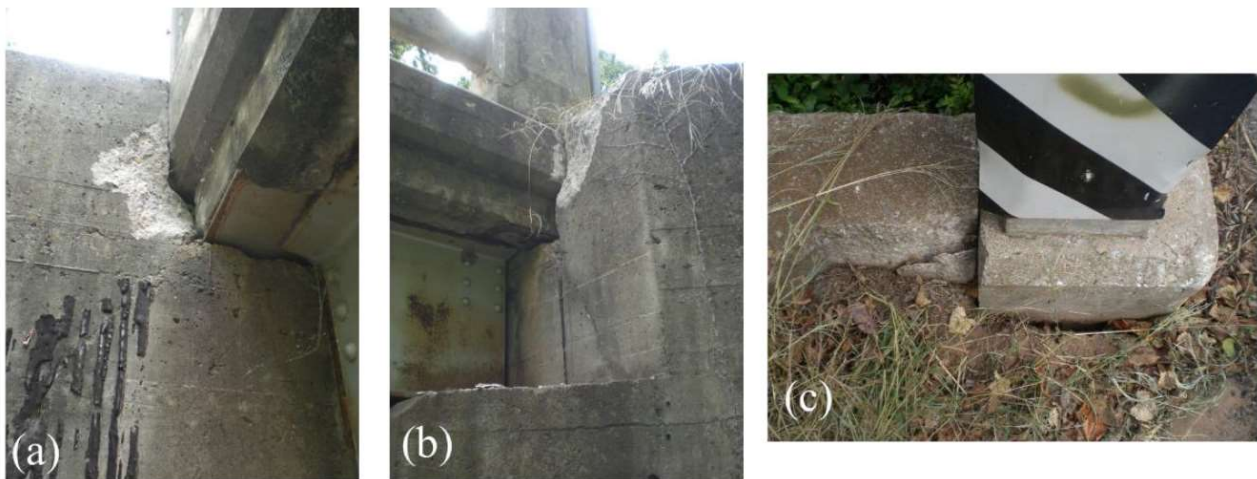
girder bridge built in 2012 to the east of Pawnee, suffered from minor cracking in a sidewalk over the approach slab, but no damage to the bridge structure itself. The Belford Bridge, a 5-span steel truss bridge over the Arkansas river, presented spalling of cover concrete on top of the abutments, which may be due to pounding between the latter and the deck, gapping between the backfill soil and the abutment backwall, and 1-2 cm wide cracks in the soil beneath the bridge at both abutments (Figure A3.5.50). According to the meta-data of the photo and KML files of Clayton *et al.* (2016), fractured anchored bolts were observed too, but corrosion appeared to be severe and the bolts may have broken before the earthquake. The bridge on Oklahoma Highway 18 over the Arkansas river, to the east of the Belford Bridge, did not suffer any damage.

Figure A3.5.50. Damage at the west abutment of Belford Bridge, which may be due to the 2016 M5.8 Pawnee earthquake: spalling of concrete (left and centre) and 4-cm wide gap between backfill soil and abutment. From GEER report (Clayton *et al.*, 2016).
