A Database of Damaging Earthquakes of Moment Magnitude from 4.0 to 5.5 (Part 2)

**Cecilia I Nievas, Michail Ntinalexis, Danai Kazantzidou-Firtinidou,
Jovana Borozan, Marialuigia Sangirardi, Helen Crowley & Julian J
Bommer**

Datum March 2019

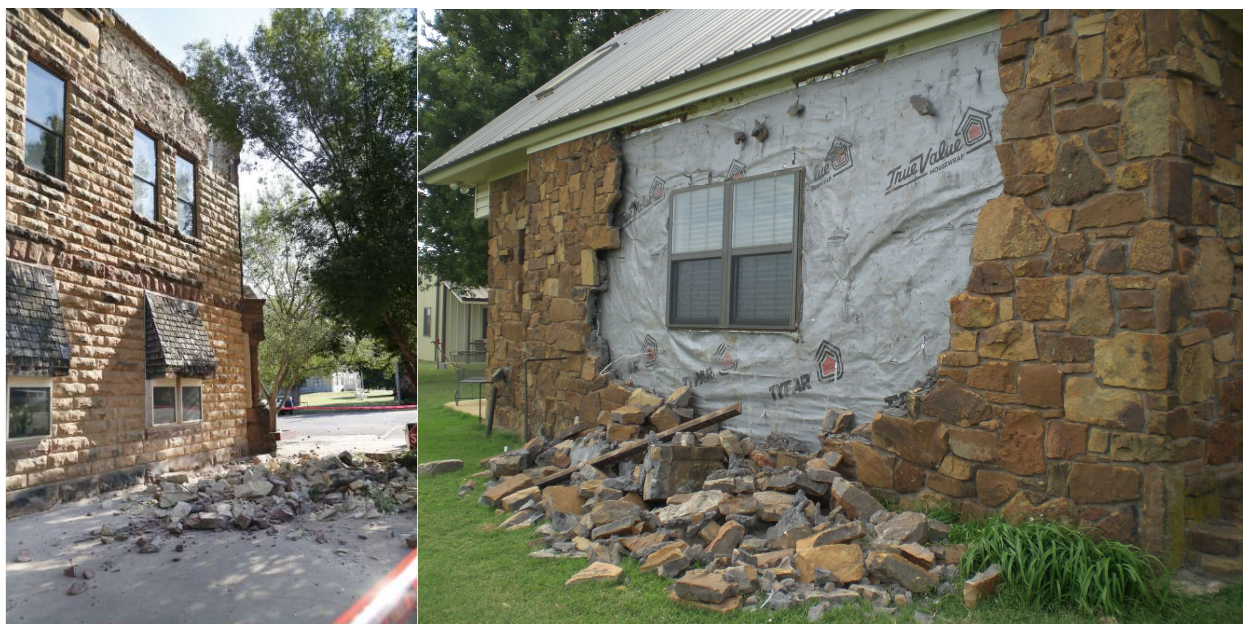
Though not mentioned in the GEER report (Clayton *et al.*, 2016), a fourth historic building in downtown Pawnee suffered from damage. The Arkansas Valley National Bank building, which is more than 110 years old, had several of its hand-cut sandstone façade blocks fallen over the sidewalk, as shown in Figure A3.5.52 (News OK, 2016b). This building is the one that seems to have received the most media coverage, possible due to its accessible location and the damage being visible from the outside (e.g., CNN, 2016b; NBC News, 2016; News OK, 2016b).

Figure A3.5.52. Examples of failures of stone façades: Arkansas Valley National Bank building (left, photo by Paul Hellstern, The Oklahoman, available from News OK (2016a), and a single-family residential house (right, photo from GEER report, Clayton *et al.*, 2016).

The GEER team did, however, observe failures of stone façades of residential buildings and noted that the stones tended to either have no mechanical connection with the structure or had an insufficient number of anchors. For example, the façade shown in Figure A3.5.52 (right) had metal strap anchors spaced at 1 to 3 metres intervals. Leaving aside the three historic sites mentioned above, two out of the five remaining buildings marked in in Figure A3.5.49 experienced façade failure, three had collapsed chimneys, and two had cracks in interior walls and finishes. In addition, one seemed to have

With respect to the 2016 Pawnee event, Clayton *et al.* (2016) point out that the lack of appropriate mechanical anchorage between stone façades and structures appears to be frequent around the area of Pawnee. Given that a large proportion of the damage observed was related to the failure of stone façades, it can be inferred that this weakness had a decisive role in the aftermath of this earthquake. From the report by Taylor *et al.* (2017) and the photo gallery of the EERI Oklahoma USA Earthquakes Clearinghouse (2016) it can be inferred that something similar occurred in Cushing with the lack of connection between the inner and outer wythes of unreinforced masonry walls, which resulted in the outer wythes easily undergoing out-of-plane failures.

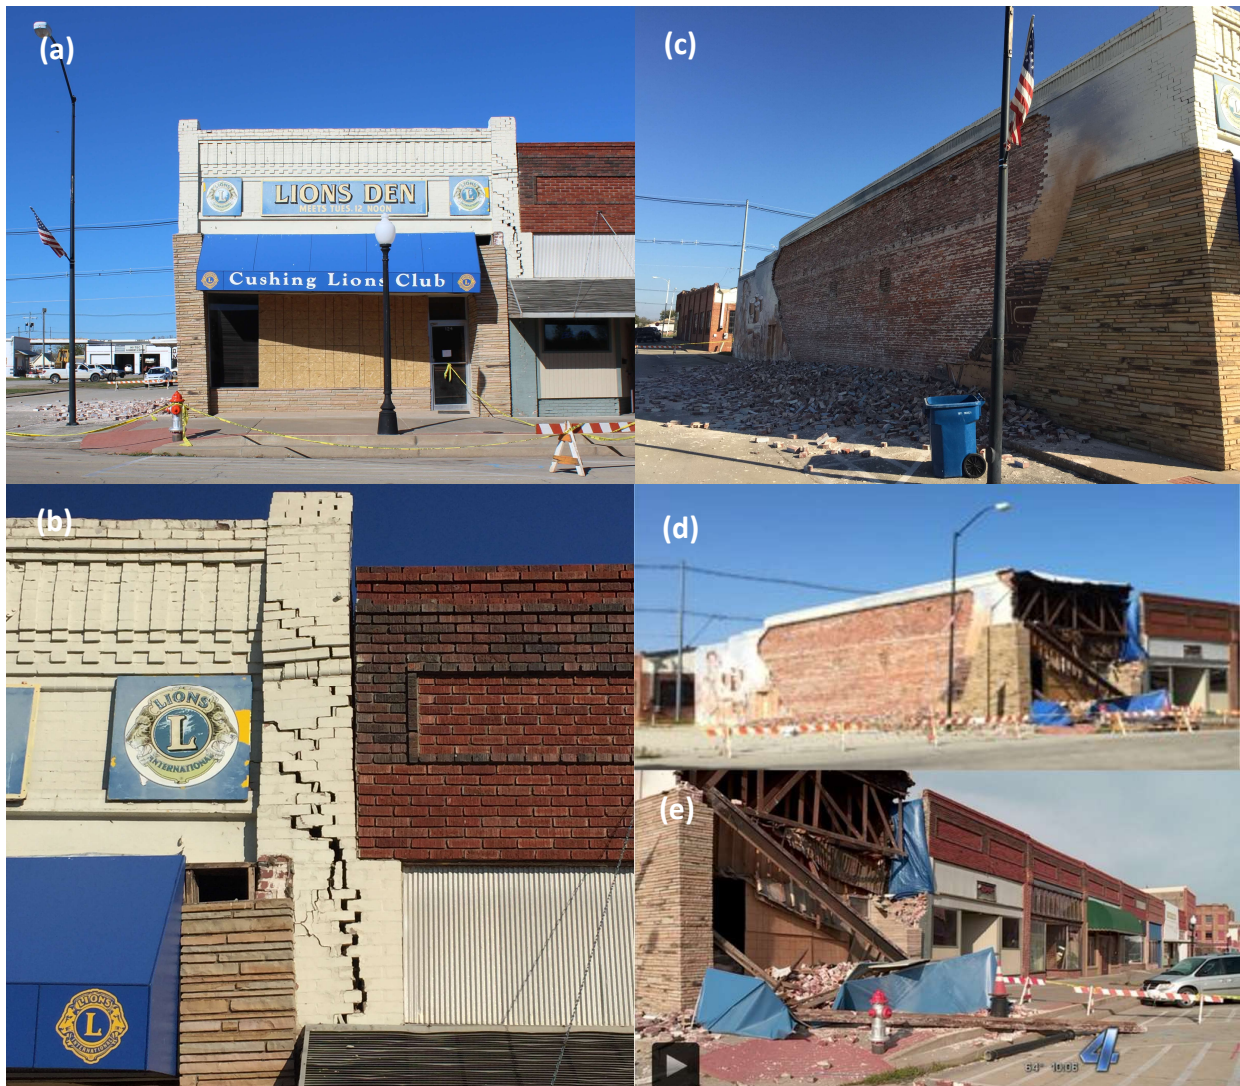
Figure A3.5.54. Damage sustained by the Lion's Den: (a) Residual deformation (photo by E. Jampole, from EERI Oklahoma USA Earthquakes Clearinghouse, 2016); (b) severe cracking in structural masonry wall (photo by A. Masroor, from EERI Oklahoma USA Earthquakes Clearinghouse, 2016); (c) failure of outer wythe of façade brickwork on side wall (photo by A. Masroor, from EERI Oklahoma USA Earthquakes Clearinghouse, 2016); (d) failure of façade in March 2017 (from 1600KUSH, 2017); (e) failure of façade in March 2017 (KFOR, 2017).

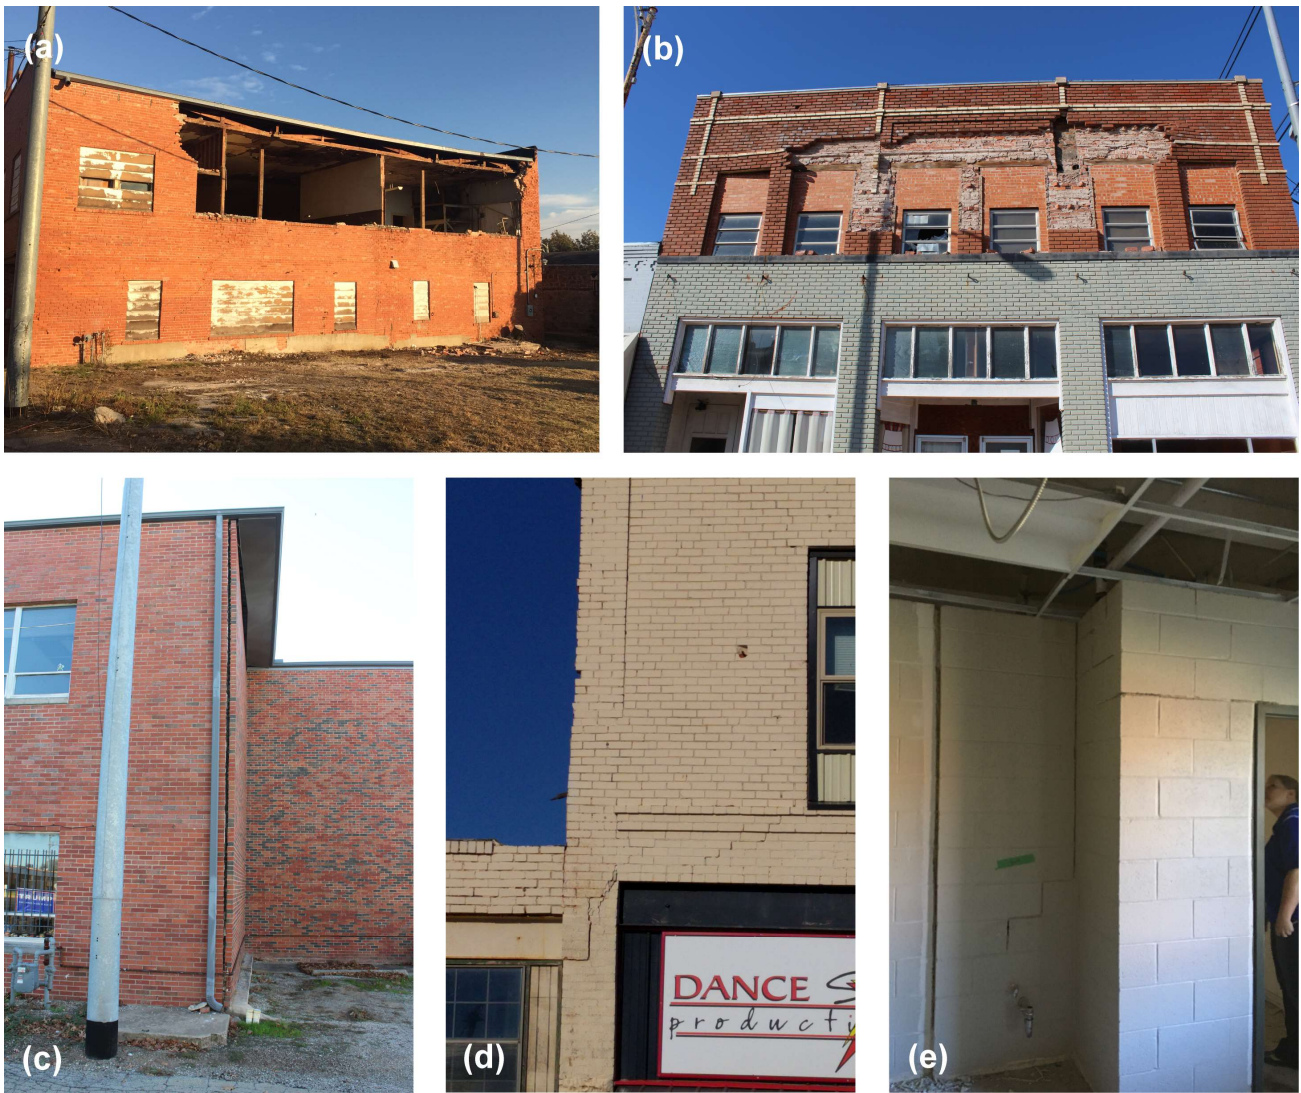
Figure A3.5.56. Examples of damage of unreinforced masonry buildings: (a) out-of-plane failure of an entire wall section of the Cushing Publishing building (not in use, photo by A. Masroor); (b) out-of-plane collapse and bulging of outer wythe (photo by E. Jampole); (c) brick façade separated from concrete masonry wall inner wythe at former St. Peter and Paul Catholic Church (photo by E. Jampole); (d) step cracks in brick wall (photo by A. Greer); (e) step cracks in concrete masonry wall (photo by E. Wilson). All photos from EERI Oklahoma USA Earthquakes Clearinghouse (2016).

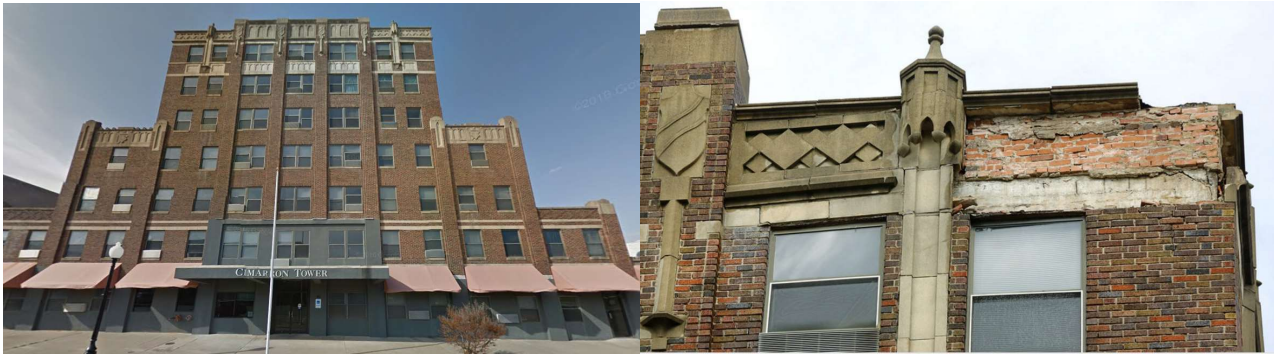
For the Cimarron Tower, the only building referred to as being a reinforced concrete frame, Taylor *et al.* (2017) report the cracking of masonry infills and the failure of masonry parapets and terra cotta cornices, as shown in Figure A3.5.57, as well as the breaking of several water supply pipes inside. They mention that the EERI team was not able to directly access the building due to safety reasons.

Figure A3.5.57. Damage to the roof parapet and cornices of 7-storey reinforced concrete Cimarron tower: before (left, Google Street View) and after the 2016 **M**5.0 Cushing earthquake (right, photo by Jim Beckel, The Oklahoman, from News OK photo gallery, 2016g).

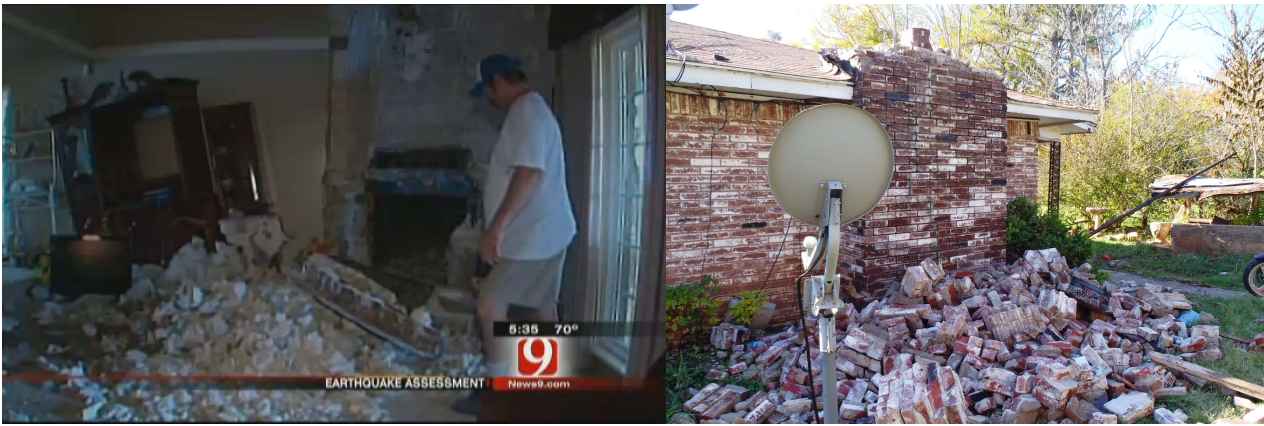
It should be noted that a commonly observed failure was the toppling or complete collapse of masonry chimneys/fireplaces. Apart from the case reported above (Figure A3.5.47), other chimneys were also severely damaged, as shown in Figure A3.5.59. This is also true for the 2016 Pawnee and Cushing earthquakes.

Figure A3.5.59. Complete collapse of a fireplace in the interior of a house in Sparks (left, News 9, 2011), and collapse of the top of a chimney of a house (right, Wikipedia).

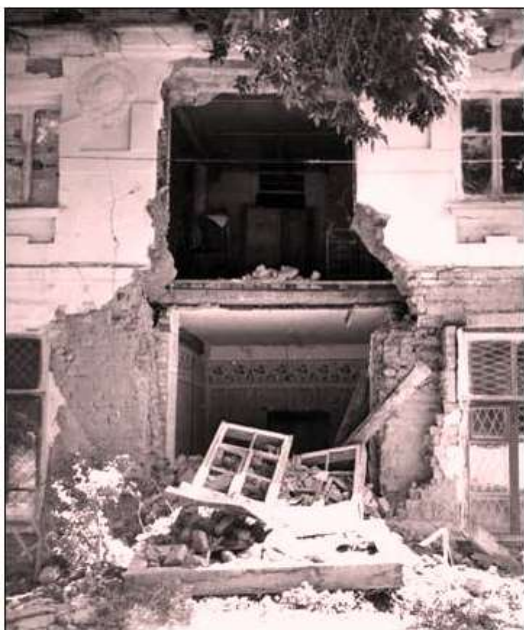
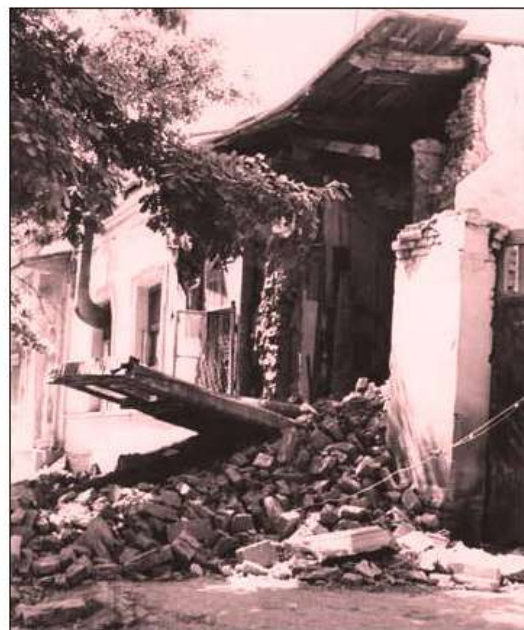
As a result of the earthquake, the buildings located in the central and densely populated area of Tashkent sustained the greatest damage (Sputnik, 2016c). Most of these damaged buildings were made of crude brick and were not designed to withstand earthquake shaking (Mavlyanova *et al.*, 2004; King *et al.*, 1999; Bubis, 1966). Such buildings were mainly one-storey houses built in the period preceding the 1917 Russian Revolution and had either shallow (0.3 to 0.6 m) or no foundations at all (Sputnik, 2016a; King *et al.*, 1999; Bubis, 1966). Examples of crude brick houses that were severely damaged or destroyed during the 1966 earthquake are shown in Figure A4.2.17.

Figure A4.2.17. Damage to buildings made of crude brick. From Attention! Earthquake! (2017).

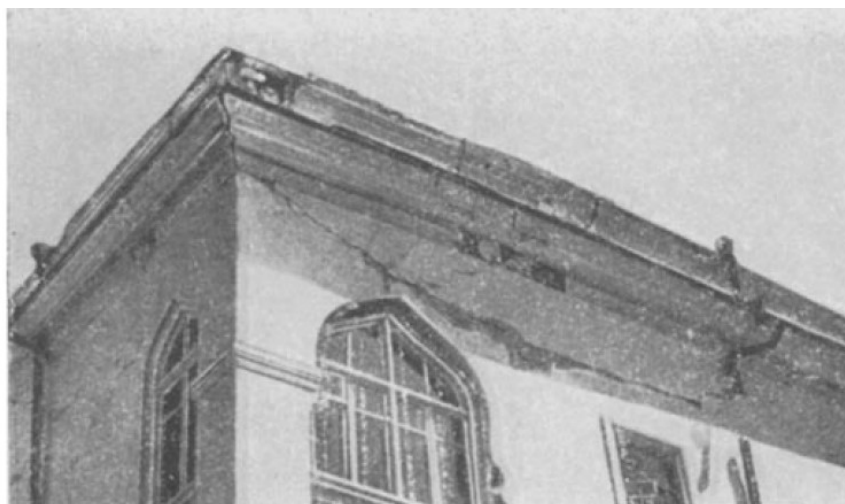
Considerable damage was also observed in fired brick multi-storey buildings that did not meet the rules of seismic design (Bubis, 1966), such as that shown in Figure A4.2.18. According to King *et al.* (1999) and IISSE NET (2017), there were 10 to 12 multi-storey brick buildings with wooden ceilings constructed in the 1940s and 1950s without consideration of seismic design that were damaged during the earthquake. Typical damage observed in buildings of this kind located in the epicentral area (seismic intensity VIII) include diagonal and horizontal cracking in single pier elements and staircases, as well as diagonal (x-type) cracking in bricks between apertures (King *et al.*, 1999; IISSE NET, 2017).

Figure A4.2.18. An example of damage induced on one of the fired brick buildings in Tashkent. From Bubis (1966).

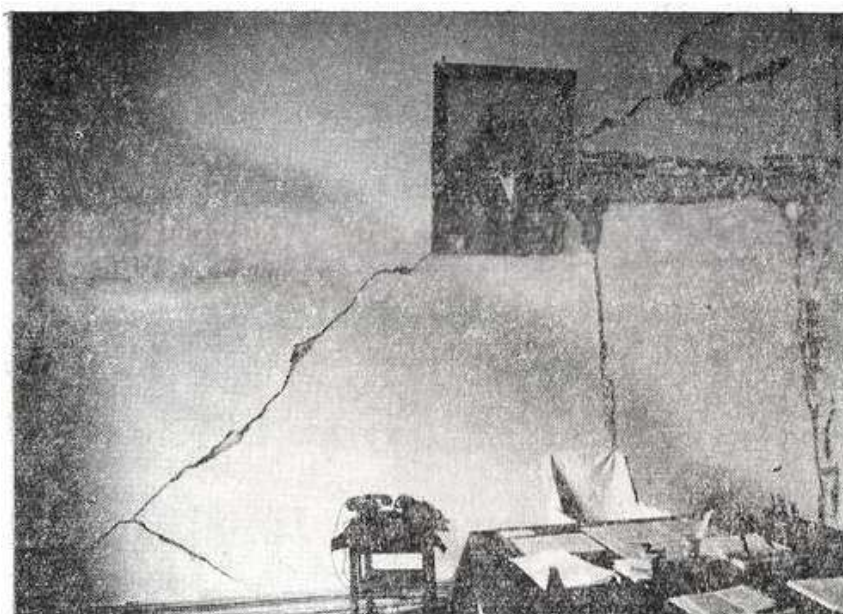
Figure A4.2.20. An example of wall cracking observed mostly in the upper floors of brick buildings located in the zone of seismic intensity VIII (GOST 6249-52). From Rasskazovsky (1967).

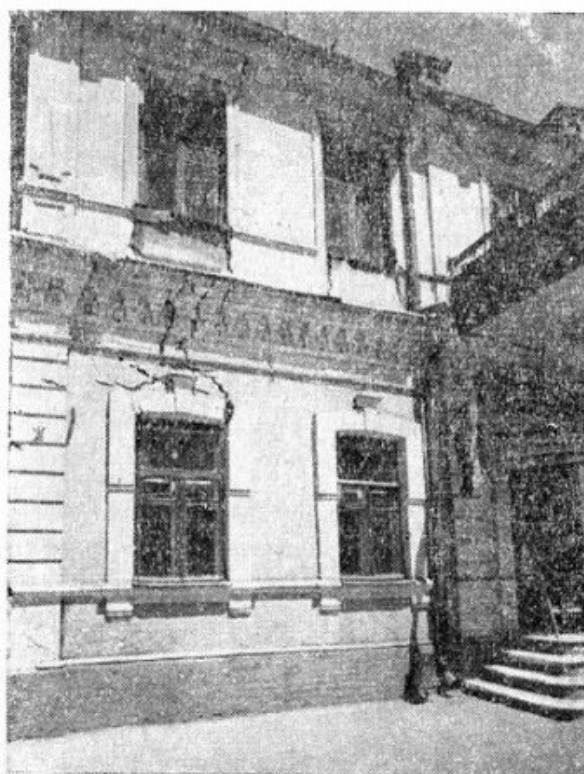
Figure A4.2.21. An example of masonry cracking commonly observed in buildings located in the zone of seismic intensity VIII (GOST 6249-52). From Rasskazovsky (1967).

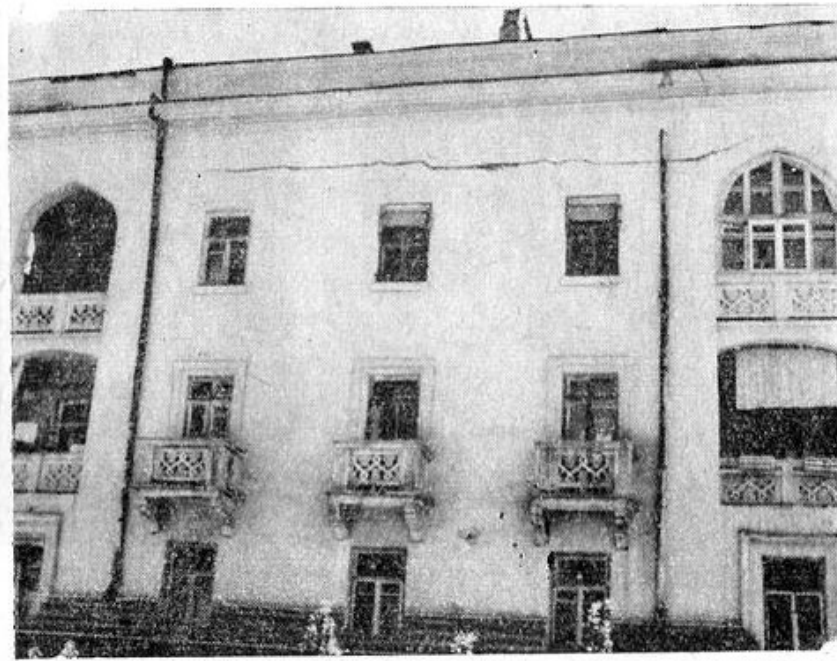
Figure A4.2.22. An example of building located in the zone of seismic intensity VIII (GOST 6249-52) with a long horizontal crack induced below the attic floor. From Rasskazovsky (1967).

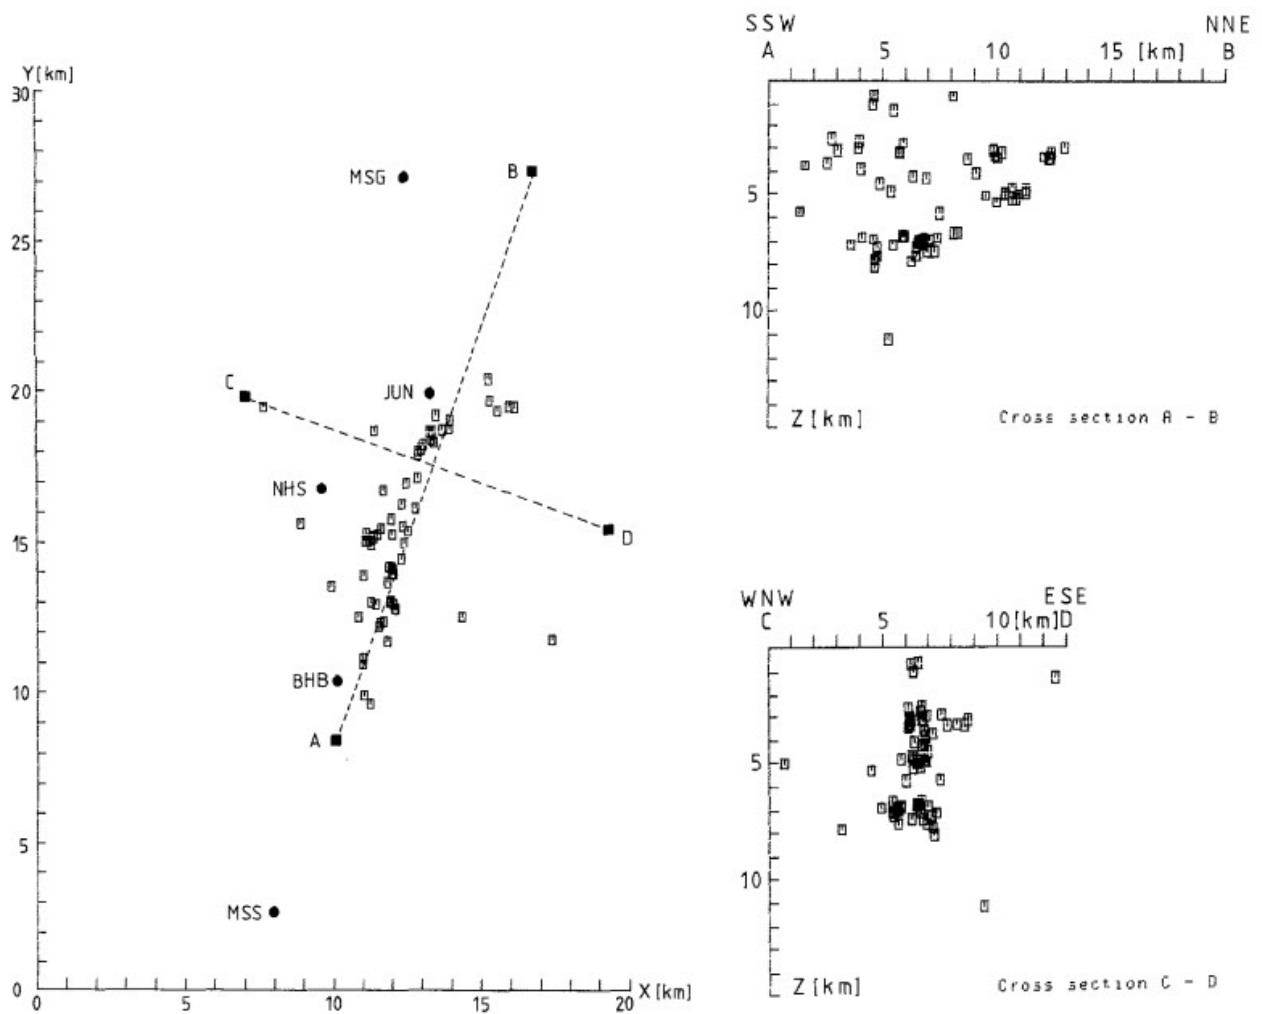
Figure A4.3.16. Hypocentres of the aftershocks of the 1978 M5.2 Albstadt earthquake, registered in the period from 4th September to 20th October: plan view (left) and cross-sections (right). From Scherbaum & Stoll (1983).

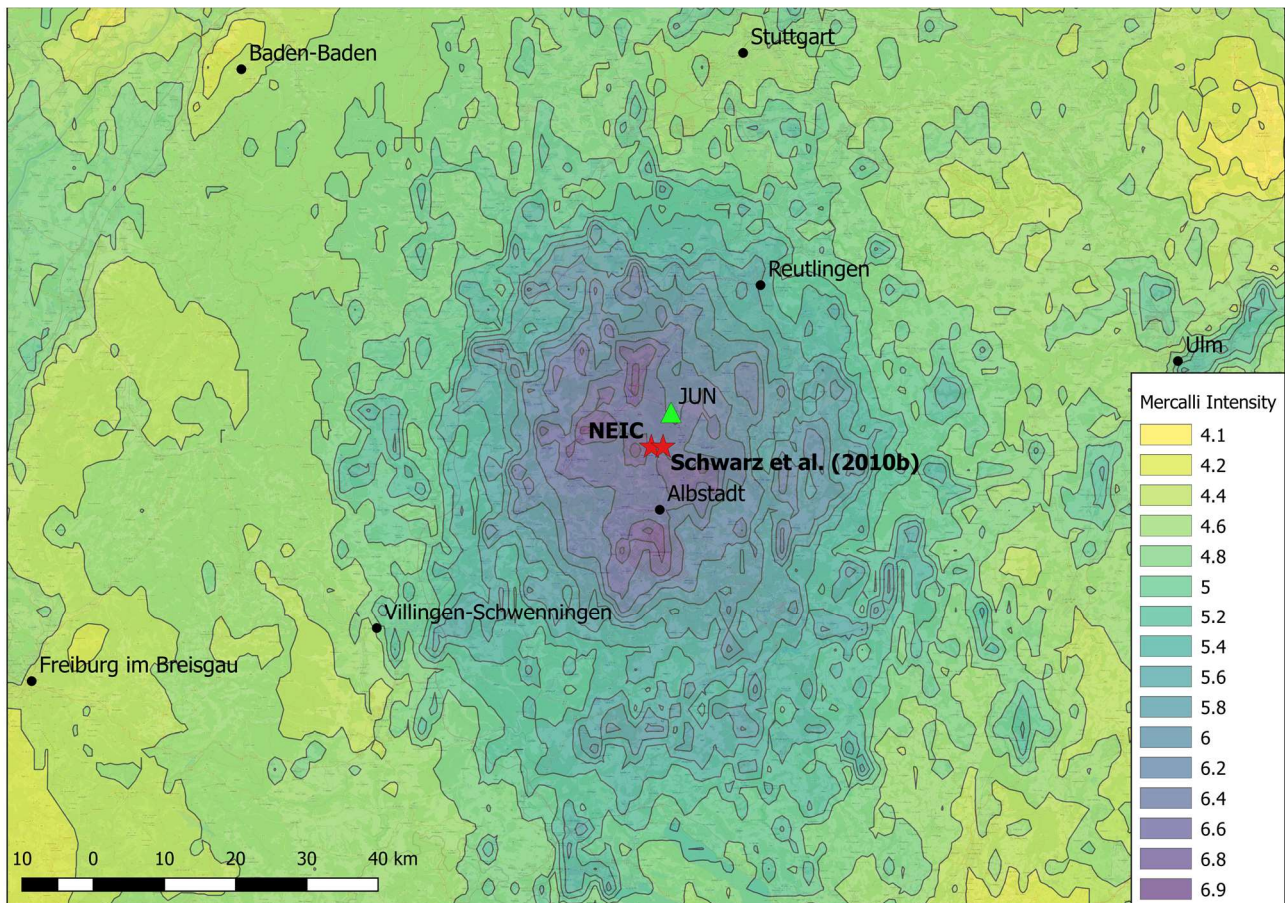
Figure A4.3.30. USGS ShakeMap (2017b) in terms of Modified Mercalli Intensities (MMI) for the 1978 M5.2 Albstadt earthquake. Red stars indicate the epicentres according to the USGS (NEIC) and Schwarz *et al.* (2010b).

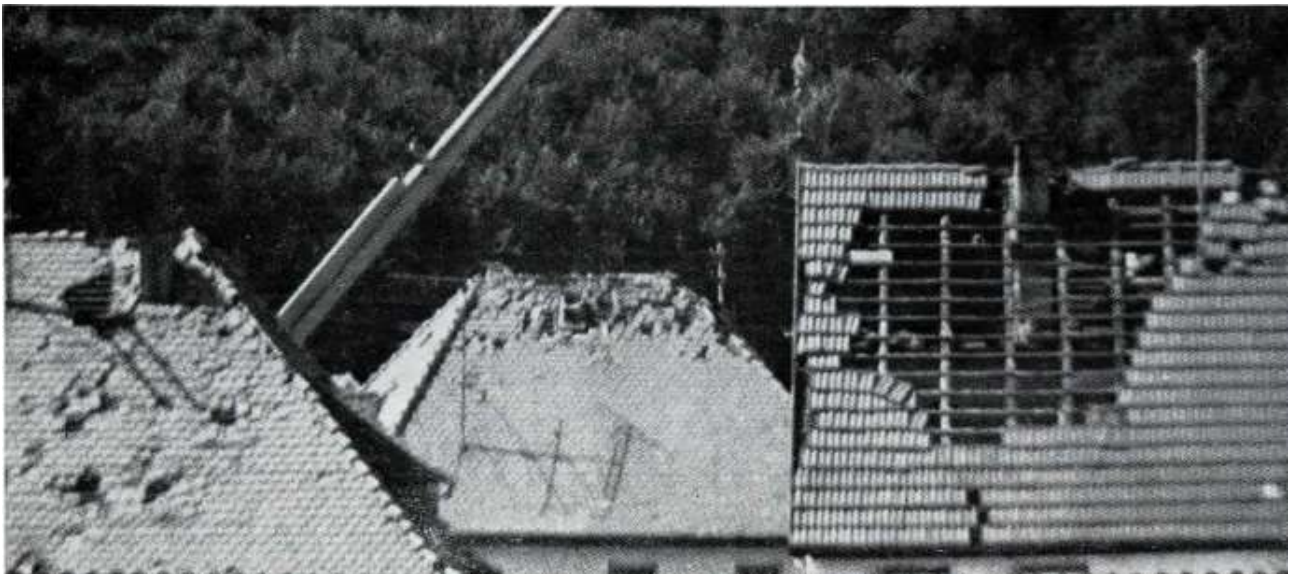
Figure A4.3.47. Falling of roof tiles induced by the 1978 Albstadt earthquake. From Blauß (1980).

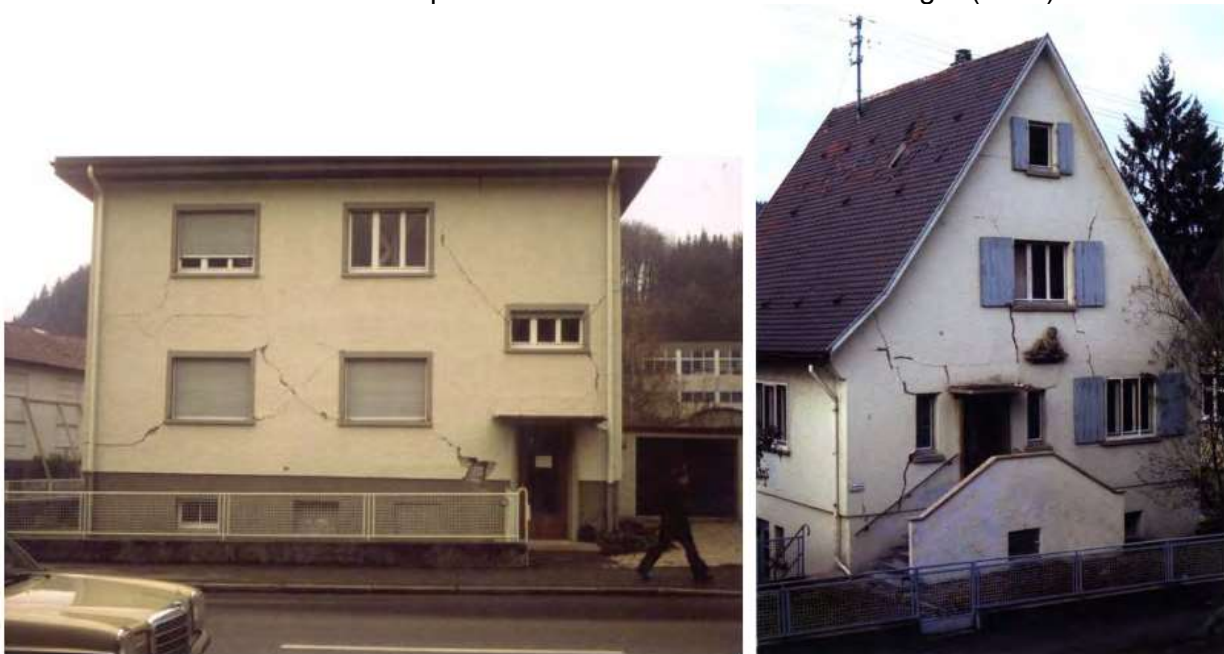
Cracking and falling of plaster was observed on the interior and exterior of many properties (Schwarz *et al.*, 2010b). Examples of plaster fractures and extensive cracking of inner walls are shown in Figure A4.3.48. Many buildings sustained considerable cracking at the corners of doors and window openings, examples of which are shown in Figure A4.3.49 (Schwarz *et al.*, 2010b; Blauß, 1980). Damaged gable ends were also commonly observed and, in some cases, like in the one shown in Figure A4.3.50, they fully collapsed. According to Blauß (1980), significant damage was sustained by buildings whose foundations were shallow and did not reach depths below the frost line (~80 cm).

Figure A4.3.49. Extensive cracking observed at the corners of windows and doors due to the 1978 Albstadt earthquake. From Schwarz et al. (2010b).

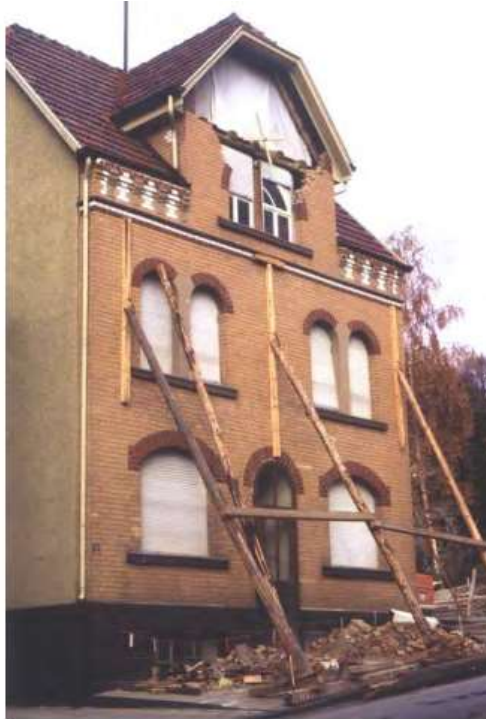
Figure A4.3.50. Damage to the gable end of a masonry building observed during the 1978 Albstadt earthquake. From Schwarz *et al.* (2010b)

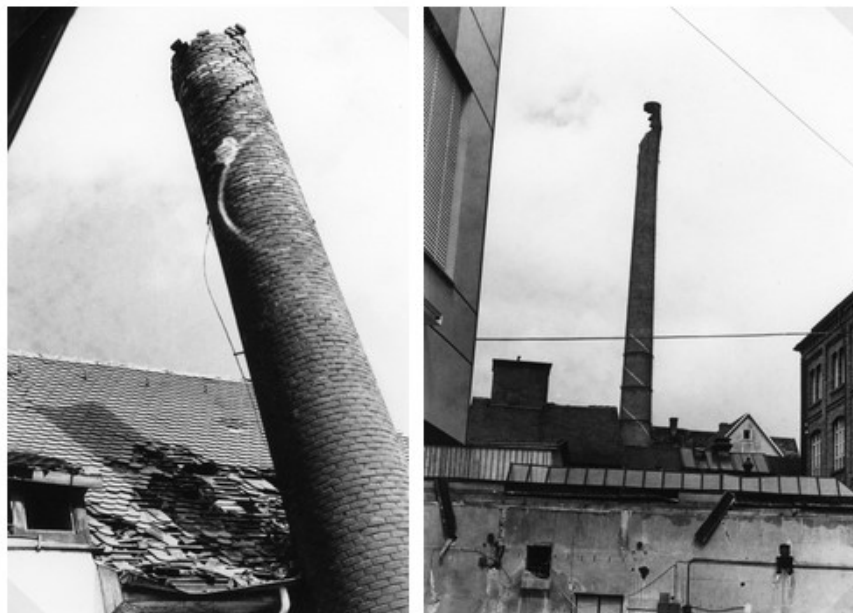
The earthquake catalogue of Schwarz *et al.* (2010b) reports 7,840 damaged buildings, of which 3,120 were in Tailfingen, 1,510 in Onstmettingen, 2,630 in Ebingen and 580 in other Albstadt communities. According to said report, 23 factory chimneys and 2,200 chimneys of residential buildings were demolished, 324 buildings were shored up, and 69 partial and one full demolition were carried out. A somewhat different number of affected house chimneys was reported by Blauß (1980) who mentions about 1,300 cases of partial chimney collapse and fallen chimney pots, and another 2,200 cases of cracking of chimney stacks. Broken chimney pots and bricks and their falling from the roof were also reported by Schwarz *et al.* (2010b). According to Blauß (1980), the great extent of chimney damage in otherwise less-damaged buildings was due to their dynamic properties being different from those of buildings to which they are attached. Dislodgment of roof tiles from rafters and their falling onto the streets was also observed, as shown in Figure A4.3.47. Blauß (1980) points out that steeply-pitched roofs and those lacking sufficient stiffness in their skeletons were damaged to a greater extent.

Figure A4.3.51. Damage to factory chimneys observed during the 1978 Albstadt earthquake. From Schwarzwälder Messenger (2013).

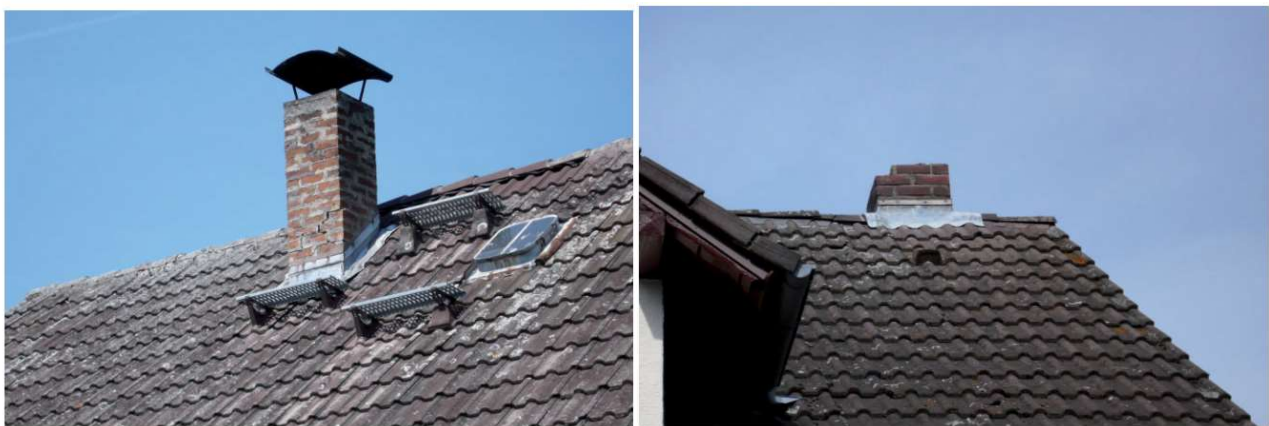
Figure A4.3.54. Cracking of a chimney stack (left) and damage to roof tiles (right) induced by the 2014 Darmstadt earthquake. From Schwarz *et al.* (2015).

Non-structural damage associated with the dislodgment and overturning of chimneys and damage to roof tiles was observed on many properties (Figure A4.3.54). According to HLNUG (2017), 36 chimneys were damaged by this event. Other free-standing building elements and structures, like the fountain shown in Figure A4.3.55, also sustained damage, mostly in the form of residual displacements and rotations. Small horizontal and diagonal cracks were observed on most of the affected properties (Schwarz *et al.*, 2015; Müller *et al.*, 2015). Damage to gable walls was mostly limited to cracks around window openings (Figure A4.3.56), as is common for earthquakes of this intensity level. More significant cracks, such as those shown in Figure A4.3.57, were in many cases generated as a result of inadequate connections between different parts of masonry constructions (Schwarz *et al.*, 2015). Vertical cracking was common in the external walls that were not designed to withstand earthquake loads. Cracking was also observed in some of the buildings presumed to correspond to EMS-98 vulnerability class C, particularly due to inadequate construction and design. An example shown in Figure A4.3.58 (left) depicts cracking observed in a building with an irregular base and a heavy reinforced concrete roof (Schwarz *et al.*, 2015). The upper parts of buildings in Nieder-Beerbach were usually found to be more damaged compared to the lower ones (Schwarz *et al.*, 2015; Müller *et al.*, 2015). The Protestant church located in this area was also significantly damaged (EDAC, 2014).

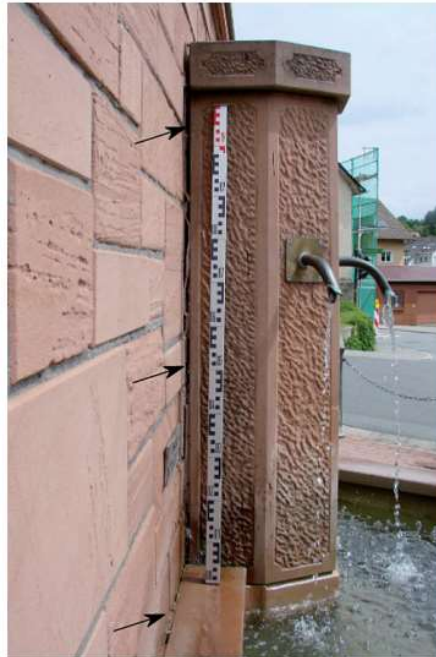
Figure A4.3.55. Rotation of the fountain up to 2.5 cm at the joint (a process which also affected many chimneys) during the 2014 Darmstadt earthquake. From Schwarz *et al.* (2015).

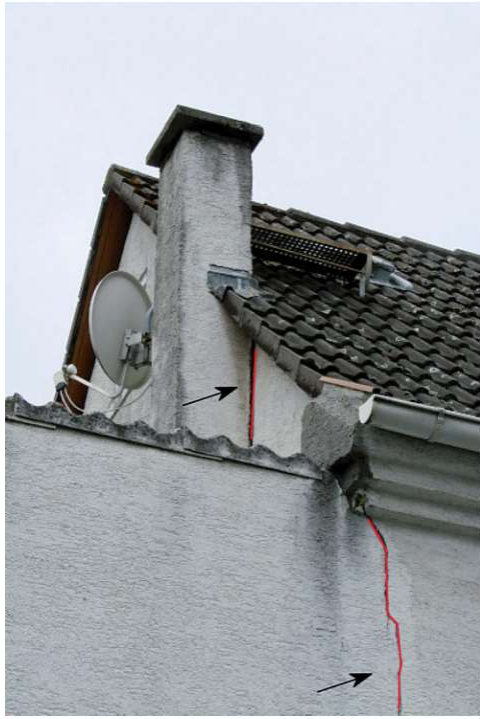
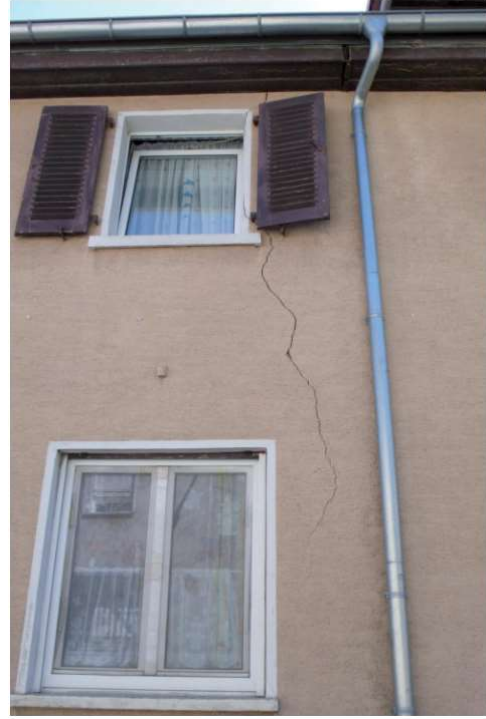
Figure A4.3.57. Cracking observed at connections between different building elements(left) and balustrade crack (right) caused by the 2014 Darmstadt earthquake. From Schwarz et al. (2015).

cracking, which was observed in the majority of the affected buildings, was used by Schwarz *et al.* (2015) as an indicator of damage grade D1, while more extensive cracks, like those shown in Figure A4.3.57, were considered to be an indicator of damage grade D2.

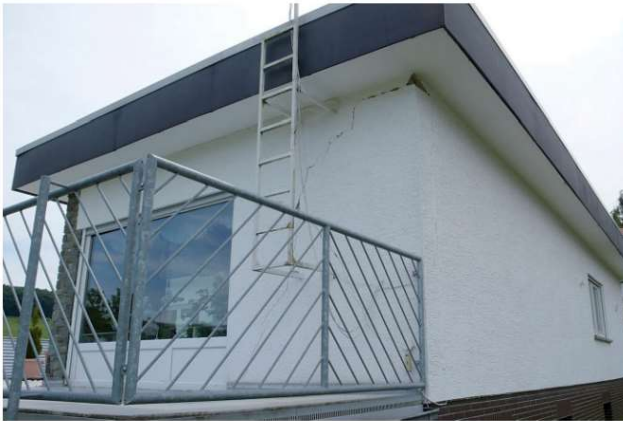
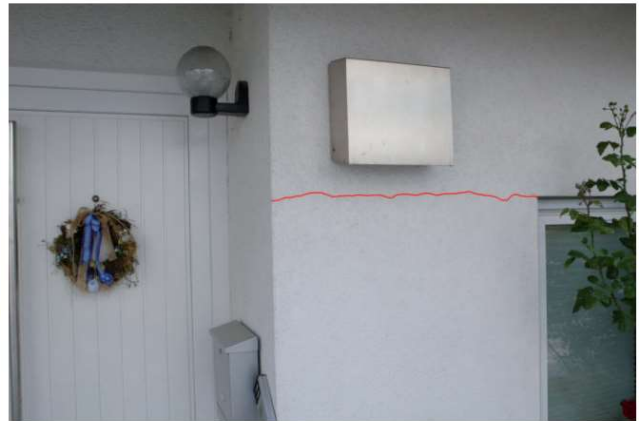
Figure A4.3.58. Thick diagonal shear crack in a modern masonry building (left); horizontal shear crack in a newer masonry building (right) induced by the 2014 Darmstadt earthquake. From Schwarz et al. (2015).

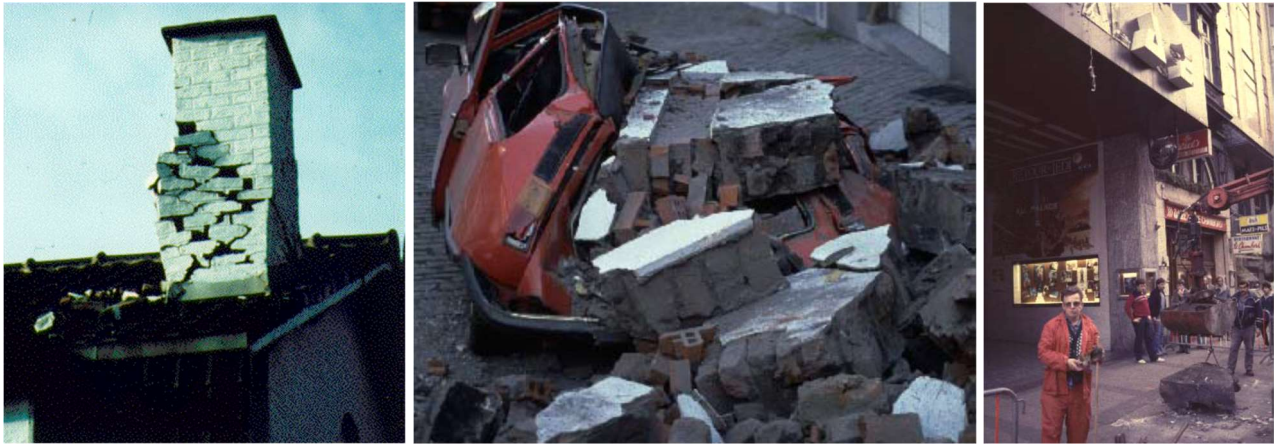
Figure A4.4.31. Chimney of good quality damaged (left); fall of chimney over a car (centre); fall of massive stone in a central road (right). From Doneux *et al.* (2003).

Chimneys are slender elements with little resistance to bending, especially when the corrosion of the mortar no longer provides a real bond to the bricks (Figure A4.4.31). According to Jongmans & Campillo (1990), about 10,000 chimney failures were observed. From the analysis of damage data and photographs, ARUP (2016) concluded that about 80% of the chimneys in Saint Nicolas, the worst affected area (EMS-98 VII), had failed, while the EEFIT survey team estimate 90% (EEFIT, 1984). This percentage quickly drops down to 2-15% in other areas subject to lower EMS-98 intensities of VI-VII and to less than 1% to 10% in areas subject to EMS-98 intensity V. From the same analysis, ARUP (2016)

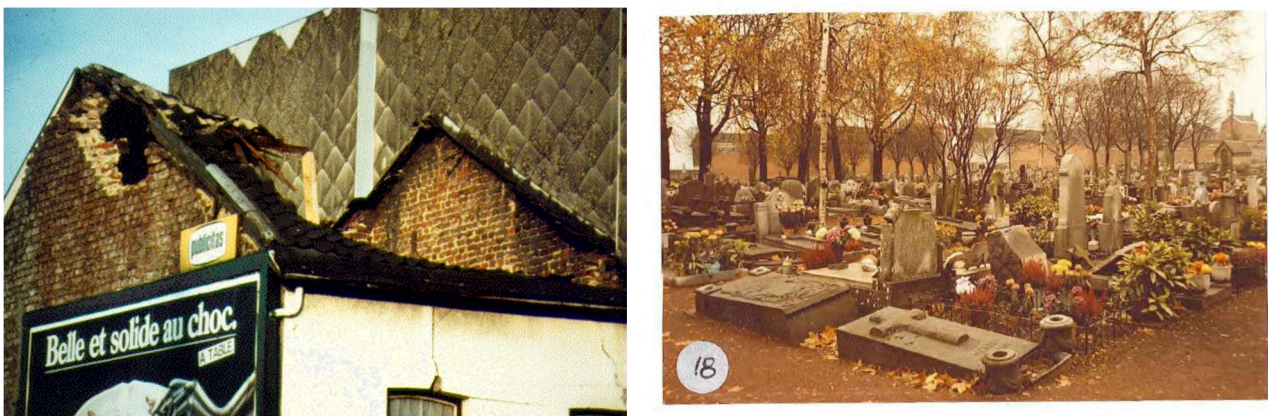
Figure A4.4.33. Roof collapse due to walls displacement, from Doneux *et al.* (2003) (left); cemetery of St Gilles, from EEFIT (1984) (right).

Partial or total collapse of the roof was observed in a more limited extent (Figure A4.4.33, left). This may be attributed to significant out-of-plane deformation of the walls and/or poor connection between the walls and the roof, heavy roofing material, or poor in-plane resistance of the horizontal roofing system (Doneux *et al.*, 2003).

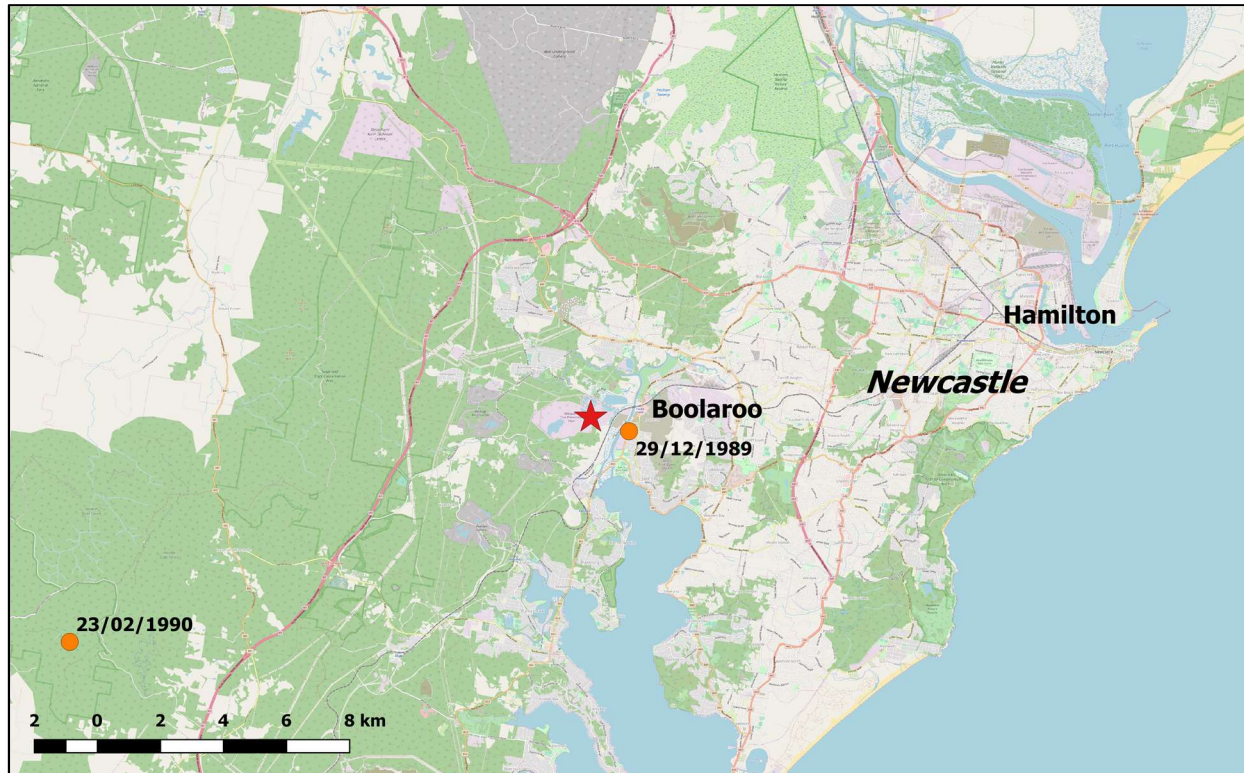
Figure A4.5.9. Location of earthquakes occurring after the main shock (orange circles). Red star indicates epicentre of main shock according to Geoscience Australia.

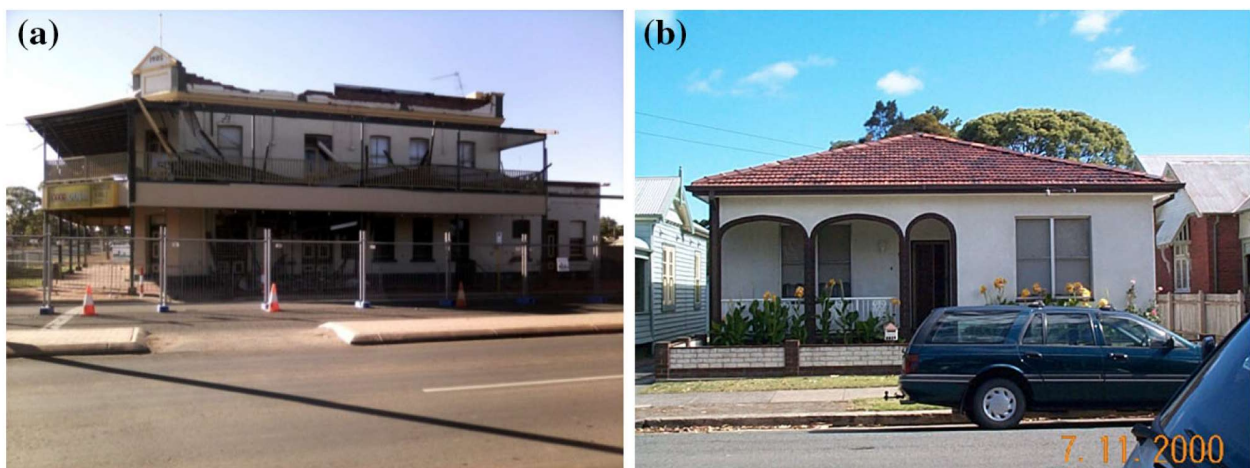
Figure A4.5.25. Examples of unreinforced masonry structures: (a) pre-1945 brick commercial building, (b) post-1945. From Maqsood *et al.* (2016).

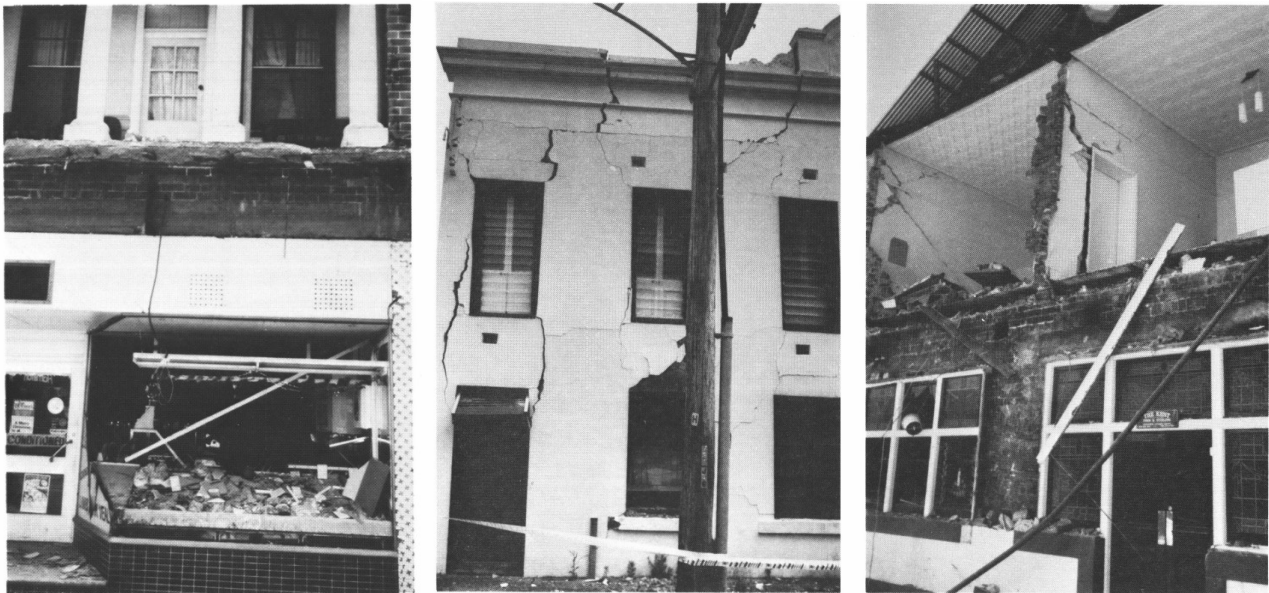
Figure A4.5.30. Awning collapse due to parapet falling onto it (left), typical damage in masonry walls (centre) and failure of both inner and outer masonry wythes of top storey and gable (right).
Photos by M. Maloy, from McCue (1990a).

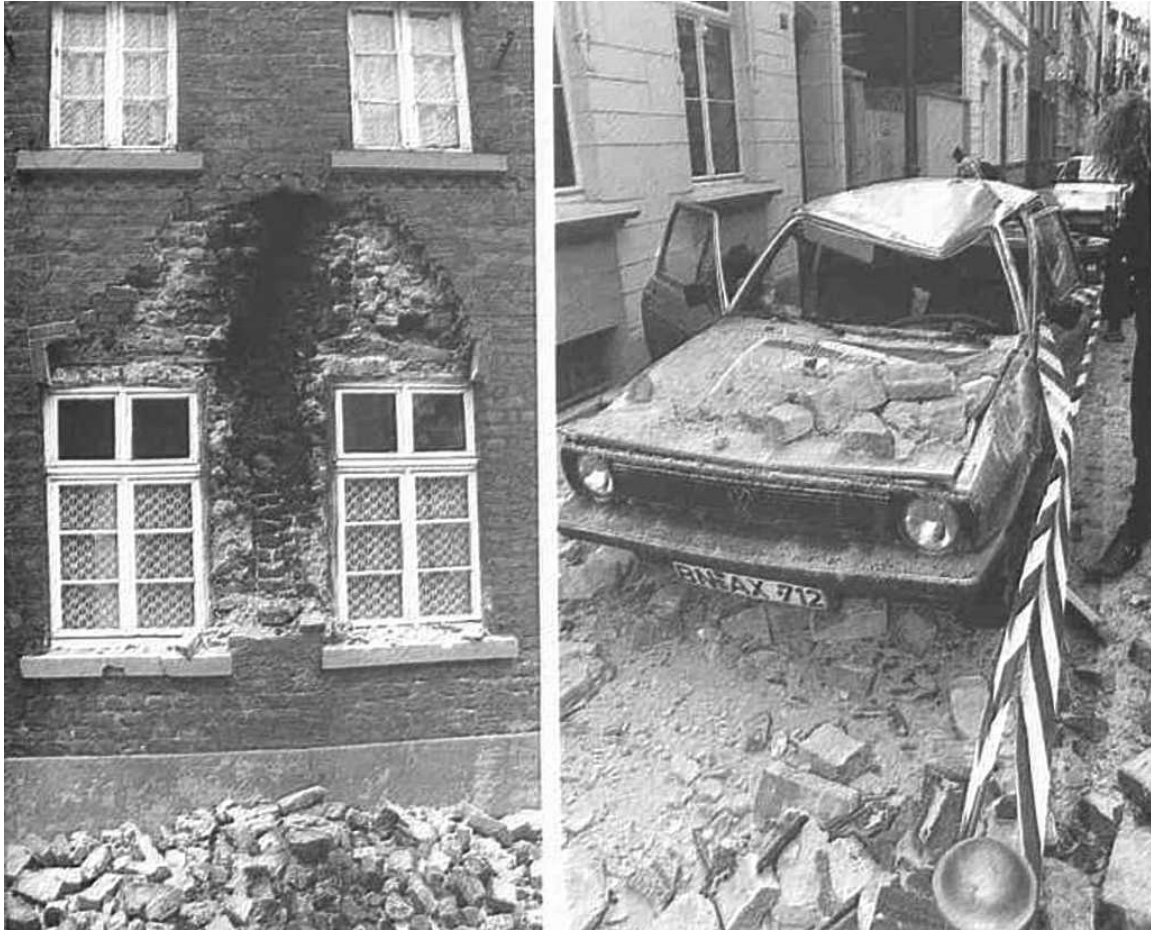
Figure A4.6.37. Damage to a residential house (left) and a car (right) in the city of Bonn (Germany). Photos copyright of Seismic Workgroup, St.-Michael-Gymnasium Monschau (2005)
