A Database of Damaging Earthquakes of Moment Magnitude from 4.0 to 5.5 (Part 2)

**Cecilia I Nievas, Michail Ntinalexis, Danai Kazantzidou-Firtinidou,
Jovana Borozan, Marialuigia Sangirardi, Helen Crowley & Julian J
Bommer**

Datum March 2019

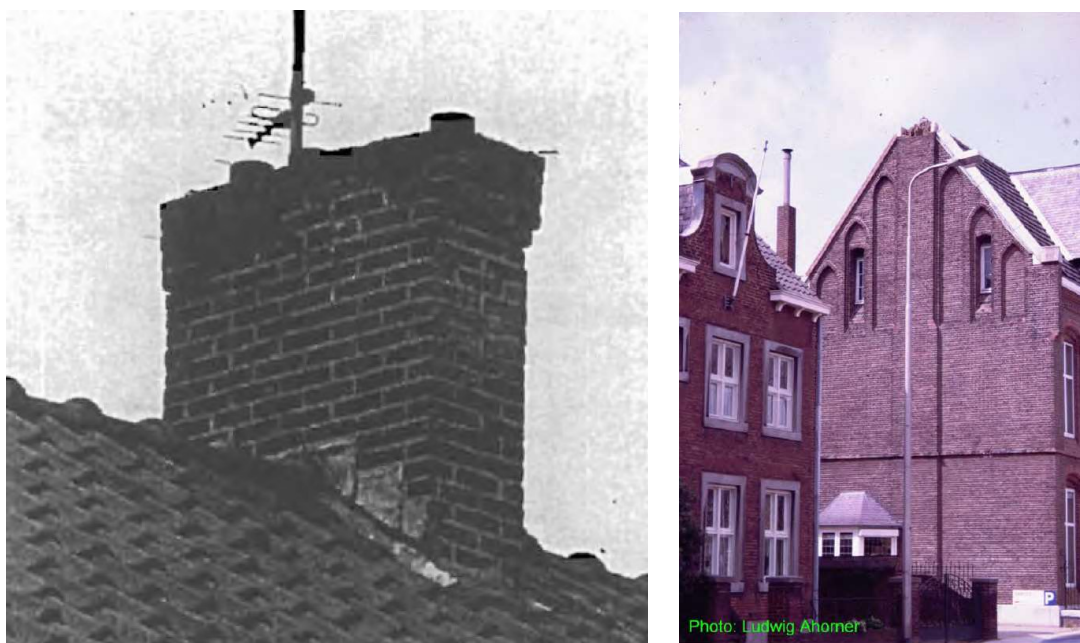
Figure A4.6.41. D2 (left) and D3 (right) damage to chimneys (Schwarz *et al.*, 2010).

No details regarding systematic causes of failure and damage were found in the literature. However, from the results of Pappin *et al.* (1994) it becomes clear that older masonry buildings were significantly more vulnerable than more modern ones. Furthermore, and as observed during other small-to-moderate magnitude earthquakes (e.g., Sargeant *et al.*, 2008), the frequency with which damage to chimneys was observed is also a sign of an increased vulnerability of these structures (Figure A4.6.41).

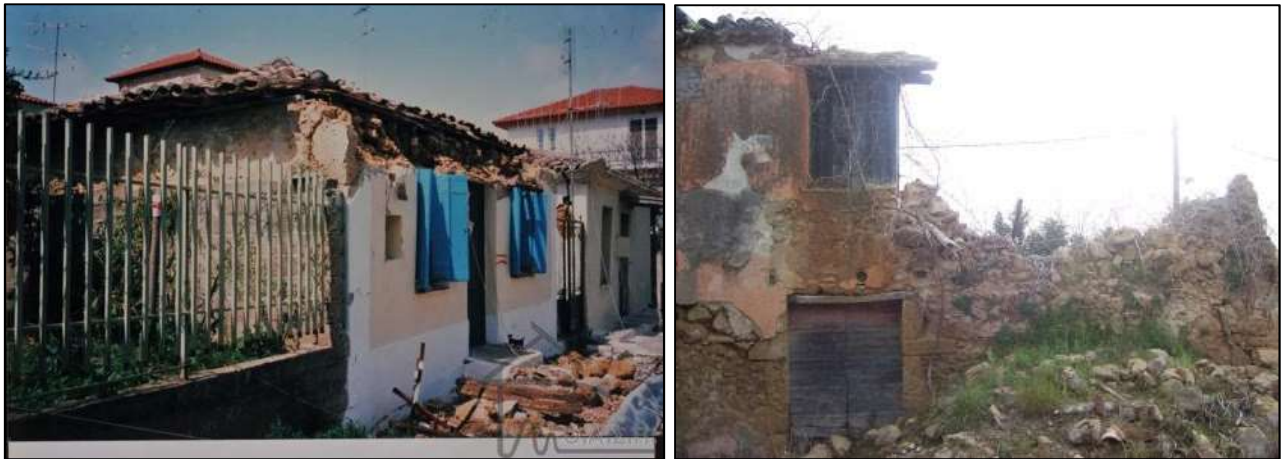
Figure A4.7.36. Adobe masonry buildings with damage from partial or total collapse (source: EPPO; left); “Motsaiko”, erected in the 19th century, was the only building that collapsed almost completely (source: Vitinaika, 2008; right).

Period	Material	Mean D.D. of all	Mean D.D. of damaged ones	Damage observed
1800-1850	Adobe; 1-2 storeys (Figure A4.7.36)	2.6 (heavy)	3.0 (very heavy)	<ul style="list-style-type: none"> - Vertical cracking of spandrel (more severe in 2nd storey) - Turnover of external whyth at the top of the walls due to out-of-plane action (especially at the 2nd storey) - Local buckling of the lower parts of the walls
1850-1900	Stone masonry walls; 1-3 storeys; (Figure A4.7.37)	1.0 (light)	1.9 (moderate)	<ul style="list-style-type: none"> - Vertical cracking of the spandrel of the upper floor and of the corners due to separation of orthogonal walls - Diagonal cracking of the piers (usually starts from the 1st storey and extends even to the roof level strong lintels)
1900-1940	Stone masonry or solid brick (few); 1-3 storeys;			<ul style="list-style-type: none"> - Vertical cracking of spandrels in the upper floors - Separation of sills from adjacent walls due to the lack of bonding - Diagonal cracking of the piers (without extension to upper walls weak lintels)

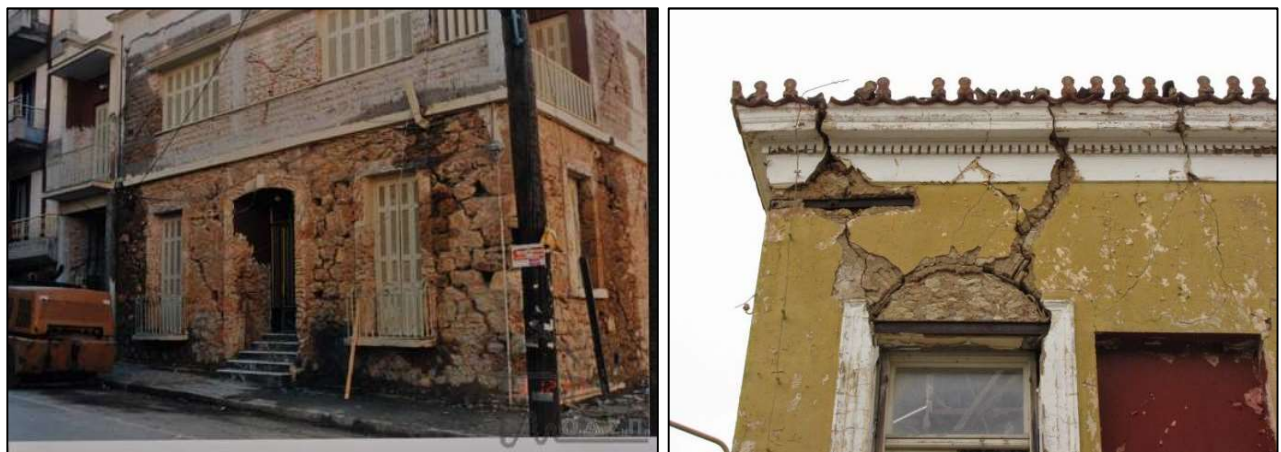
Figure A4.7.37. Severe damage to stone buildings: (left) diagonal cracking at piers (source: EPPO); (right) vertical cracking of spandrels of upper floor (source: Tempo24, 2016).

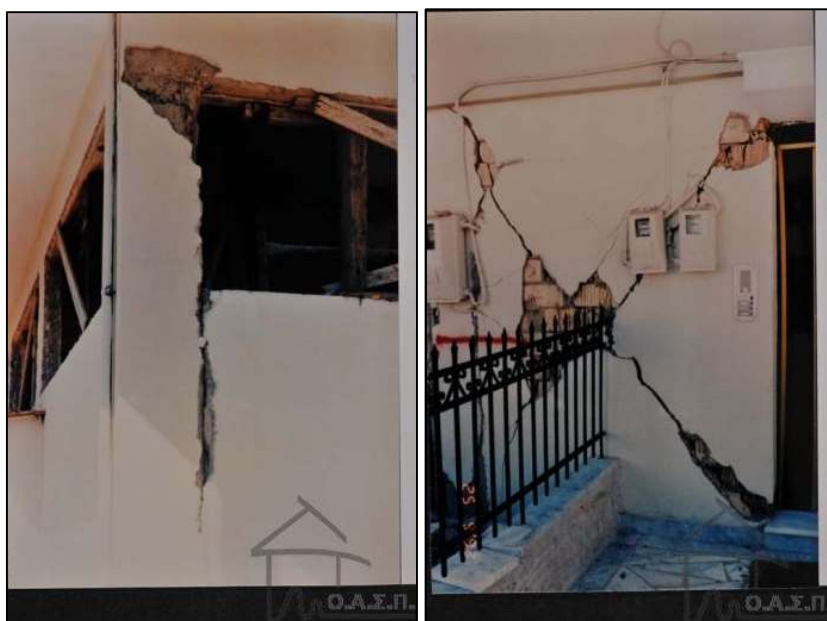
Figure A4.7.38. Example of severely damaged RC building with severe cracking and concrete spalling at the node and column and diagonal cracking of the infill panels (source: EPPO).

Damage to RC buildings was limited, despite the contrasting difference between the seismic design coefficients of 0.06-0.12 g for which most of the building stock of Pyrgos was designed (1959 ERD Code) and the 0.45 g maximum PGA recorded during the main shock (Karantoni & Bouckovalas, 1997). 22 buildings with 2 to 7 storeys developed cracks in the RC frame itself (Figure A4.7.38). Most of these were located within the districts of Dexameni and Lapato. The buildings located at Dexameni developed very light diagonal cracking at the top of the first storey columns and shear walls, while those in Lapato presented much more serious instances of damage, such as the disintegration of the concrete of the first storey columns (Karantoni & Bouckovalas, 1997). Apart from these localised cases, most of the RC buildings in the city presented damage to the infill masonry. The latter is usually constructed in Pyrgos and Greece with hollow clay bricks and cement-lime mortar. Karantoni & Bouckovalas (1997) describe the typical damage pattern to infill panels being diagonal cracking due to in-plane seismic action, with cracks developed within the mortar joints as well as the bricks themselves. In addition, the different displacement capacity of the RC frame and the more fragile infill panels led to small-width repairable cracks at the joints of the RC elements with the infill walls.

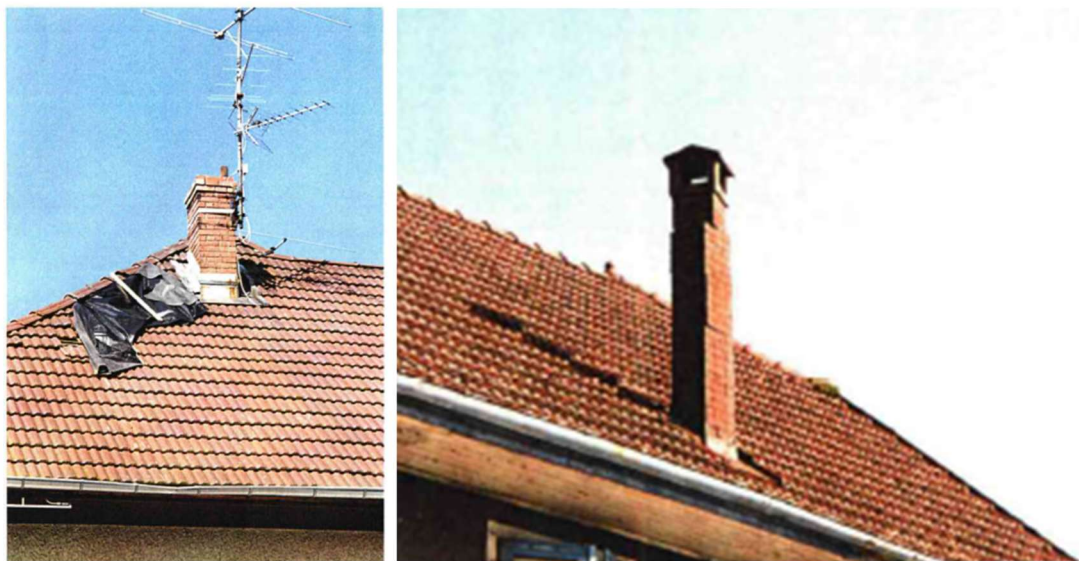
Figure A4.8.28. Damaged roof from chimney fall in Metz Tessy (left). Rotated chimney in Chaumontet (right). From Dominique *et al.* (1996).

Around 600 chimneys exhibited some degree of damage (cracking, displacement, rotation) or collapsed damaging the roofs as well as the cars parked underneath, as shown in Figure A4.8.28 (Arnal *et al.*, 2000). Chimneys made of brick, being the most vulnerable, suffered most of the damage, while reinforced concrete chimneys performed quite well, with only their covering plates being displaced (Dominique *et al.*, 1996). The slippage and detachment of roof tiles, especially from the ridge flashing, was also common. Damage to the old buildings' dormers (*i.e.*, rooftop windows that come out of the plane of the roof, Figure A4.8.29, left) was observed, as well, with the fall of that of a renovated ancient building hosting a nursery school (Figure A4.8.29, right) being the most severe one (Dominique *et al.*, 1996).

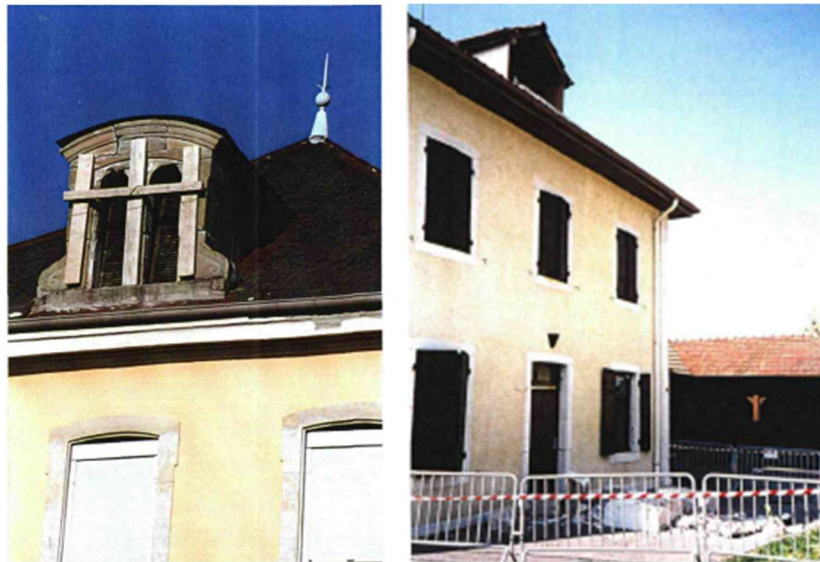
Figure A4.8.29. Confined dormer of Rumilly hospital severely cracked (left); fall of stone dormer at the nursery school of Metz-Tessy (right). From Dominique *et al.* (1996).

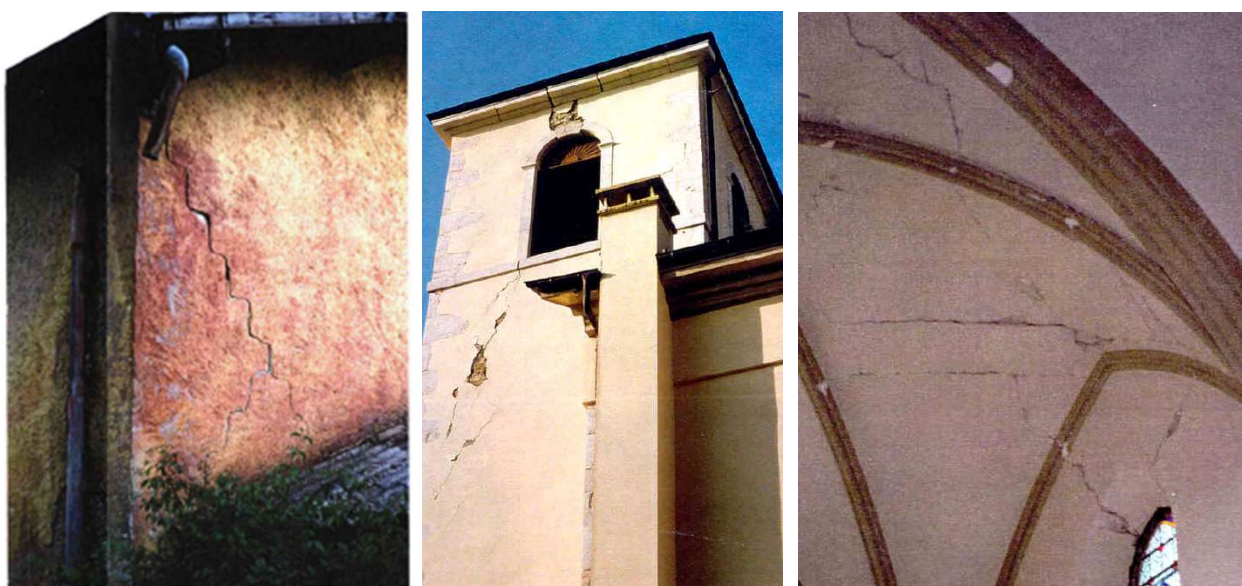
Figure A4.8.30. Deep cracks on the angle of a building in Pont-Verre (left), from Dominique *et al.* (1996). Large cracks on the severely damaged church of Epagny (centre) and cracks at the vault of the church in Poisy (right), both from Davidovici (N/A).

The most common type of structural damage observed in masonry buildings was cracking of the façade wall or in its connection to perpendicular bearing walls or slabs, an example of which is shown in Figure A4.8.30 (left) (Le moniteur, 1997). Cracks of different width appeared also on the façades and the vaults of numerous churches, as those shown in Figure A4.8.30 (centre and right) (Dominique *et al.*, 1996). In some cases, the extensive fall of plaster revealed cracks on the internal walls of residential buildings and churches as well (Dominique *et al.*, 1996). Severe cracks and partial falls of the pediments (*i.e.*, ornamental gable-like structures usually placed over façades) were attributed to the movement of the ridge board of the roof (Dominique *et al.*, 1996).

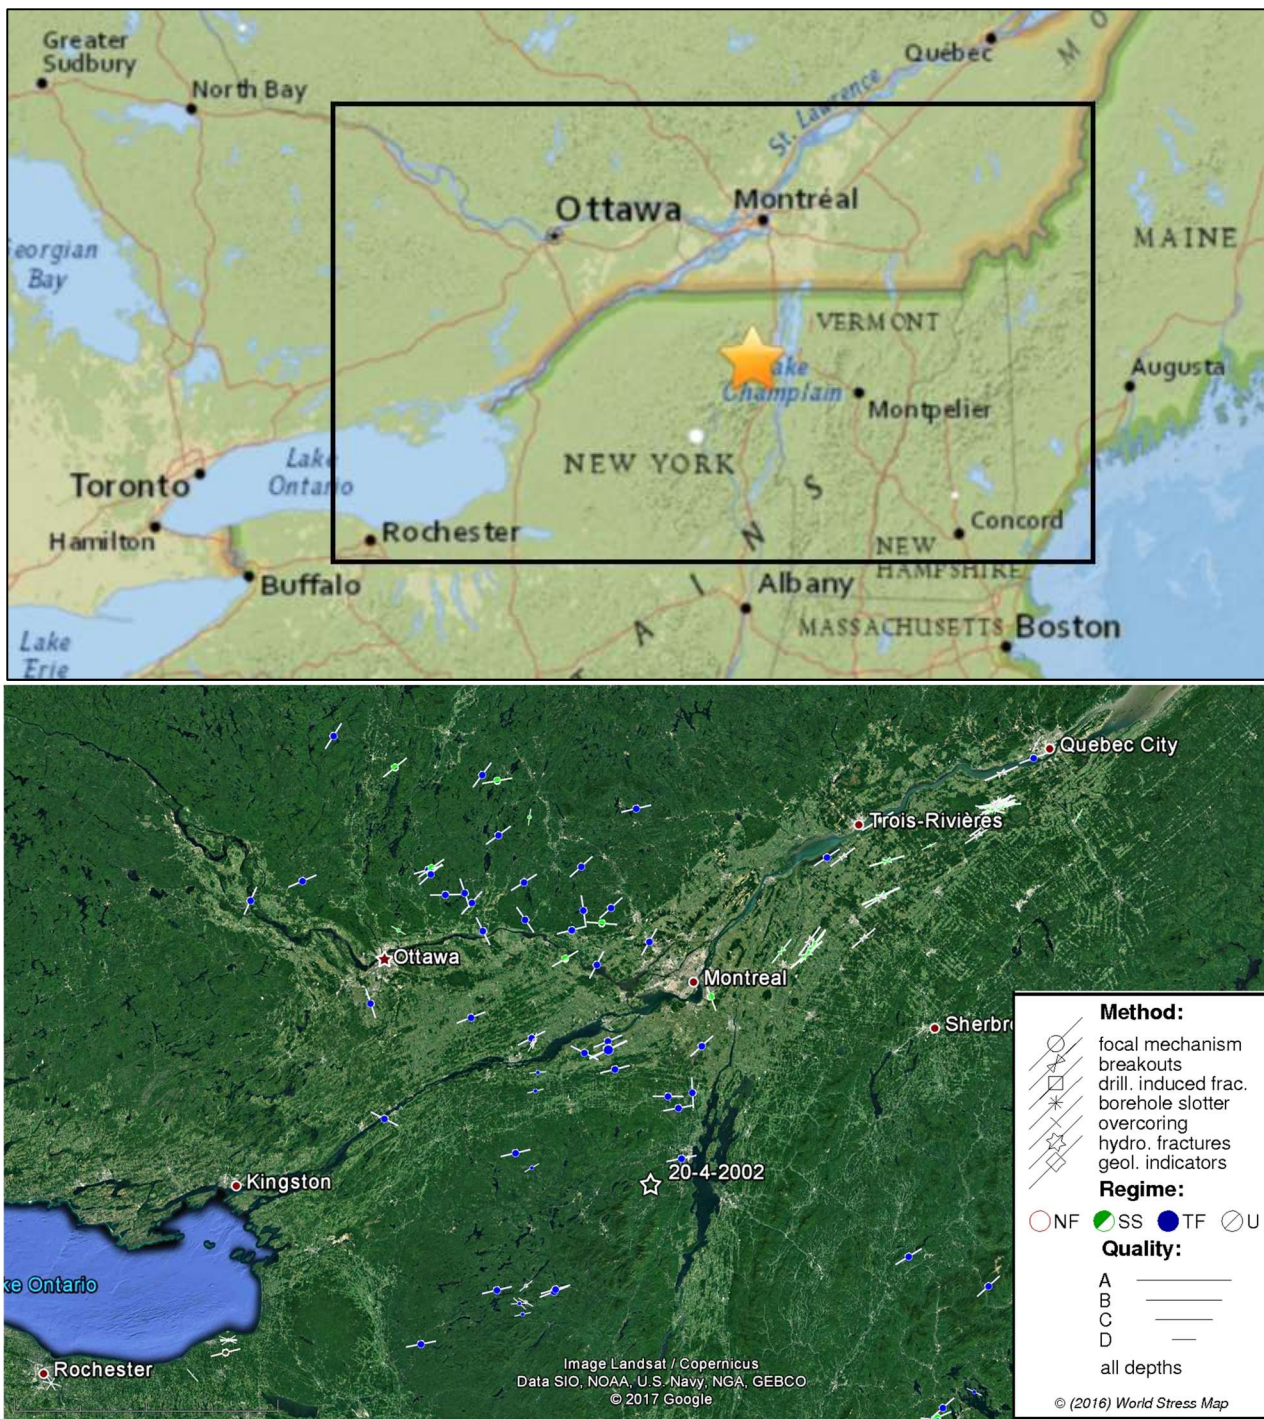
Figure A4.9.1. USGS map showing the location of the 2002 Au Sable Forks earthquake (yellow star) within the region of Eastern North America (ENA) (top). Map presenting the tectonic stress direction and the style of faulting in the broader region, created in Google earth using data from the World Stress Map Database (Heidbach *et al.*, 2016) (bottom). Blue solid circles indicate reverse faulting and white bars denote the direction of the principal compressional component of the tectonic stress tensor (σ_1).

The area which hosted the Au Sable Forks earthquake of 20th April 2002 is situated in the Eastern North America (ENA) craton of Grenville at the north-eastern flank of the Adirondack massif, in the state of New York (Figure A4.9.1, top). Tectonic features in the area were formed over a long time interval, from 2.8 Ga to 115 Ma during (a) the activity of the Great Meteor hotspot (Crough, 1981), (b) the major Grenvillian orogeny associated with the collision of Laurentia (Eastern North America) with Amazonia (Western South America), and (c) the subsequent formation of the Rodinia supercontinent (Levin, 2006) that transects this region (Faill, 1997). Similarity between the tectonic setting of the Grenville orogen and the modern Alpine-Himalayan orogen suggests that they both formed as a consequence of similar continent-to-continent collisional processes (Carr *et al.*, 2000).

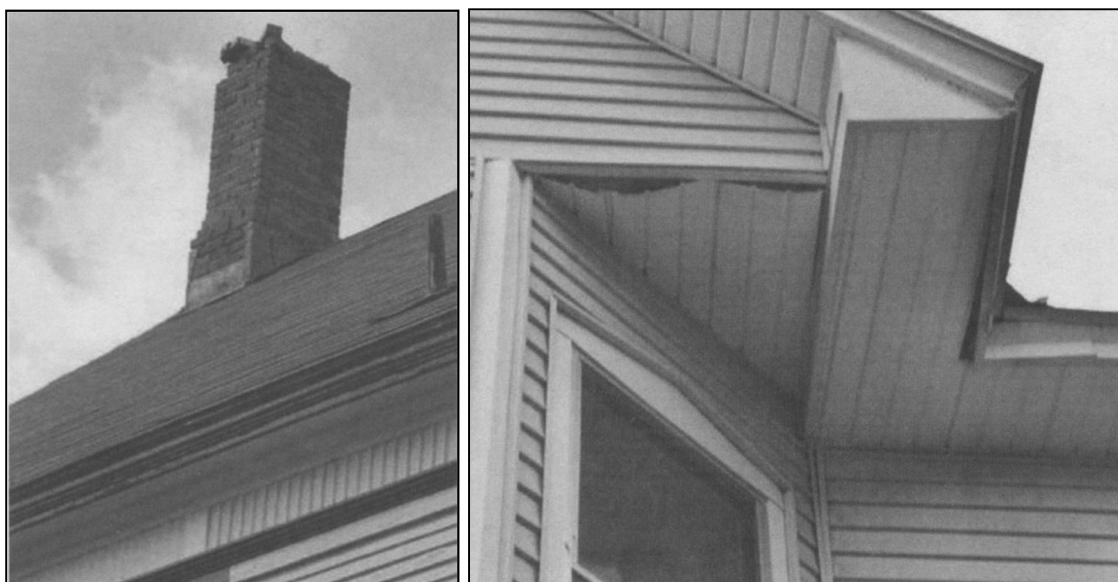
- cracking and toppling of chimneys (*e.g.*, Figure A4.9.25, left),
- damage to wooden cornices (*e.g.*, Figure A4.9.25, right),
- cracking of non-structural heavy cladding of unreinforced masonry,
- damage to cladding of structural timber buildings (*e.g.*, Figure A4.9.26),
- damage to foundations of older buildings located over alluvial deposits, attributed by Pierre & Lamontagne (2004) to the tendency of the latter to amplify ground motions.

Figure A4.9.25. Rotation and partial destruction of a chimney in Au Sable Forks (left); deformed cornices at a residential building in Au Sable Forks (right). From Pierre & Lamontagne (2004).

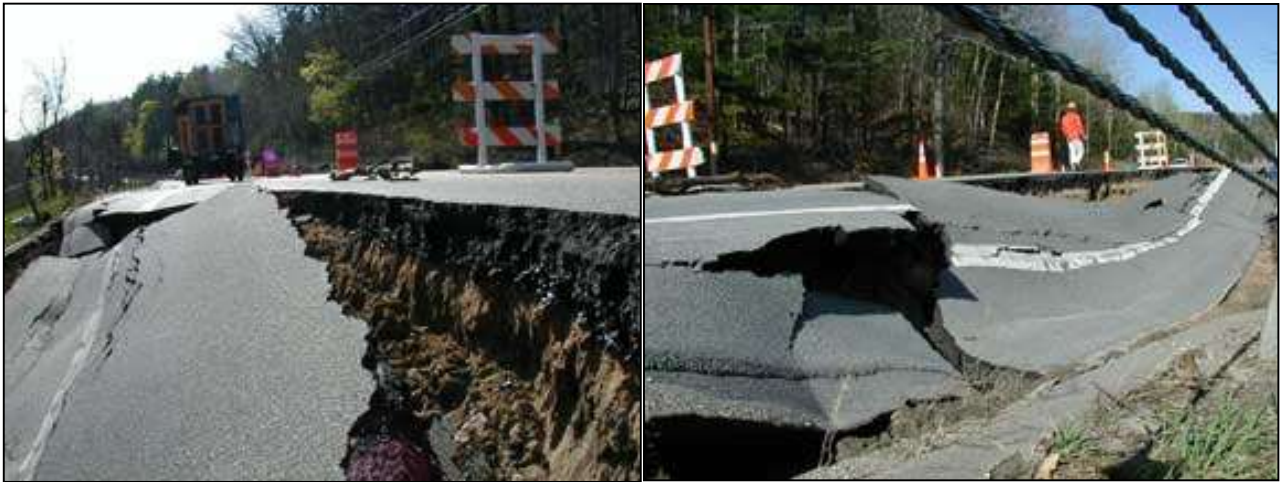
A major impact of the earthquake was the damage to the road network and in particular to a part of State Route 9 between Keeseville and Clintonville, as explained by Pierre & Lamontagne (2004) and depicted in Figure A4.9.27. As discussed in Section A4.9.5.3, the fill of the steepened slope liquefied, leading to the collapse of some sections of the road at a length of around 60 metres (ABC News, 2011). Vague reference is also made to other local failures of the road network by Pierre & Lamontagne (2004). ABC News (2011) briefly state that County Road 39 was also damaged. CNN (2002) mentions that the New York Department of Transportation immediately started the inspections for the adequacy of bridges, the outcome of which does not appear to have been made publicly available. Only damage to a small masonry arch bridge from 1936 has been reported by Pierre & Lamontagne (2004). The bridge was cracked at its sidewalks, parapets and stonework of

its arch, mainly due to settlement at its end supports. Finally, a shallow crack of unconfirmed origin was observed at the support of the small Fern Lake Dam. Temporary measures were taken to prevent possible leaks.

Figure A4.9.27. Damage on State Route 9 (Photo Courtesy of Frank Revetta and Eric Therm at APN Magazine, 2003).

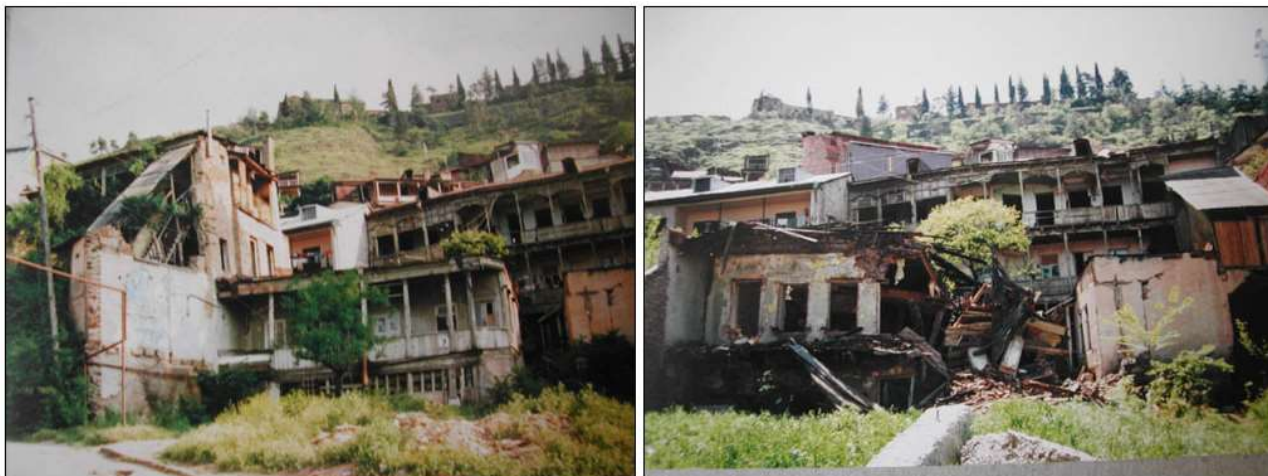
Figure A4.10.24. Vernacular buildings in Betlemi Micro-Quarter in Tbilisi. Before (left) and after (right) the 2002 Tbilisi earthquake. From ICOMOS (2002/03).

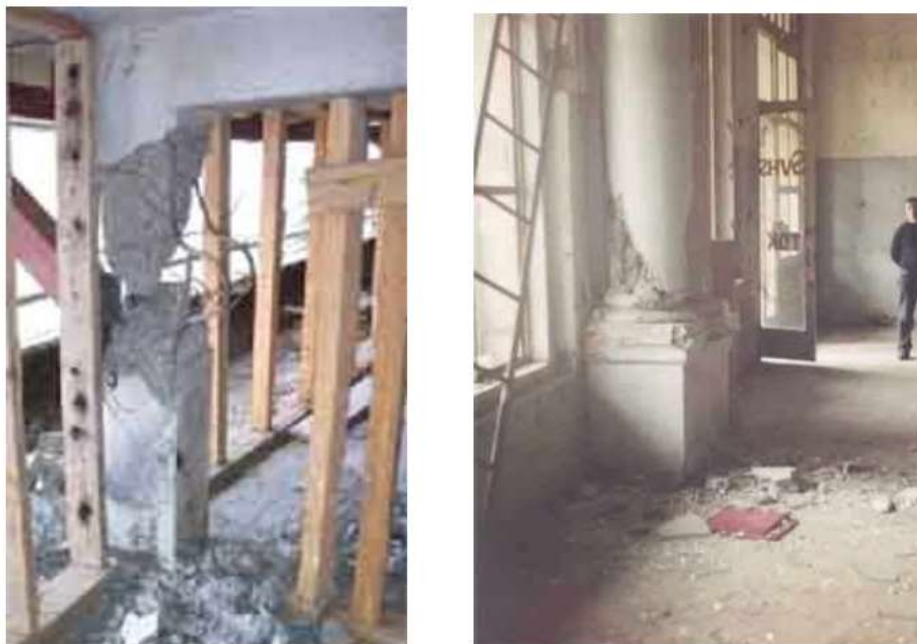
Examples for some of the kinds of damage listed above are shown in Figure A4.10.25 through Figure A4.10.27.

Figure A4.10.25. Damage to columns. Inst. of Mathematics (a); residential building in Kostava str. (b). From Gabrichidze *et al.* (2004).

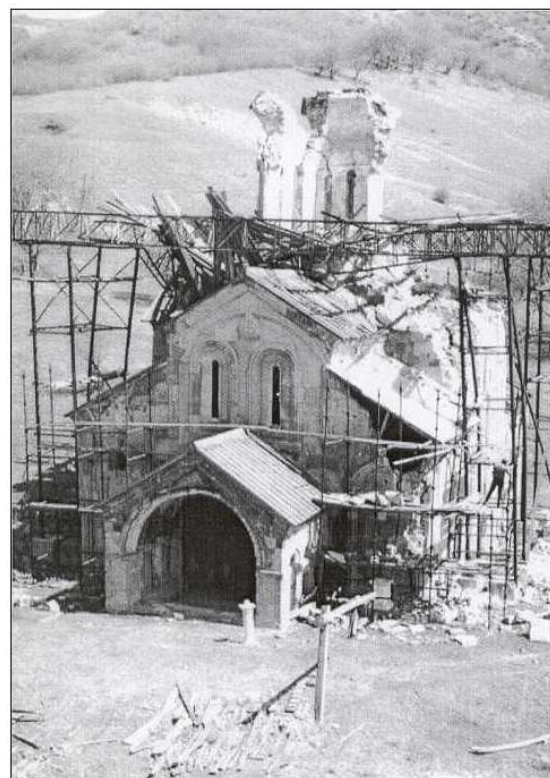
Figure A4.10.27. Damaged parapet of a residential house in Sololaki quarter (left) and Ikorta church of the Archangel after the earthquake (right). From ICOMOS (2002/03)

Based on the information from a report from October 2002 (ReliefWeb, 2002c), 26 churches were assessed and some of them were found to be in a need of urgent repair. An example of a church that was heavily damaged by the earthquake and repaired afterwards is given in Figure A4.10.27 (right).

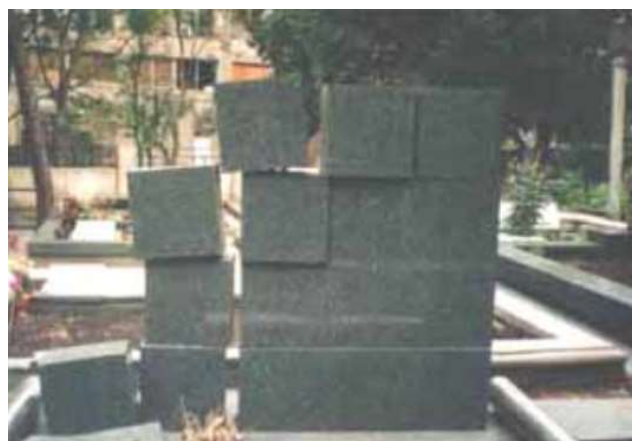
Many monuments of three graveyards in central Tbilisi were damaged, as exemplified in Figure A4.10.30 (Varazanashvili *et al.*, 2008; Gabrichidze *et al.*, 2004).

Figure A4.10.30. Shifted and overturned monuments in graveyards. From Gabrichidze *et al.* (2004).

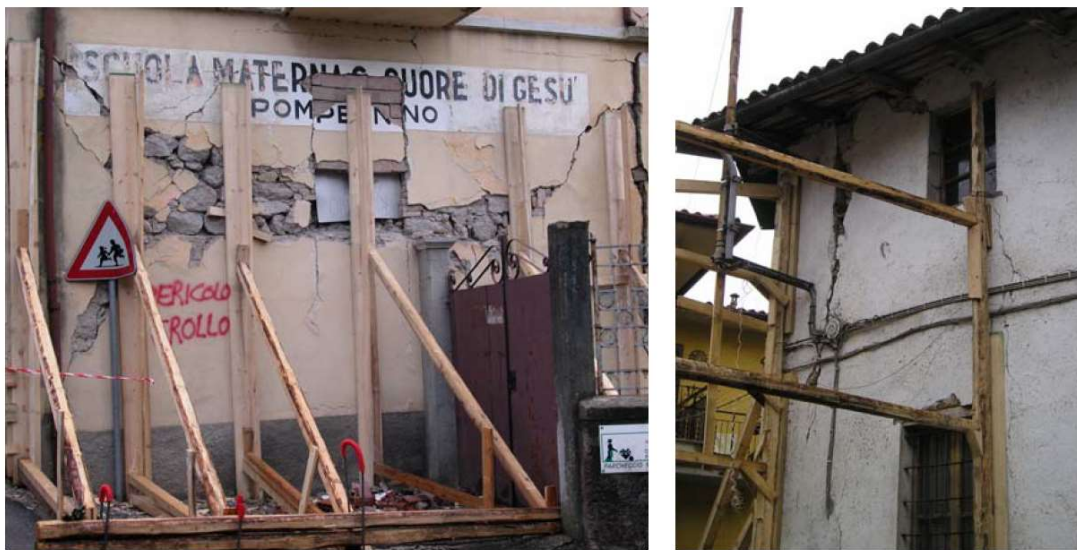
Figure A4.11.28 through Figure A4.11.31 show some examples of the damage observed in Pompegnino and Clibbio, the two most-affected locations to which an MCS intensity of VII-VIII was assigned (Bernardini *et al.*, 2005).

Figure A4.11.28. Collapse of masonry wall of poor quality (left) and out-of-plane deformation and cracking of masonry walls (right) in Pompegnino (MCS VII-VIII). From Dimova *et al.* (2004).

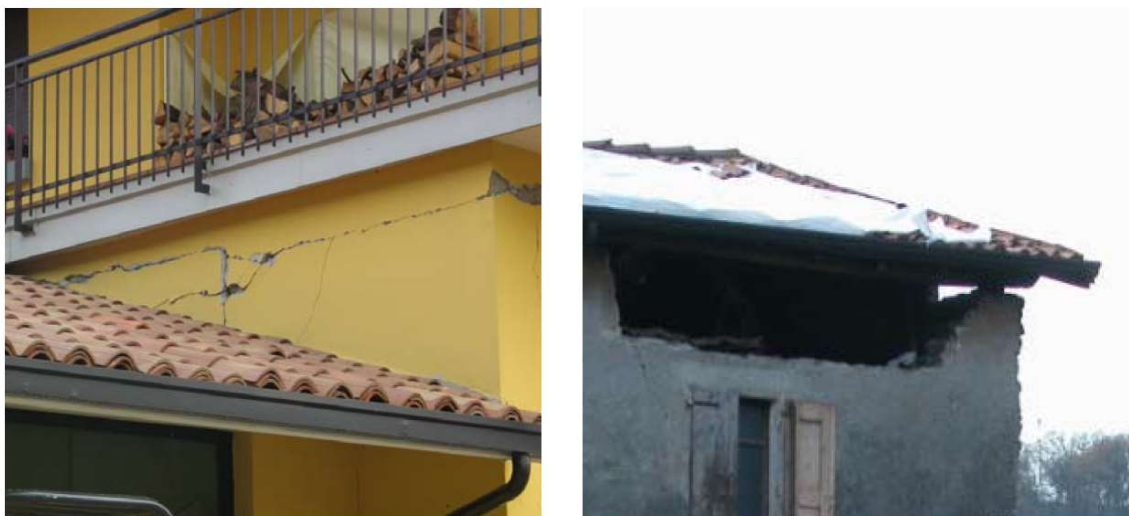
Figure A4.11.29. Failure of masonry due to pounding between buildings without seismic joints (left) and disintegration and failure of unconfined masonry under roof structures in Pompegnino (MCS VII-VIII). From Dimova *et al.* (2004).

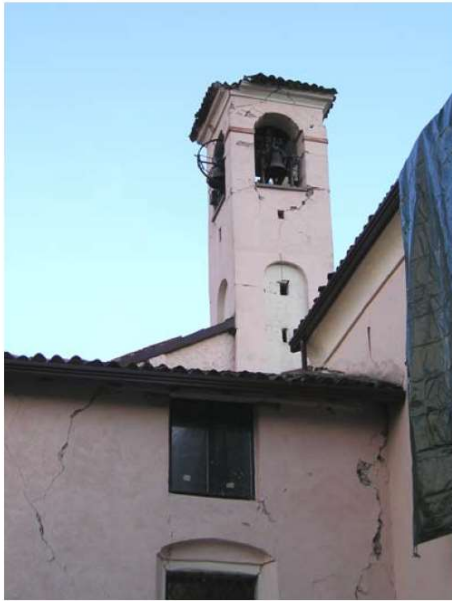
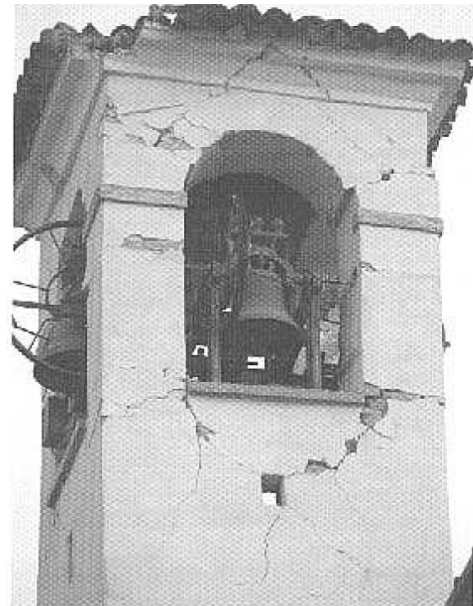
Figure A4.11.30. Damage to the church of Clibbio (Sàbbio Chiese): general view (left; from Dimova *et al.*, 2004) and detail (right; from Bernardini *et al.*, 2005).

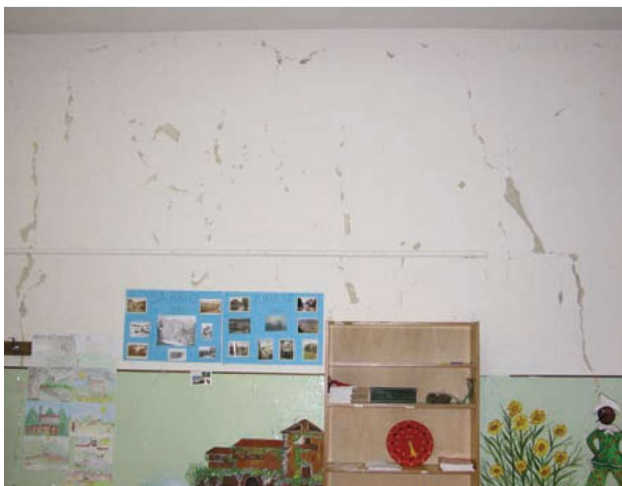
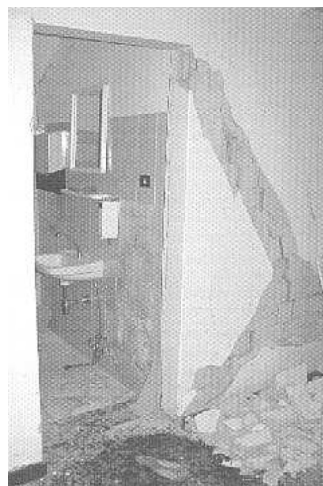
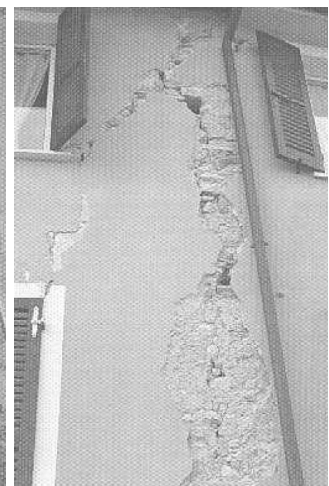
- Clibbio (small section of Sàbbio Chiese): Dimova *et al.* (2004) classify it as EMS-98 VI-VII, just like for Pompegnino, but the detailed enumeration is slightly different in this case:
 - Many buildings of class A and a few buildings of class B suffered damage of grade 2.
 - Most buildings of class A and many buildings of class B suffered damage of grade 1.
 - Isolated buildings of class C suffered damage of grade 2 (e.g., Figure A4.11.31, centre).

Figure A4.11.31. Fall of plaster and cracking of masonry wall in the school of Sàbbio Chiese (left), damage to infill masonry of an RC building in Clibbio (centre) and damage to load-bearing masonry in the junction between two neighbouring buildings in Salò (right). From Camassi *et al.* (2011; left) and Bernardini *et al.* (2005; centre and right).

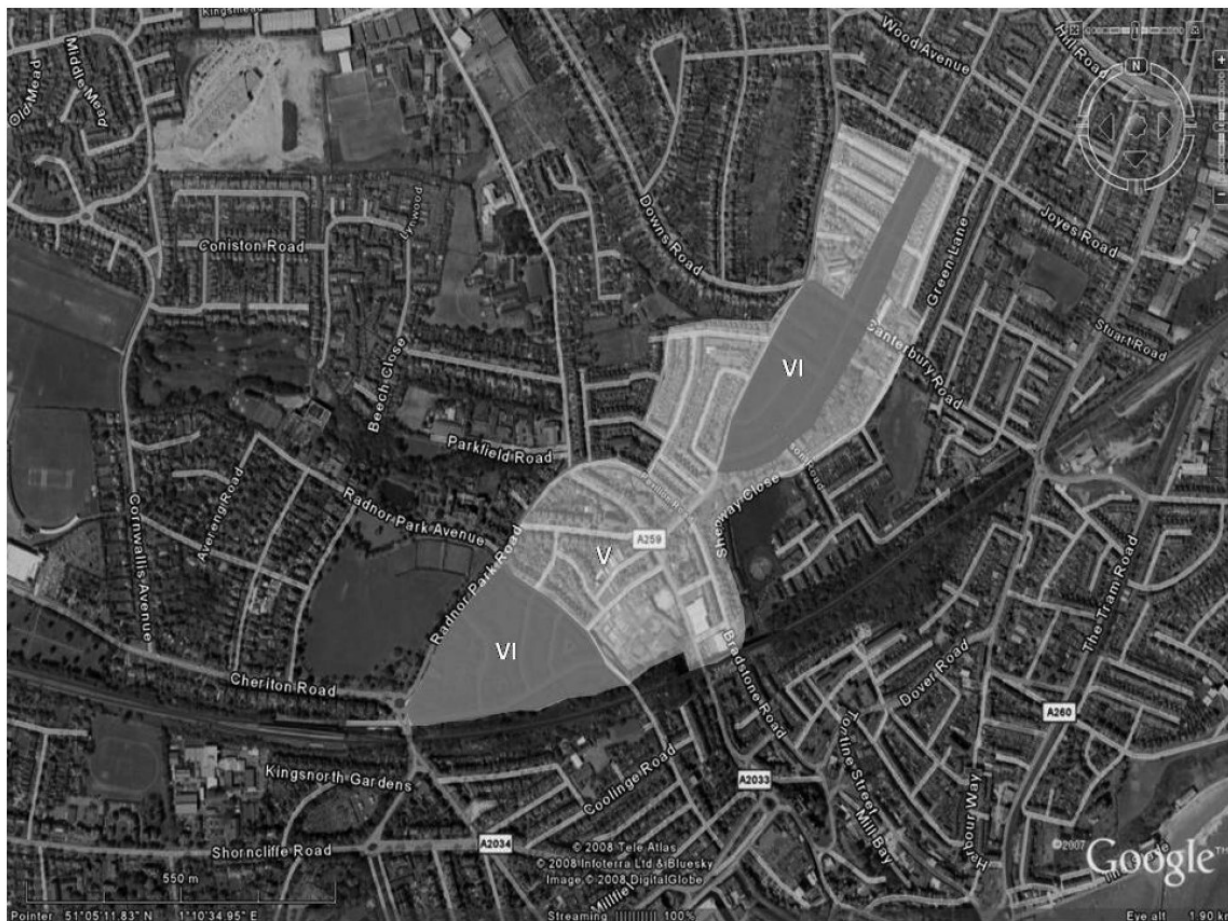
The maximum assigned macroseismic intensity was the matter of an extensive debate by Sargeant *et al.* (2008), mostly related to the interpretation of the EMS-98 scale (Grünthal, 1998). The two main issues under discussion were the consideration of cracks and partial collapse of chimneys as being structural or non-structural damage, and the actual vulnerability class of the building stock, the two resulting alternatives being maximum EMS-98 intensities of VI or VII. Sargeant *et al.* (2008) finally concluded that an EMS-98 intensity of VI was the most reasonable estimate for the most heavily damaged areas of Folkestone. These and those with an assigned intensity of V are marked in the map of Figure A4.12.13.

Figure A4.12.13. Areas with assigned EMS-98 intensities of 5 and 6 based only on the results of the field survey after the Folkestone earthquake (considering chimneys as non-structural components). From Sargeant *et al.* (2008).

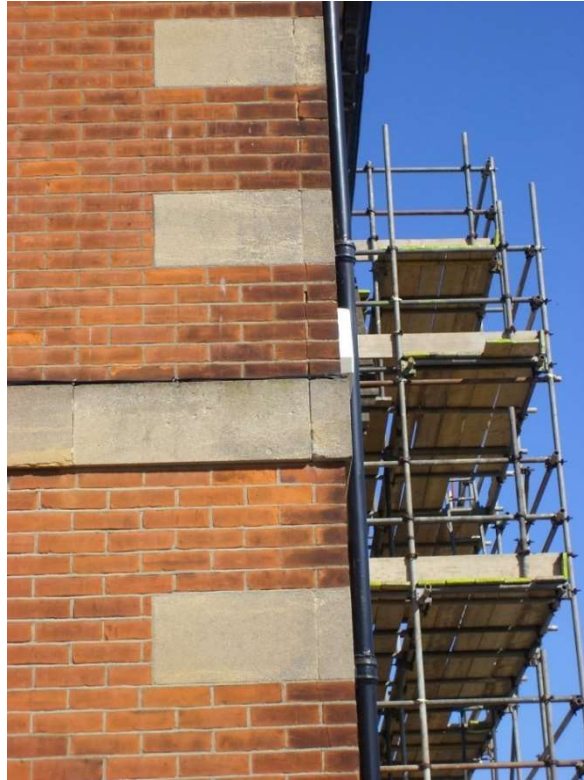
Figure A4.12.30. Harvey Boy's Grammar School: vertical cracking exacerbated by the earthquake strong shaking. Courtesy of Dr. Graeme Weatherill.

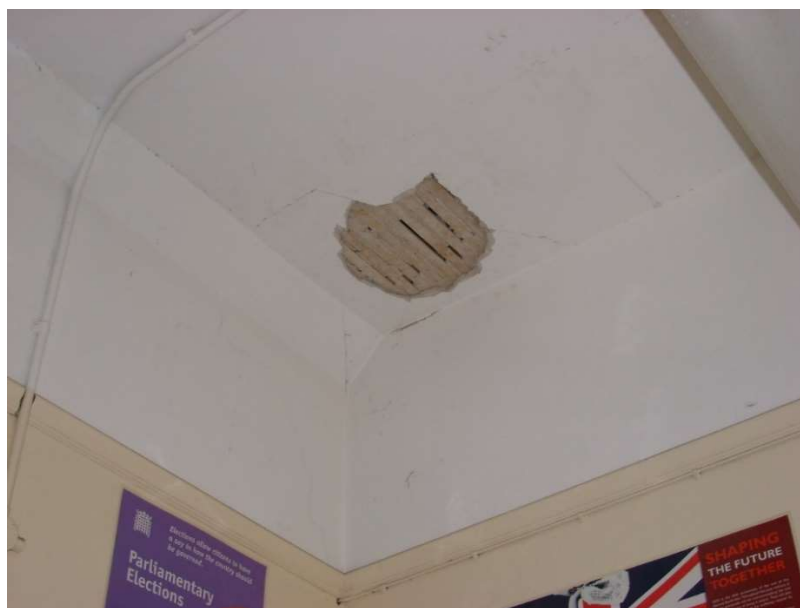
Figure A4.12.31. Harvey Boy's Grammar School: cracked and fallen plaster observed in the classroom. Courtesy of Dr. Graeme Weatherill.

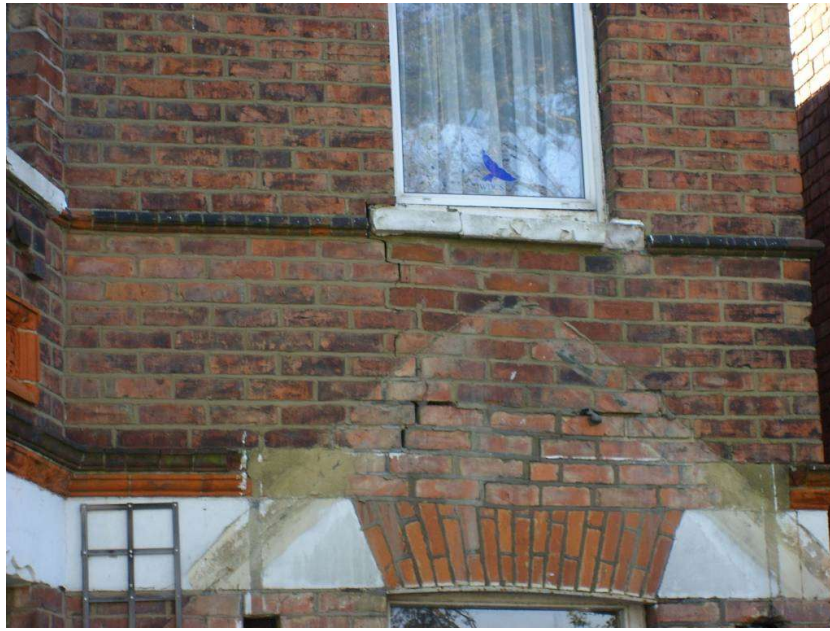
Figure A4.12.32. Cracks in masonry observed in Radnor Park Road. Photograph credit: G. Weatherill. From Sargeant *et al.* (2008), colour version courtesy of Dr. Graeme Weatherill.

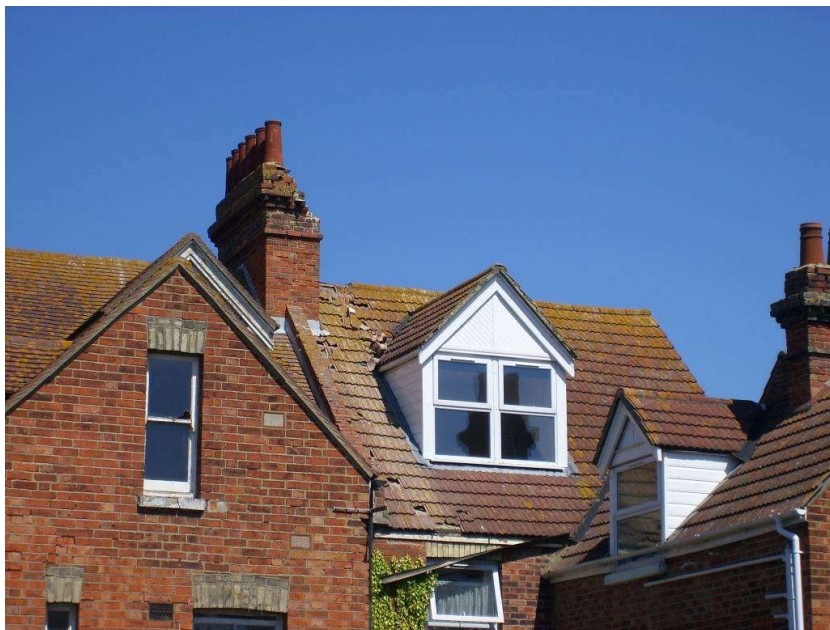
Figure A4.12.33. Chimney stack and damage to roof tiles. Photograph credit: G. Weatherill. From Sargeant *et al.* (2008), colour version courtesy of Dr. Graeme Weatherill.

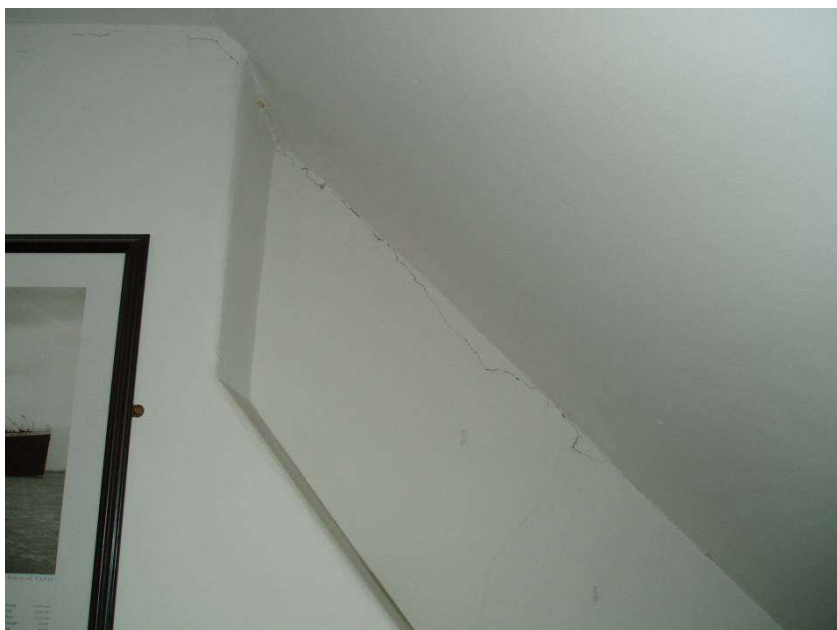
Figure A4.12.34. Cracking of interior of property in Gladstone Road. Photograph credit: S.L. Sargeant, courtesy of Dr. G. Weatherill.

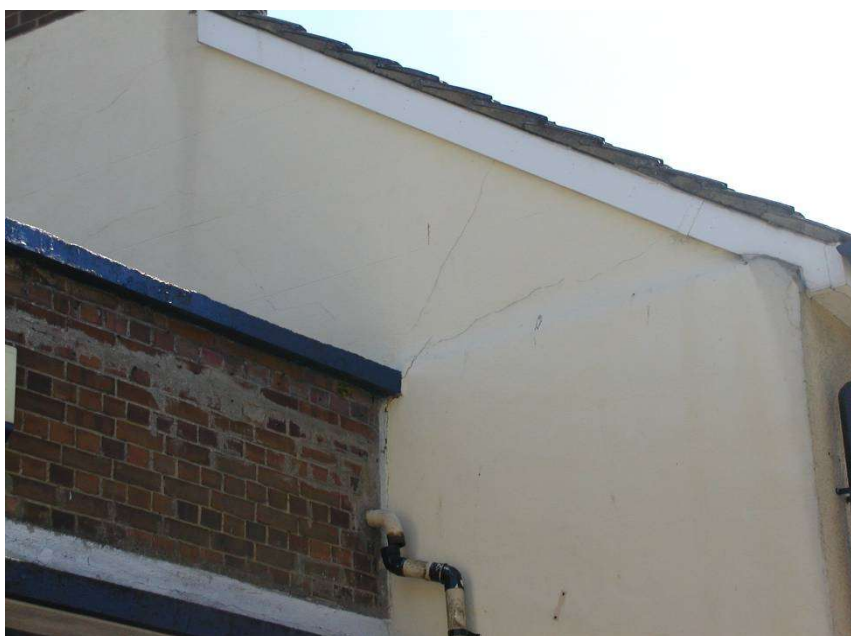
Figure A4.12.35. Cracking at junction between terrace house style (to right) and a 1960s inserted replacement property. Photograph credit: P.W. Burton, courtesy of Dr. G. Weatherill.

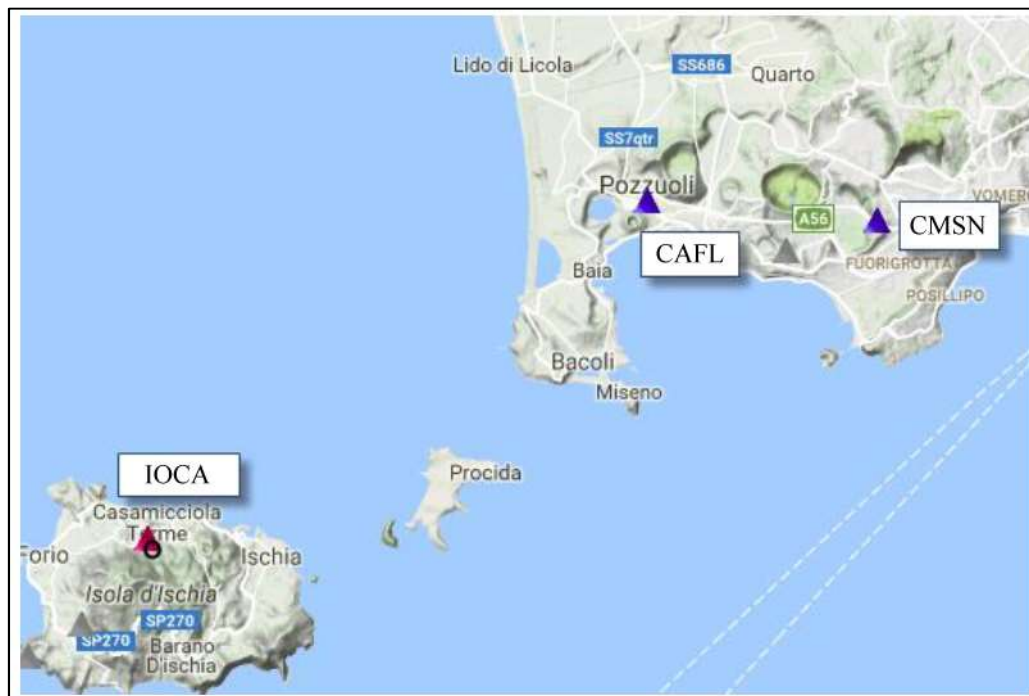
The maximum values of PGA were recorded at the IOCA station, which is located in the centre of Casamicciola (Figure A4.13.24), at low topography (altitude of 123 m, ESM, 2017), 0.8 km away from the epicentre calculated by the INGV and reported in Table A4.13.3 (8.5 km according to the CSEM/EMSC estimate) and 0.5 km away from the most affected area, according to INGV G.D.L. (2017). According to ESM (2017), it is situated on EC8 soil type B. However, this characterization was obtained from geological considerations, without a

Figure A4.13.24. Location of the IOCA station on the island and of the closest stations (CAFL, CMSN) on the mainland. Modified from Iervolino *et al.* (2017).

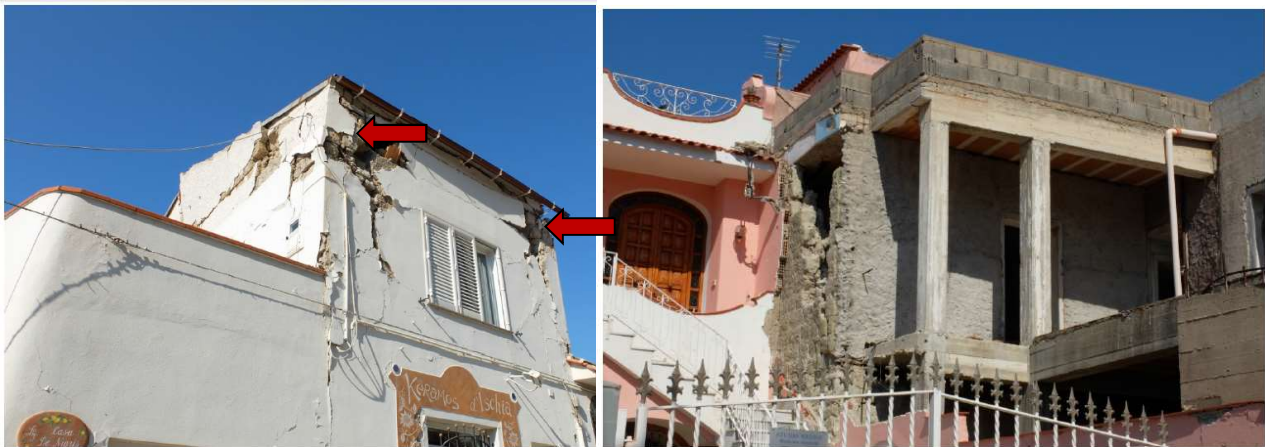
Not many details on prior damage or retrofit of the built environment are available. Only Di Manna *et al.* (2017) mention that during the damage surveys it has been possible to identify masonry buildings with strengthening interventions in the past, such as the addition of steel rods under the roof (Figure A4.13.44, left). They have recognized, as well, buildings that have undergone interventions for enlargement during which attempts for structural upgrade with RC elements have been endeavoured, such as the example on Figure A4.13.44 (right).

Figure A4.13.44. Masonry building with addition of steel rods under the roof (left), and enlargement of building with attempts of structural strengthening by means of RC elements (right). From Di Manna *et al.* (2017).

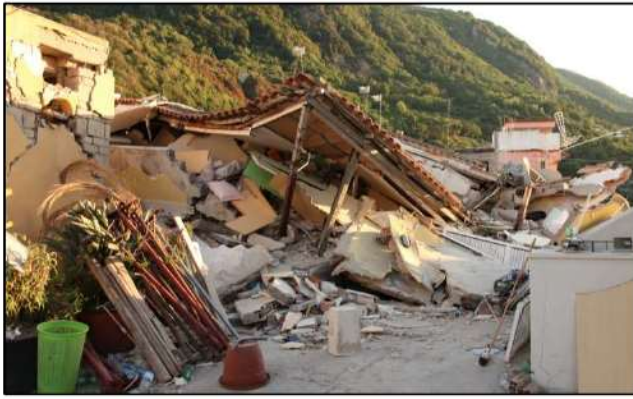
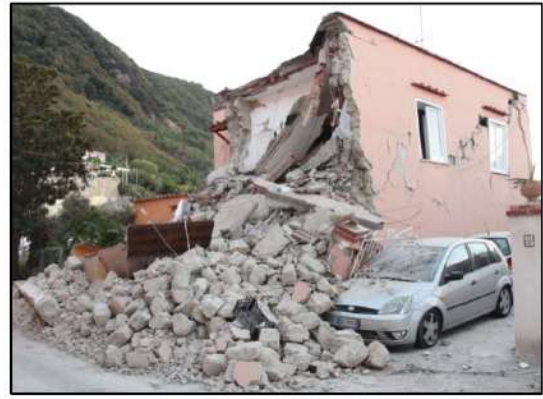
Figure A4.13.48. Total (left) and partial (right) collapse in the red zone of Casamicciola. From Azzaro *et al.* (2017).

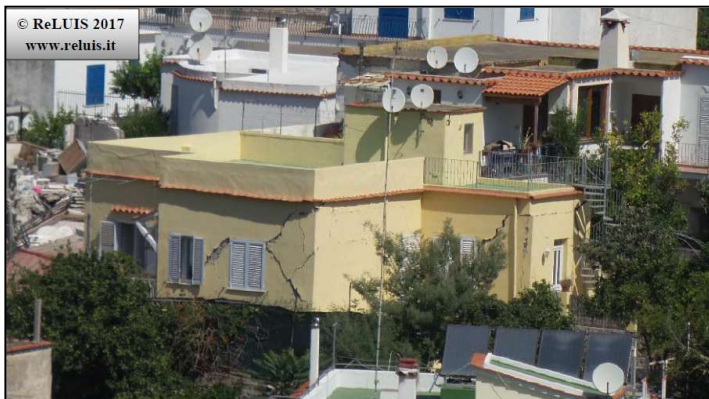
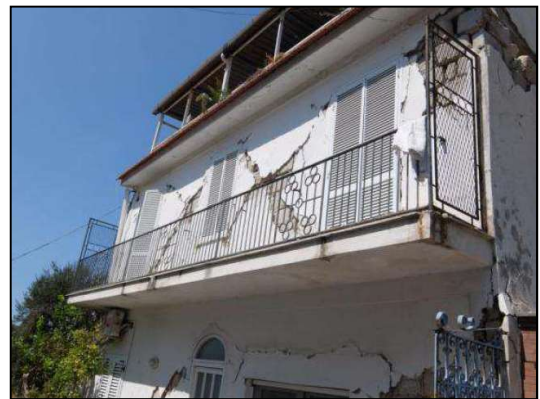
Zuccaro *et al.* (2017) comment that the out-of-plane failure of the walls was not a common type of failure during the earthquake of Ischia and, instead, diagonal shear cracking (Figure A4.13.49) appeared more often. The authors interpret this observation as a hint of “good box-like behaviour, high masonry quality and good interlock of cantonal walls”. Moreover, they attribute the detachment of the wall corners to the good restraint of the walls. These explanations are rather contradictory to the descriptions of Di Manna *et al.* (2017), included in Section A4.13.7.2, who discuss the low-quality masonry and poor interlocking of walls.

Figure A4.13.49. Diagonal shear cracks in masonry buildings. From D'Ambra *et al.* (2017; left) and Zuccaro *et al.* (2017; right).
