A Database of Damaging Earthquakes of Moment Magnitude from 4.0 to 5.5 (Part 2)

**Cecilia I Nievas, Michail Ntinalexis, Danai Kazantzidou-Firtinidou,
Jovana Borozan, Marialuigia Sangirardi, Helen Crowley & Julian J
Bommer**

Datum March 2019

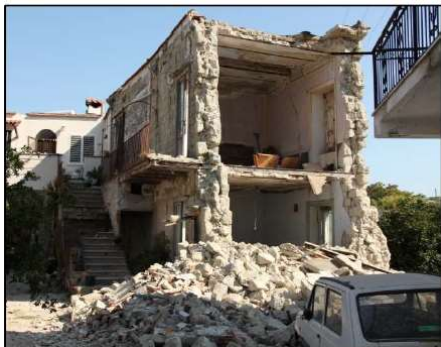
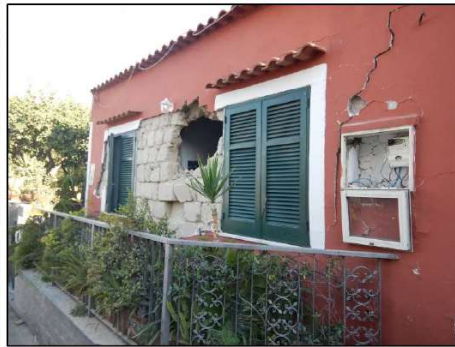
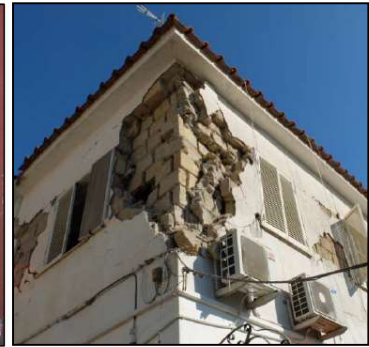
Figure A4.13.50. Out-of plane wall failure in Fango at Lacco Ameno (left); masonry expulsion and diagonal cracks in Casamicciola red zone (centre); delamination of wythes and corner failure (right). From Azzaro *et al.* (2017; left and centre) and Di Manna *et al.* (2017; right).

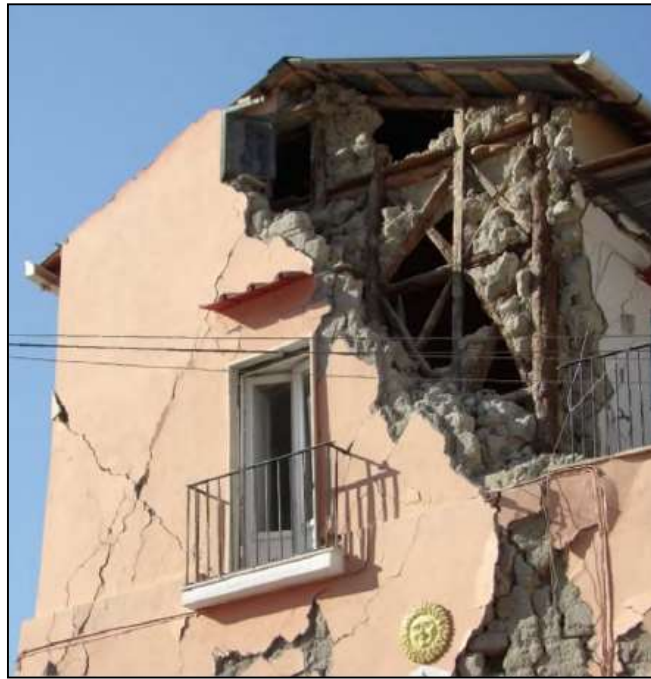
Both teams of Lekkas *et al.* (2017) and Zuccaro *et al.* (2017) have dedicated comments to the building with the dual system of Figure A4.13.51, highlighting that, despite the partial collapse of the masonry walls, the timber frame sustained the roof and prevented a more extensive collapse of the structure as a whole.

Figure A4.13.51. Damage to the masonry walls of the dual system building (Lekkas *et al.*, 2017).

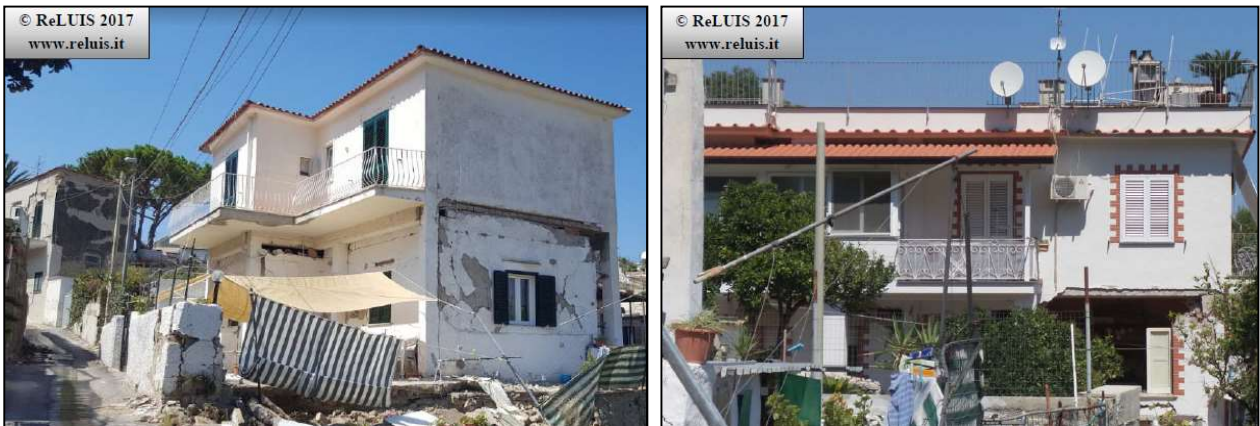
Lekkas *et al.* (2017) briefly report that only non-structural damage has been observed in RC buildings, while Azzaro *et al.* (2017) specify that limited cases of damage states 1 or 2 are observed in these typologies. D'Ambra *et al.* (2017) have noticed cracks, detachment (Figure A4.13.52, left) and collapse (Figure A4.13.52, right) of the infill panel of some RC buildings.

Figure A4.13.52. Detachment (left) and collapse (right) of infill panels of RC buildings. From D'Ambra *et al.* (2017).

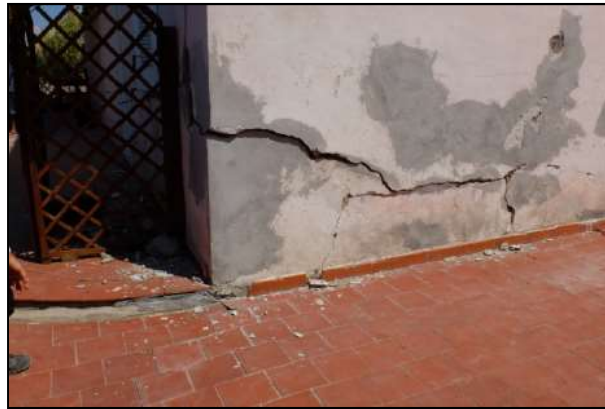
Subsidence of the foundations was observed by Di Manna *et al.* (2017) in some new and recently repaired buildings in Fango (Figure A4.13.53).

Figure A4.13.53. Subsidence of foundation of a residence in Fango (Di Manna *et al.*, 2017).

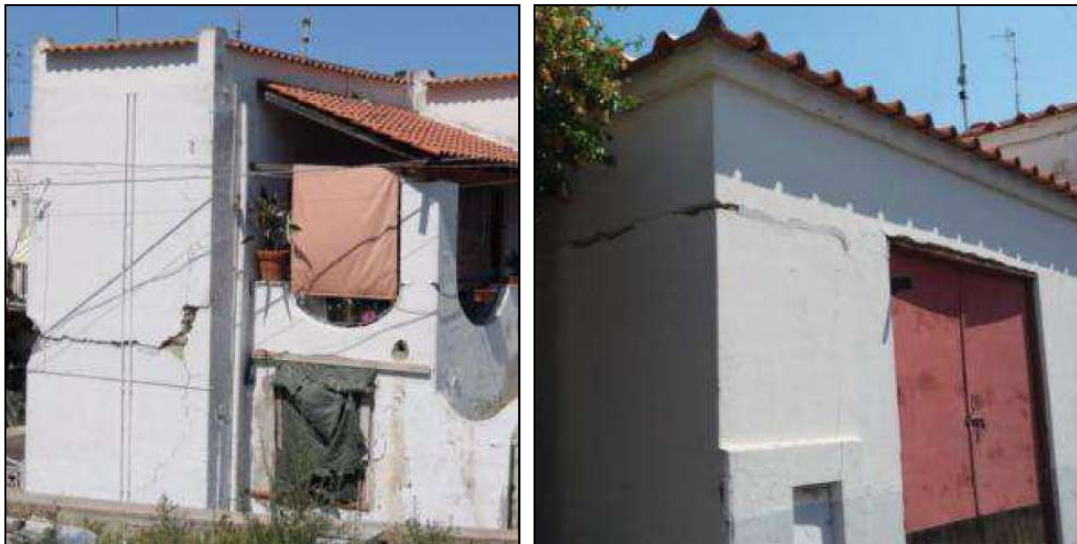
Horizontal cracks, running parallel to the intermediate floors or the roof, have also been observed in both masonry and RC buildings (Figure A4.13.54) and have been interpreted by Zuccaro *et al.* (2017) as a result from the combined effect of storey drifts and the large vertical component of the ground motion. In fact, several evidences of the high vertical component have been registered in the built environment, as illustrated by Figure A4.13.55

Figure A4.13.54. Horizontal crack at floor level due to story drift (Zuccaro *et al.*, 2017)

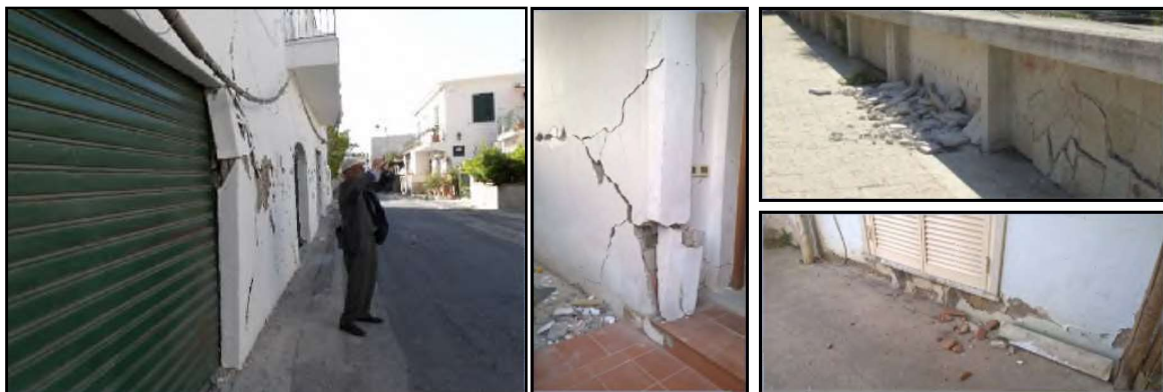
Figure A4.13.55. Damage in different buildings evidencing the impact of the high vertical seismic component (Lekkas *et al.*, 2017).

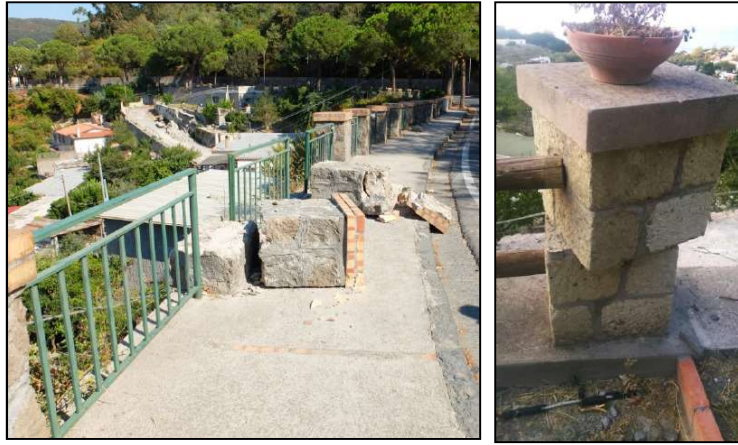
(Lekkas *et al.*, 2017), as well as to non-structural elements (Zuccaro *et al.*, 2017). Damage to the latter consisted mainly on the overturning of parapet walls located along the side of the street (Figure A4.13.56, left), detachment and overturning of a staircase, as well as horizontal cracks at columns (Figure A4.13.56, right).

Figure A4.13.56. Collapse of parapet side walls (left) (Di Manna *et al.*, 2017); rotation of tuff stone column (centre) (INGV G.D.L., 2017); collapse of house retaining wall (right) (INGV G.D.L., 2017).

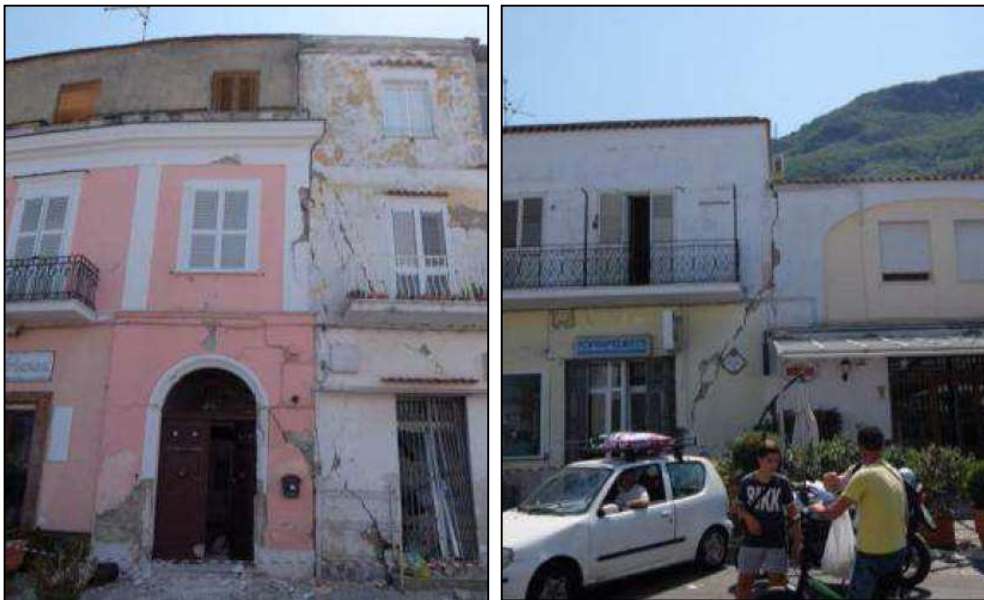
Another type of damage is reported by Zuccaro *et al.* (2017) and concerns cracks in adjacent buildings due to hammering due to staggered floors and lack of seismic joints, such as shown in Figure A4.13.57.

Figure A4.13.57. Damage to adjacent buildings due to hammering (Zuccaro *et al.*, 2017)
